ECO INSPECTION REPORT

Vehicle Information

Model	RS e-tron	Registration Type	Private
Year	2021	Registration No.	DL10CG3657
Trim	GT	VIN/Chassis Number	16191
Exterior Color	Grey	Kms Run	15025
Interior Color	Beige	Manufacturing Date	2021-05-20
Body Type	Sedan	Registration Date	2021-07-15
Fuel Type	Electric	Insurance Expiry	2022-7-14
Motor No.	452390	Location	Janak Puri
Number of Owners	1	Motor Sound Link	Listen Engine Sound

Order ID : 20588 Generated : 12 Feb 2021

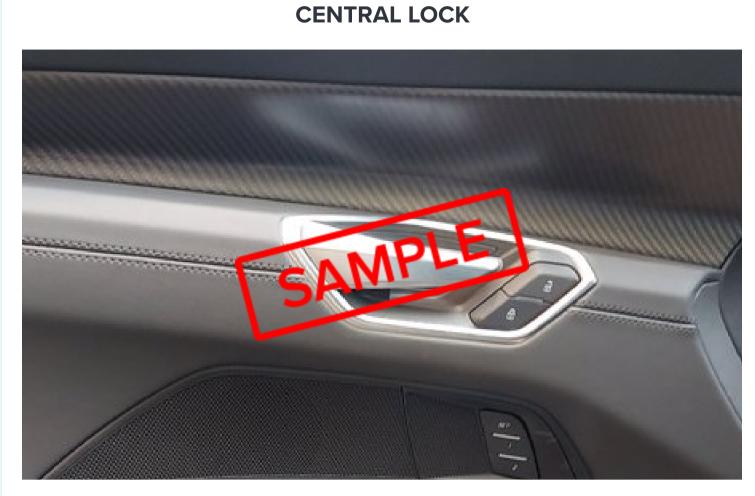
Central Lock Not Working Remarks

Repair Estimate ₹600

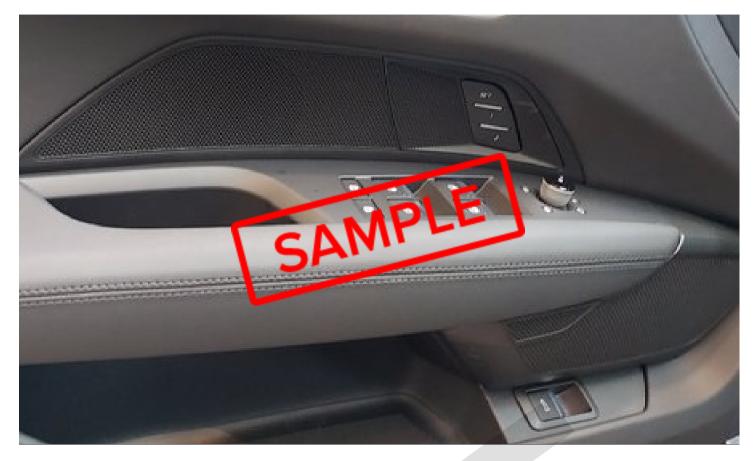
Power Window Not Working

Repair Estimate ₹600
