203682
Order ID

06 Sep 2022
Generated on

Vehicle Health Report

BMW X3 2018, XDRIVE 30I LUXURY LINE

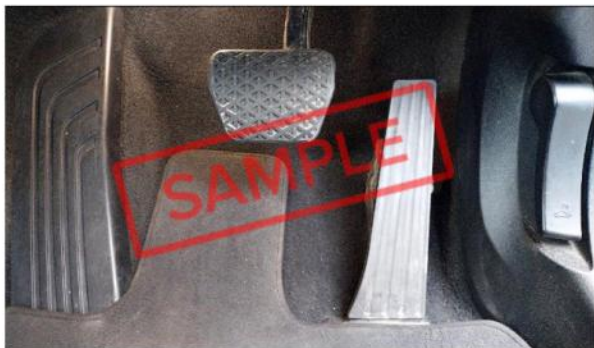
PEDAL BOOT CONDITION

Remarks Major Wear & Tear
Repair Estimate ₹ 5000

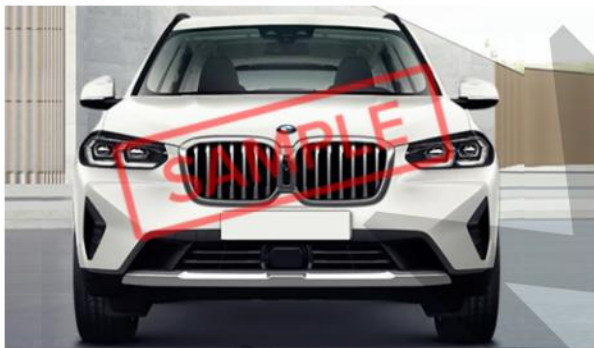
EXTERIOR HSRP COLOUR STICKER

Remarks HSRP colour sticker is not available
Repair Estimate ₹ 600

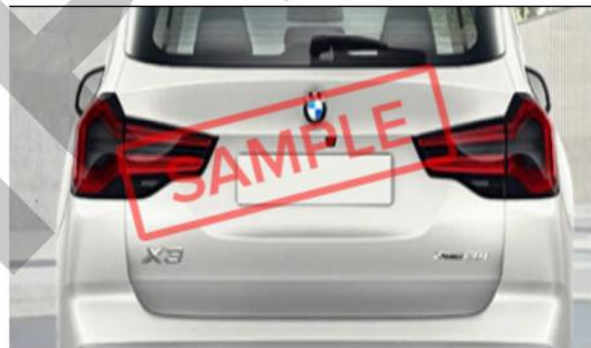
EXTERIOR REAR WINDSHIELD WIPER

Remarks Rear windshield wiper is not working or is damaged
Repair Estimate ₹ 100

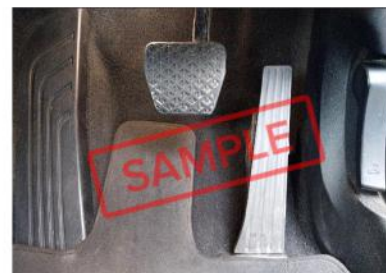
PEDAL BOOT CONDITION?

4 Pedals
