ECO INSPECTION REPORT

10 / 02 / 2022

Triumph Bonneville T100 2020

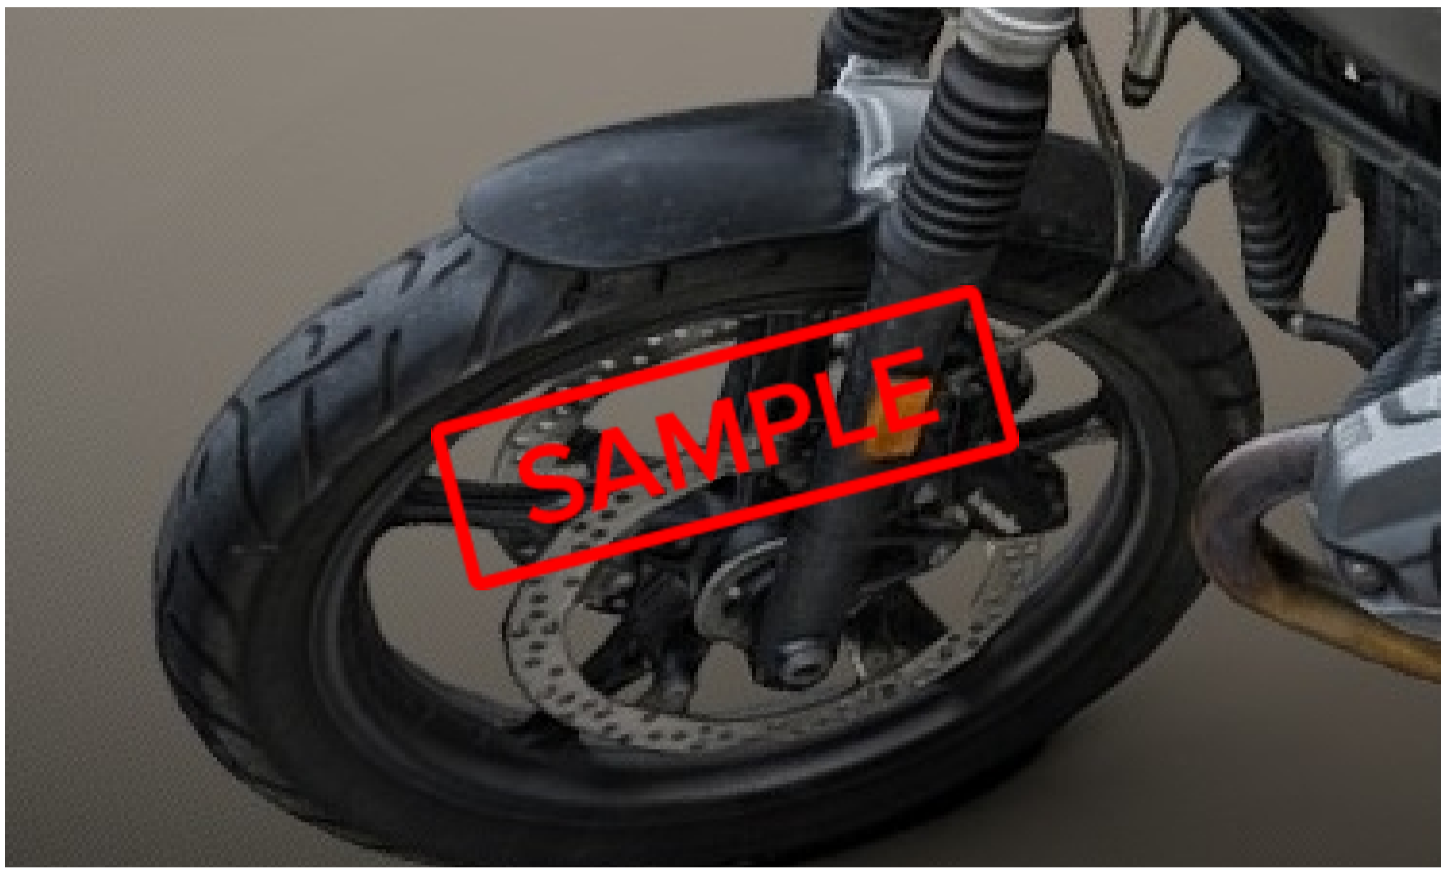
FRONT FENDER

Remarks: Front Fender Damage
Repair Estimate: ₹ 400

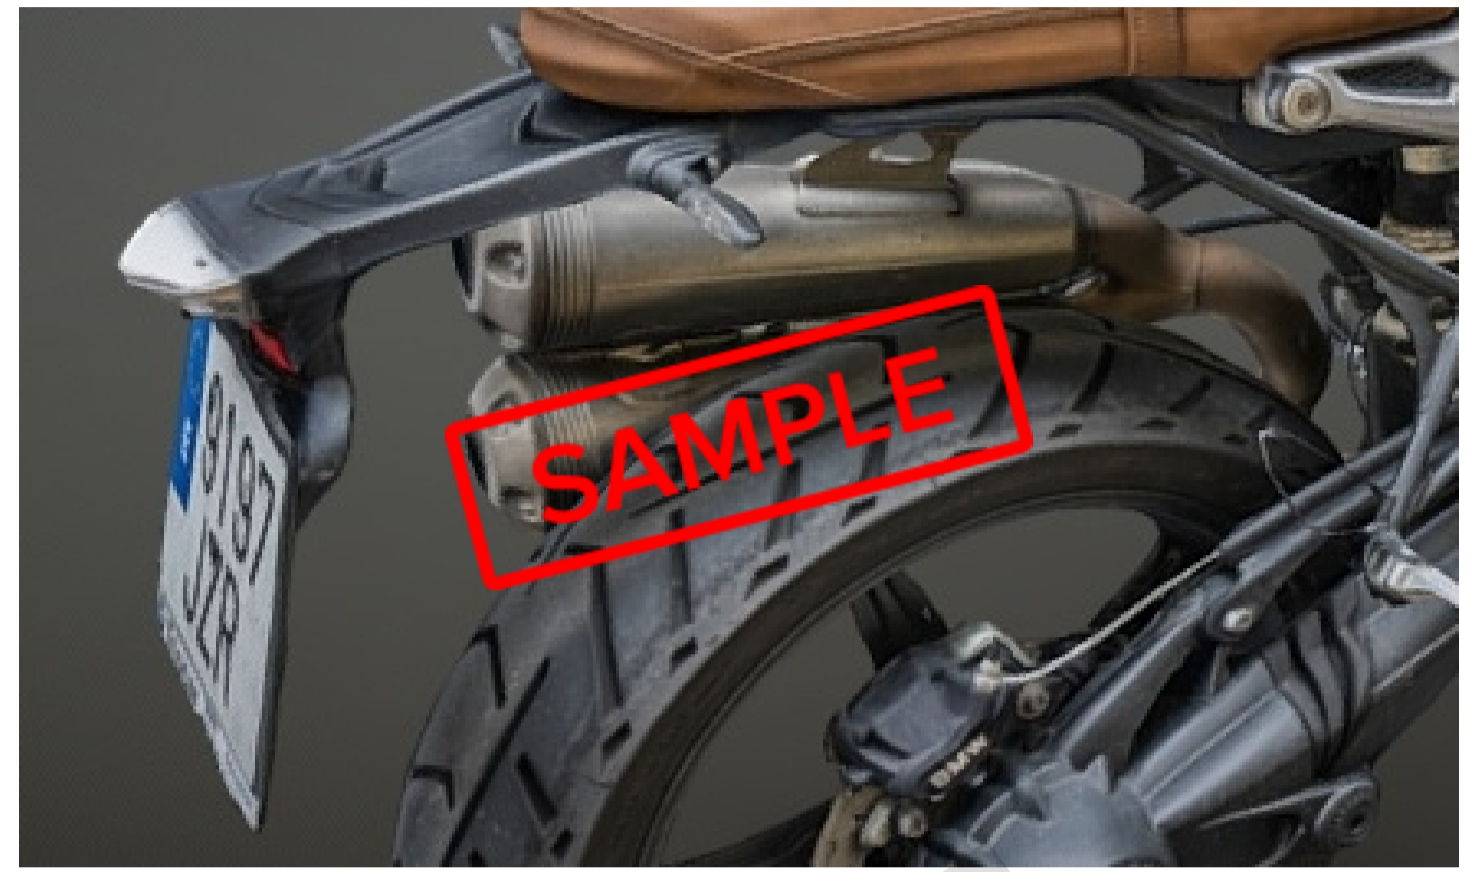
REAR FENDER

Remarks: Rear Fender Cracked
Repair Estimate: ₹ 300

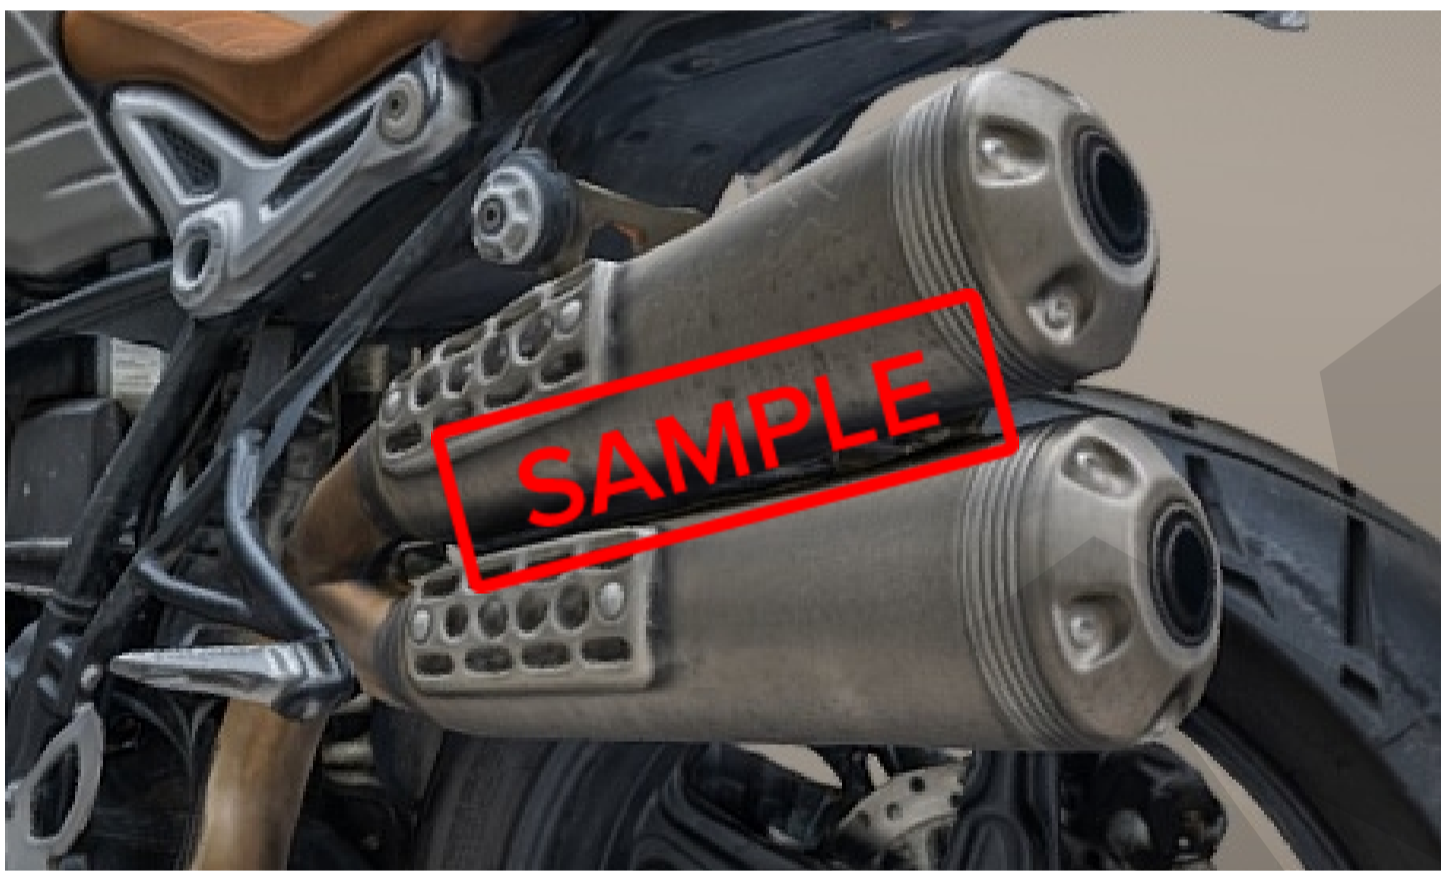
SILENCER/MUFFLER

Remarks: Silencer Not Working Properly
Repair Estimate: ₹ 350

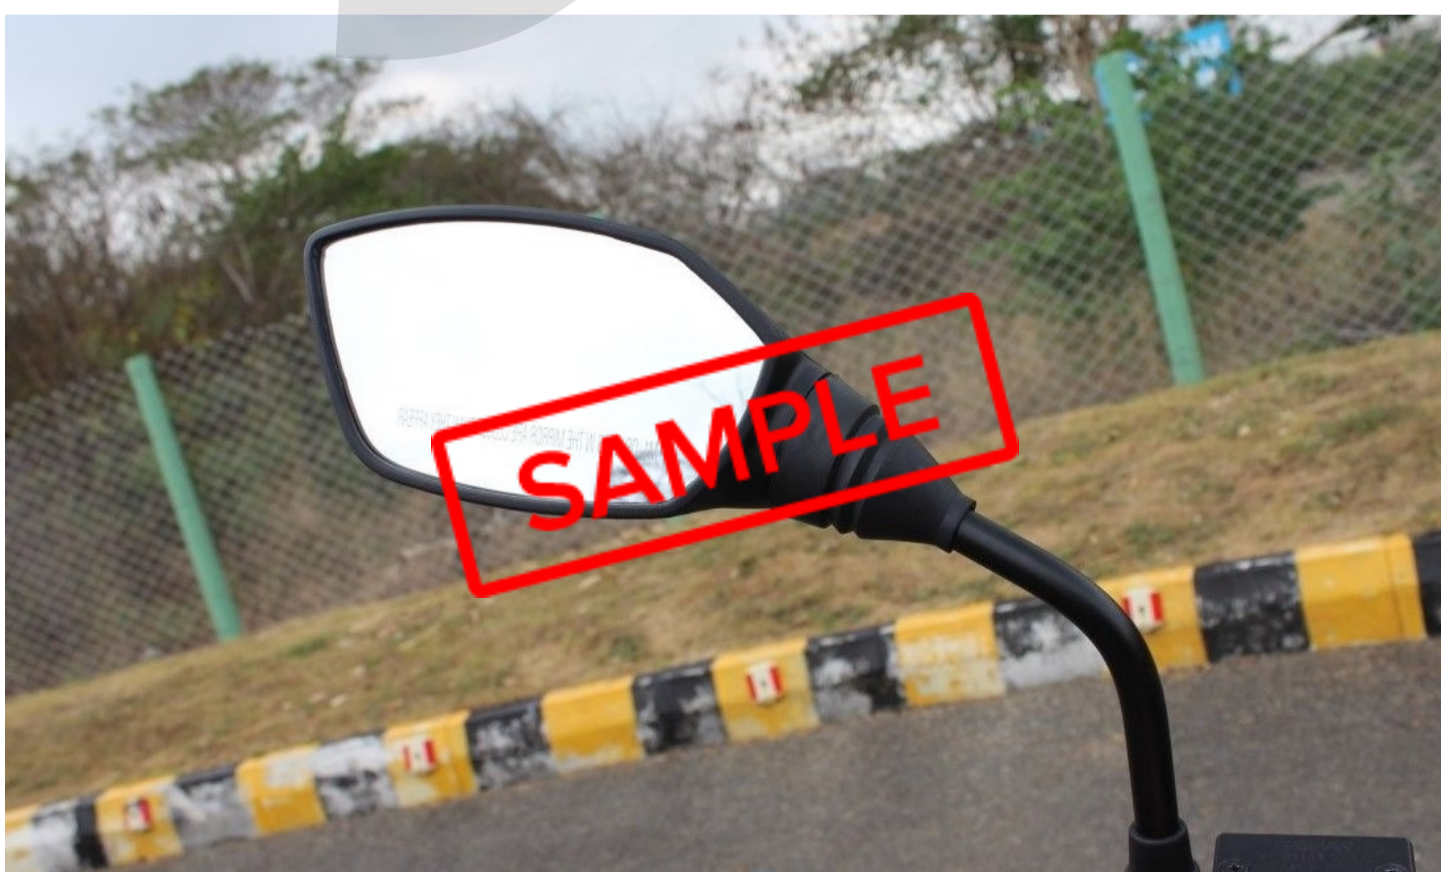
LH REAR VIEW MIRROR

Remarks: Glass Broken
Repair Estimate: ₹ 150

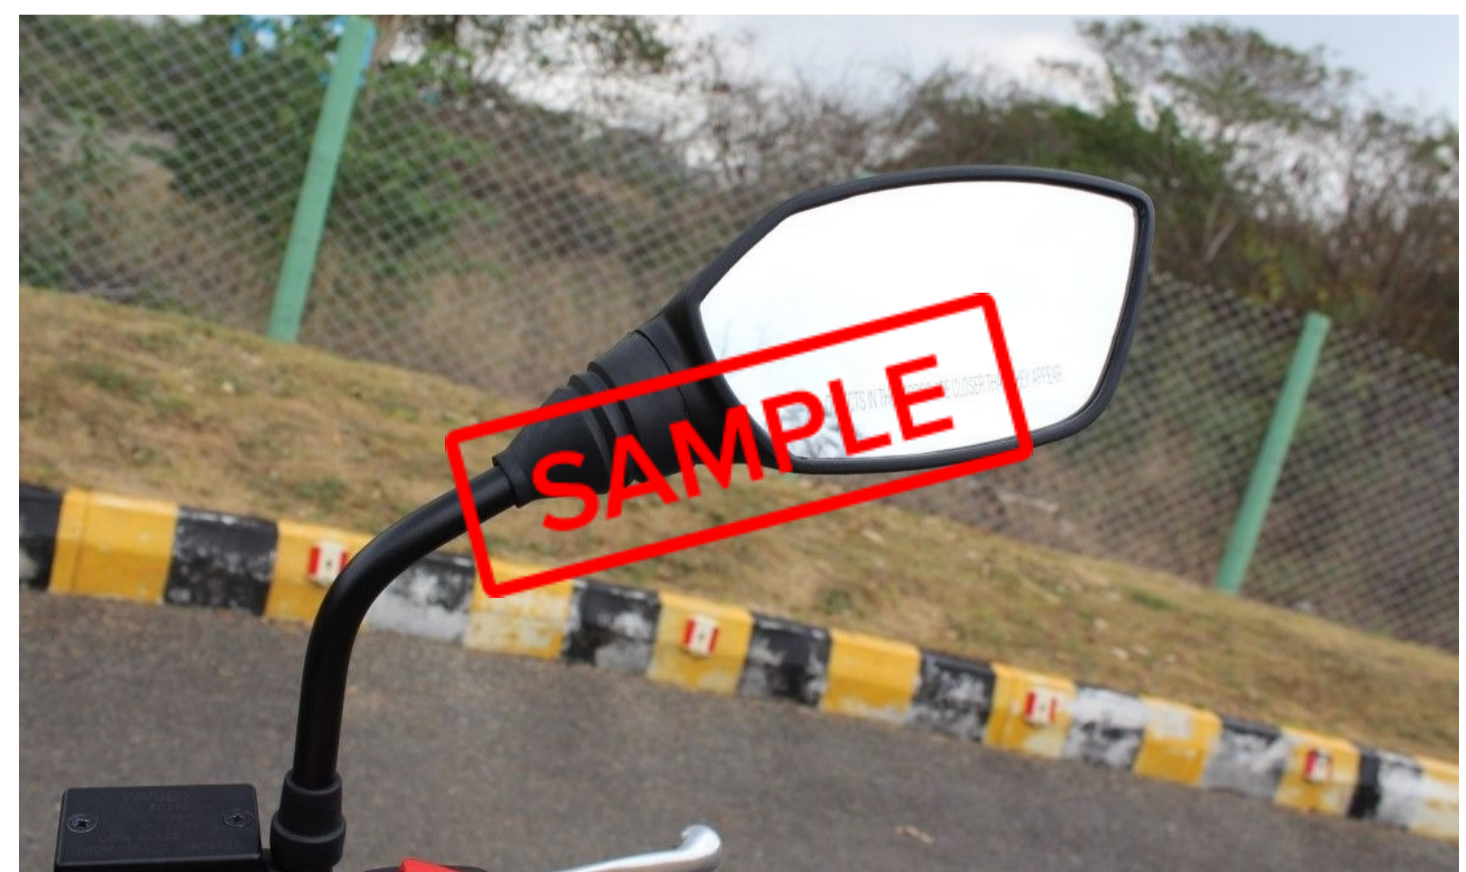
RH REAR VIEW MIRROR

Remarks: Casing Torn
Repair Estimate: ₹ 100

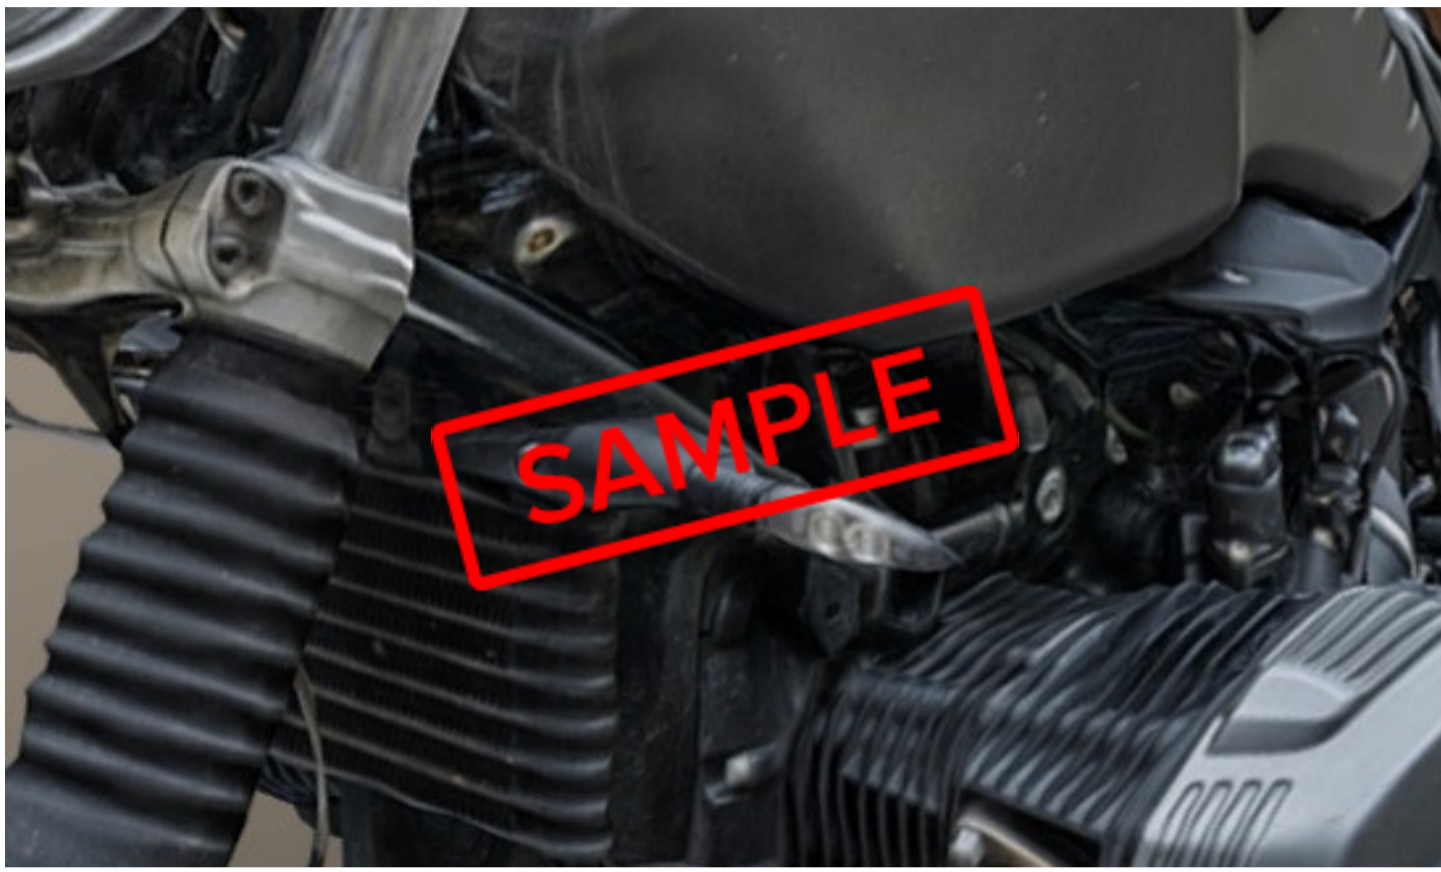
LH FRONT INDICATOR

Remarks: Bulb Needs To Be Replace
Repair Estimate: ₹ 300

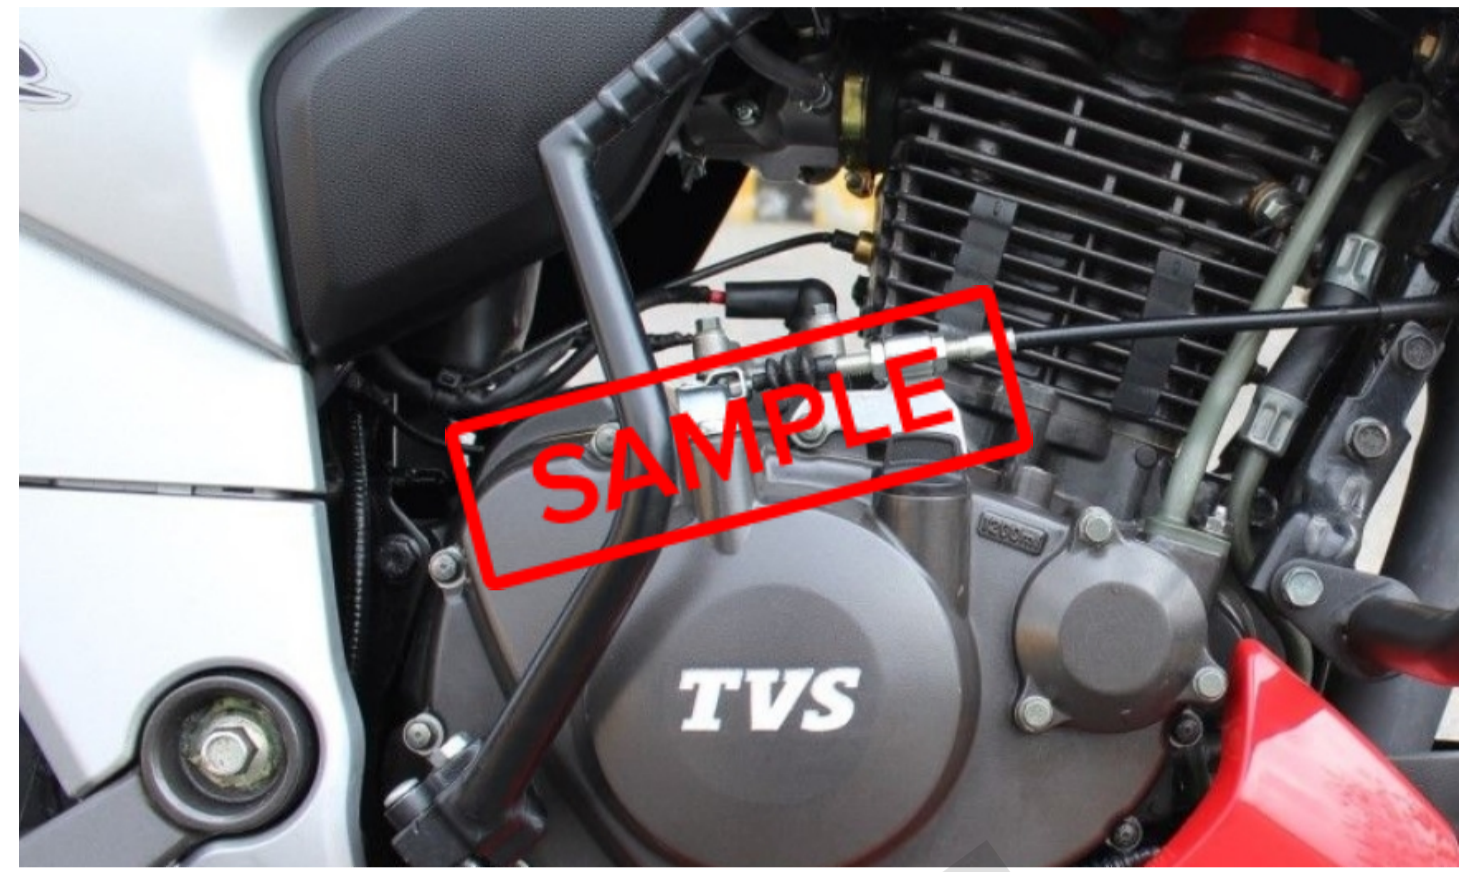
KICK START LEVER

Remarks: Lever Bearing Needs To Be Replaced
Repair Estimate: ₹ 350

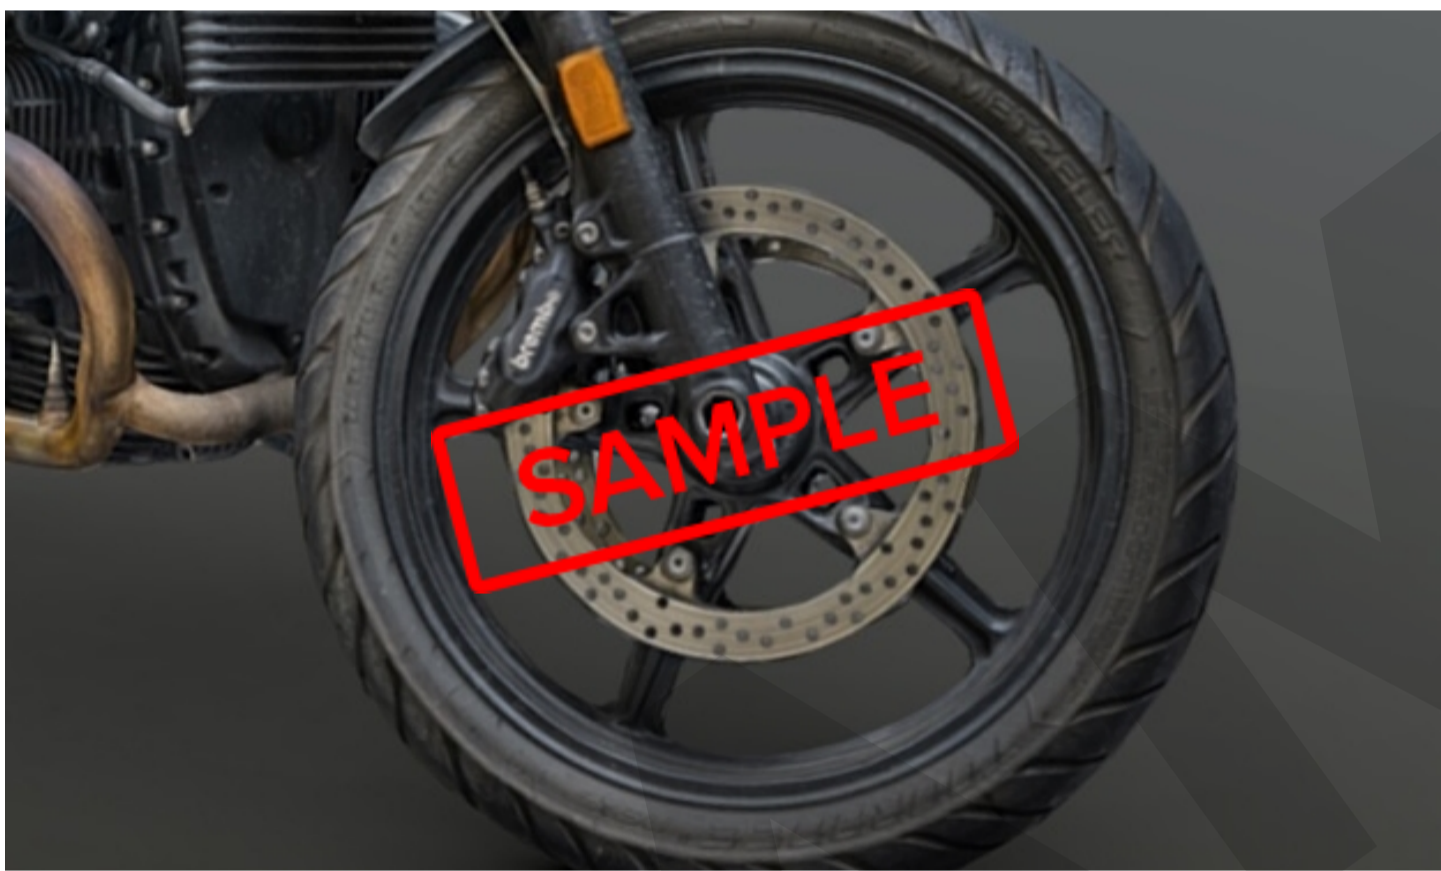
FRONT BRAKE

Remarks: Front Brake Needs Grease
Repair Estimate: ₹ 50

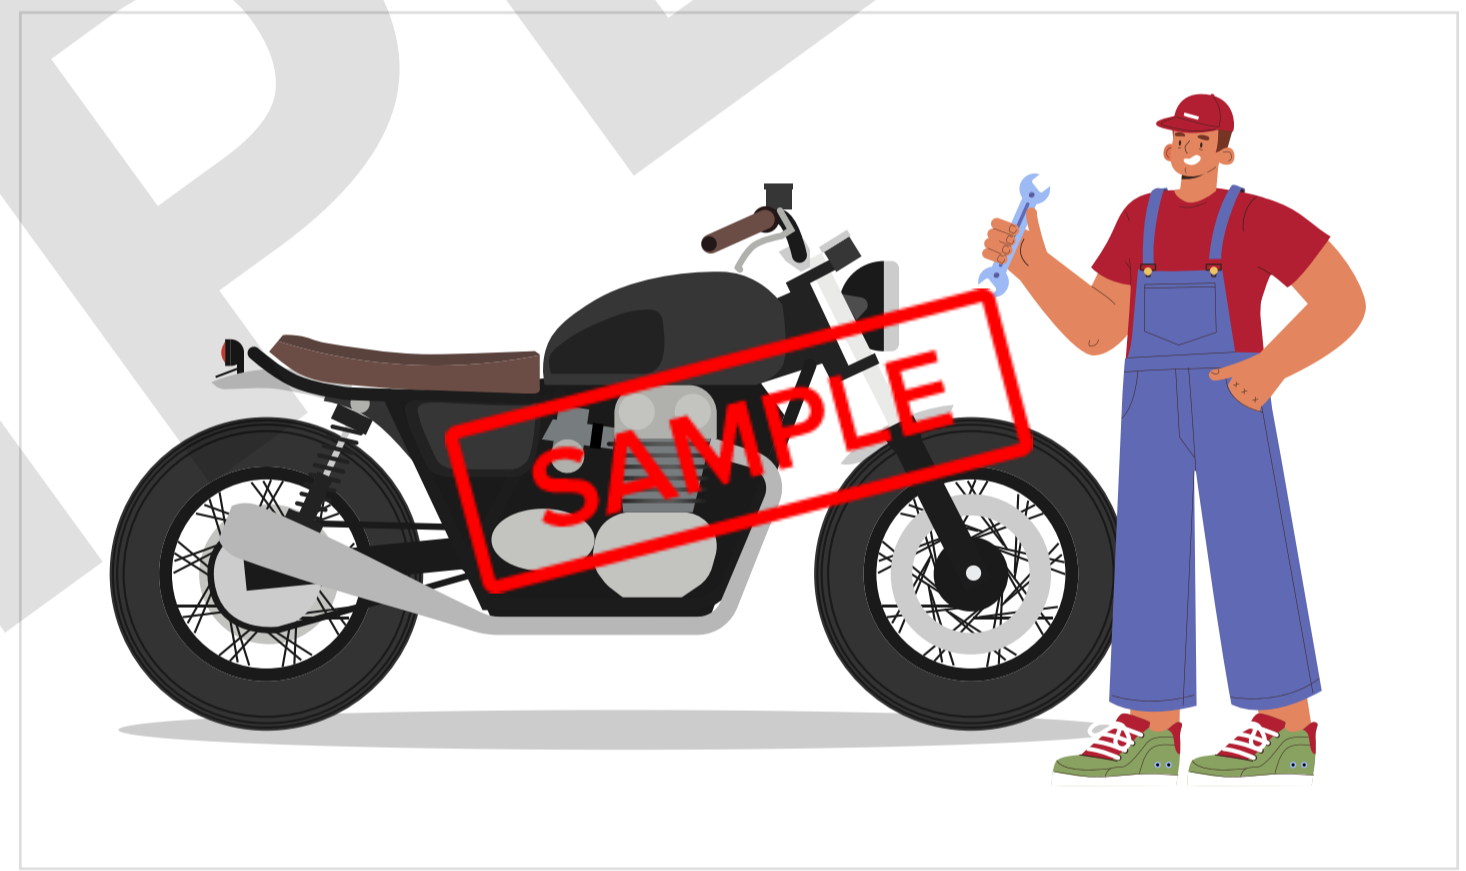
BRAKES CONDITION REAR

Remarks: Rear Brake Need Overhaul
Repair Estimate: ₹ 800

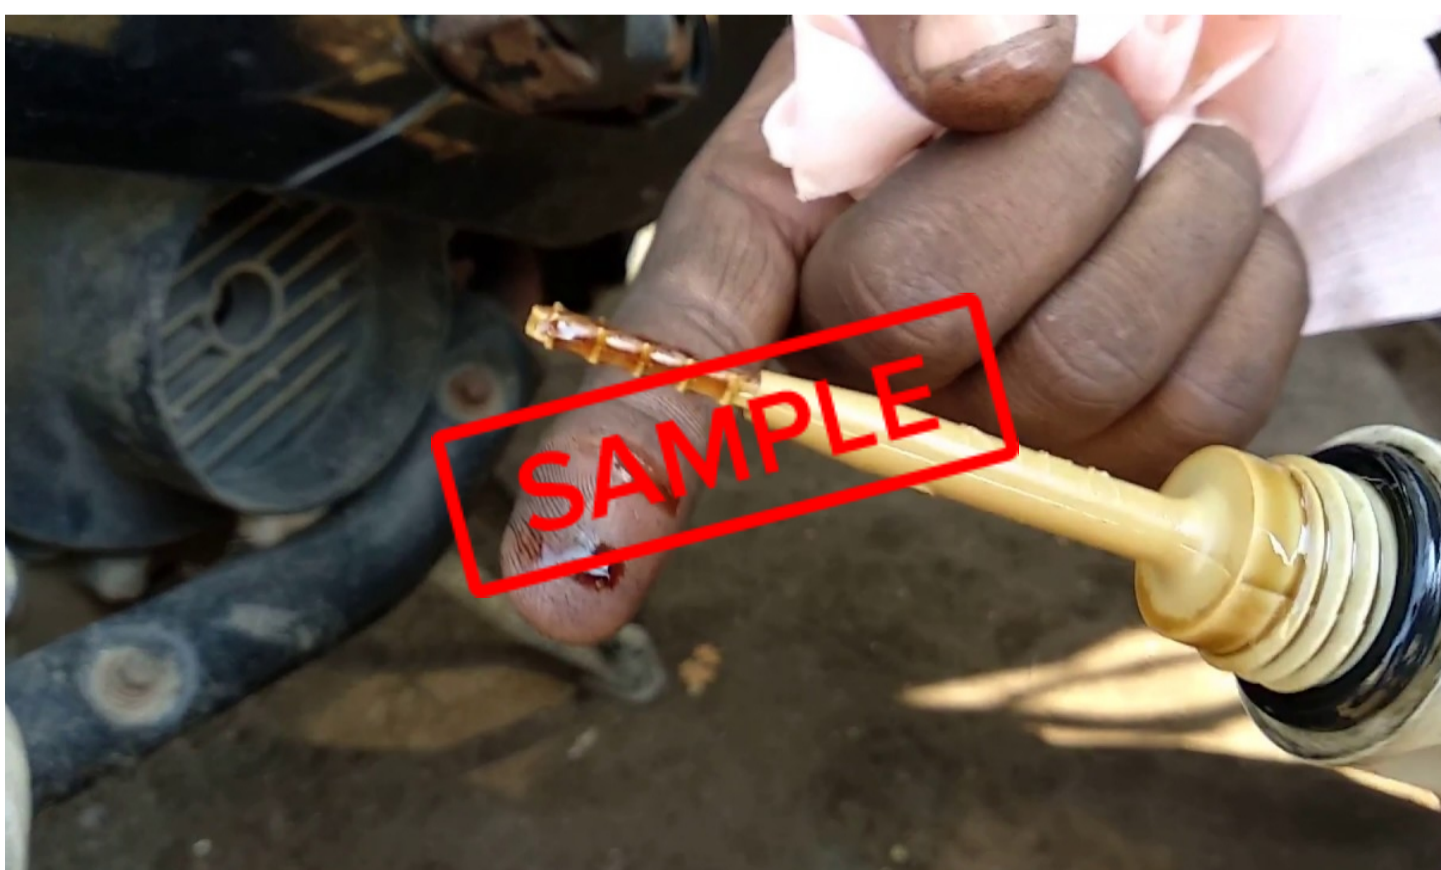
ENGINE OIL LEVEL

Remarks: Engine Oil Needs Replacement
Repair Estimate: ₹ 400

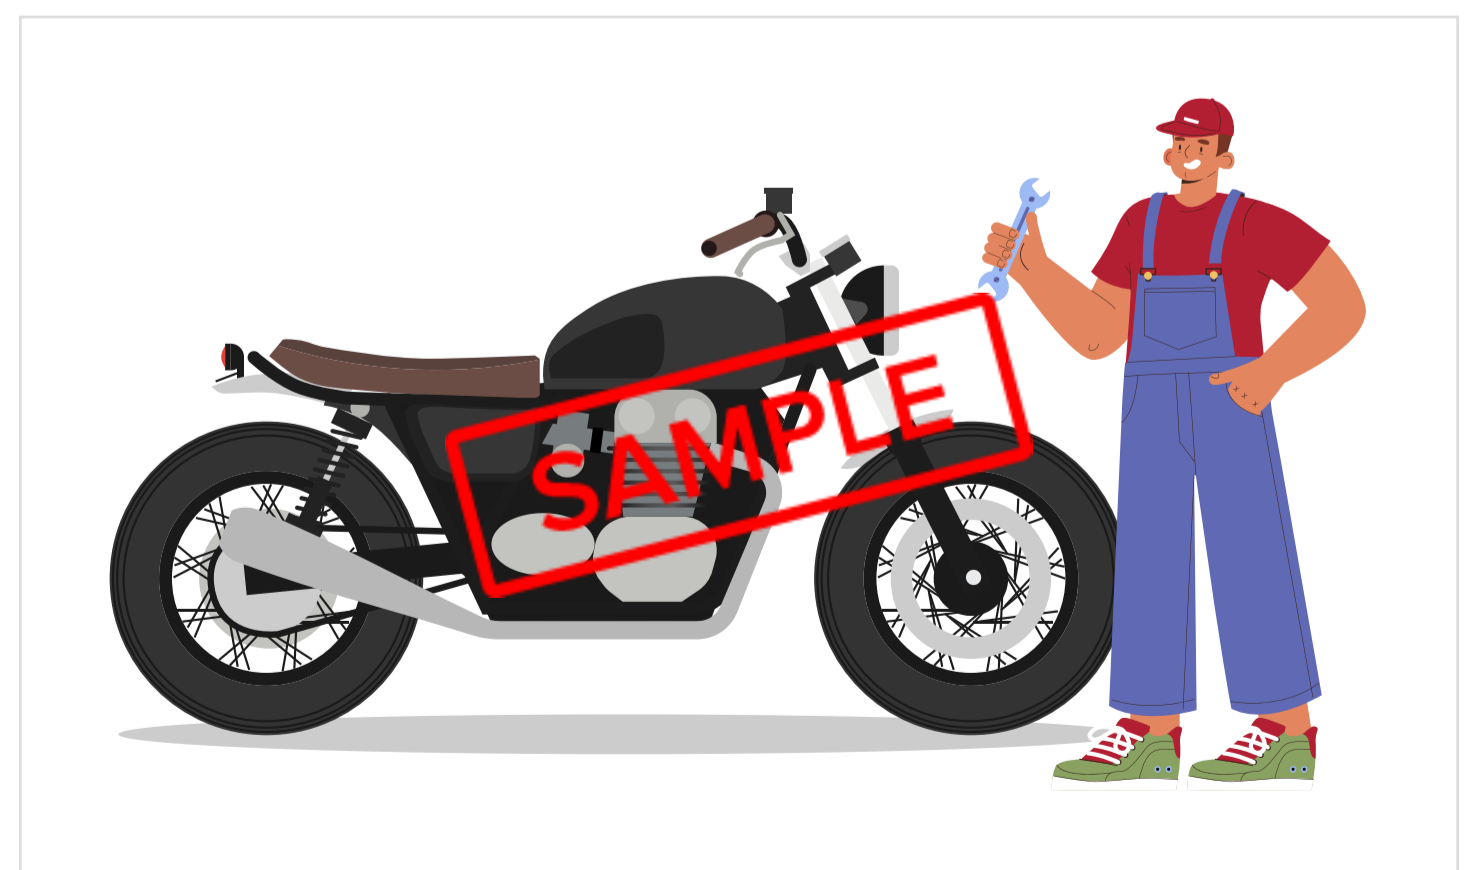
CHAIN LUBRICATED

Remarks: Chain Performance Has Major Fault
Repair Estimate: ₹ 600
