ECO INSPECTION REPORT

10 / 02 / 2022

Triumph Bonneville T100 2020

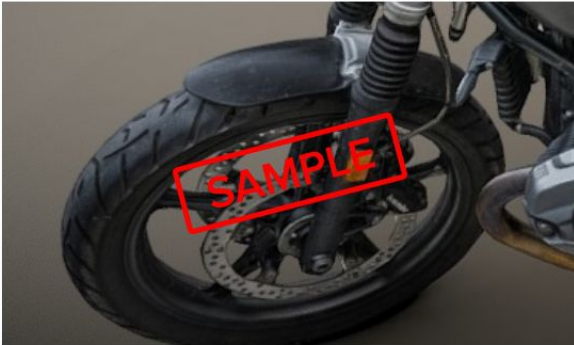
FRONT FENDER

Remarks Front Fender Damage
Repair Estimate ₹ 400

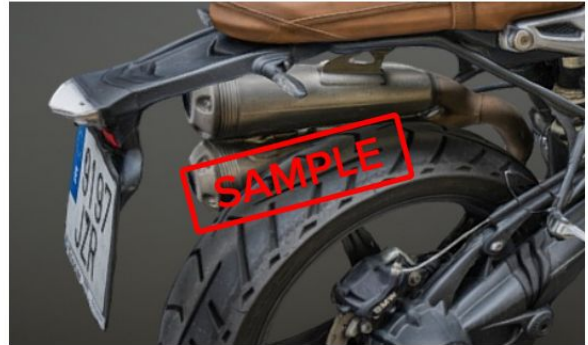
REAR FENDER

Remarks Rear Fender Cracked
Repair Estimate ₹ 300

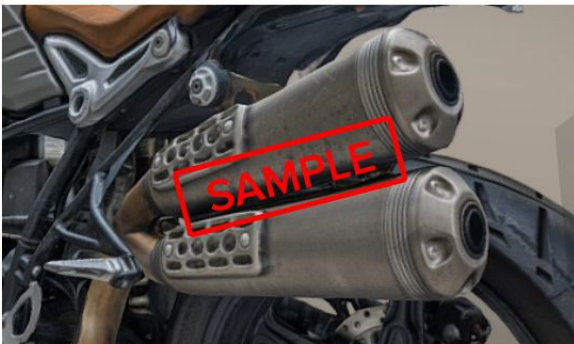
SILENCER/MUFFLER

Remarks Silencer Not Working Properly
Repair Estimate ₹ 350

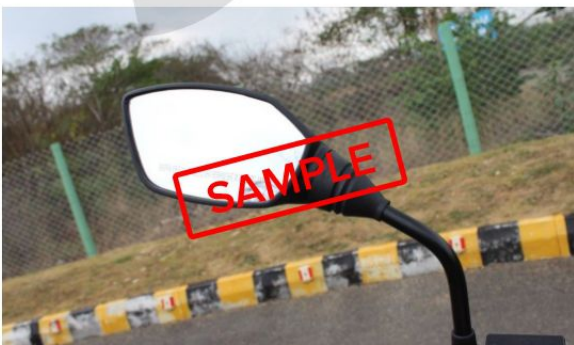
LH REAR VIEW MIRROR

Remarks Glass Broken
Repair Estimate ₹ 150

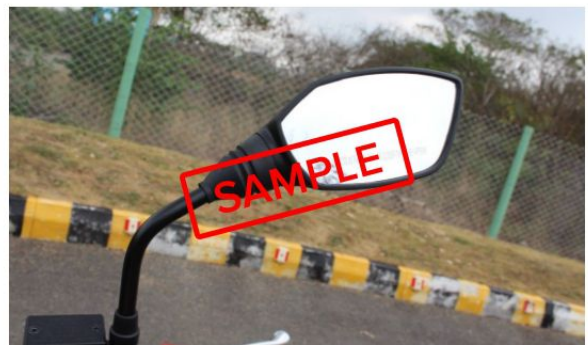
RH REAR VIEW MIRROR

Remarks Casing Torn
Repair Estimate ₹ 100

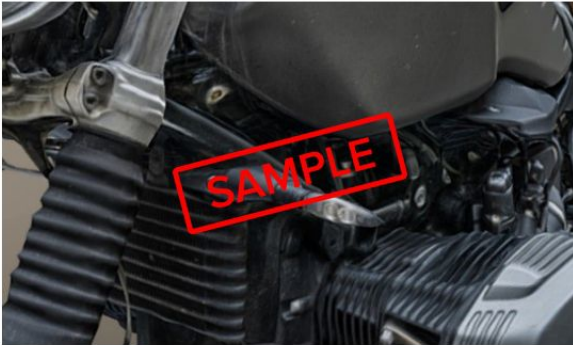
LH FRONT INDICATOR

Bulb Needs To Be Replace

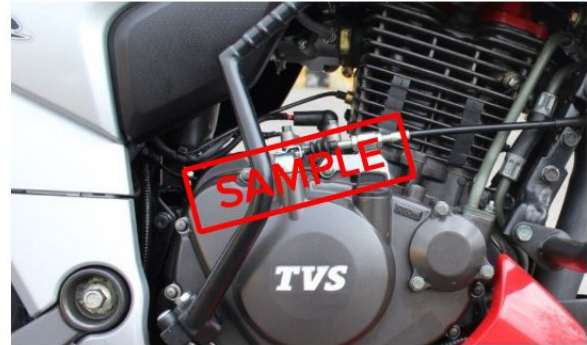
KICK START LEVER

Lever Bearing Needs To Be Replaced

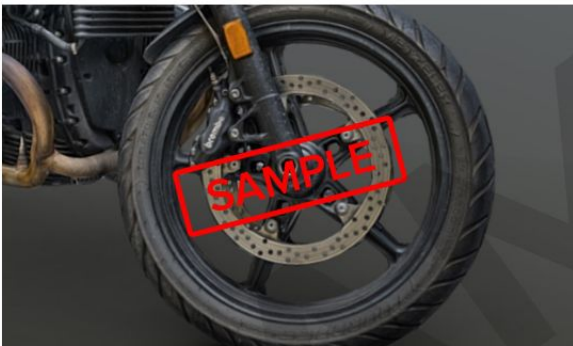
FRONT BRAKE

Front Brake Needs Grease

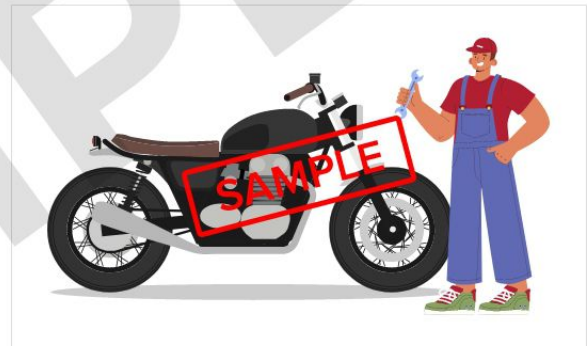
BRAKES CONDITION REAR

Rear Brake Need Overhaul

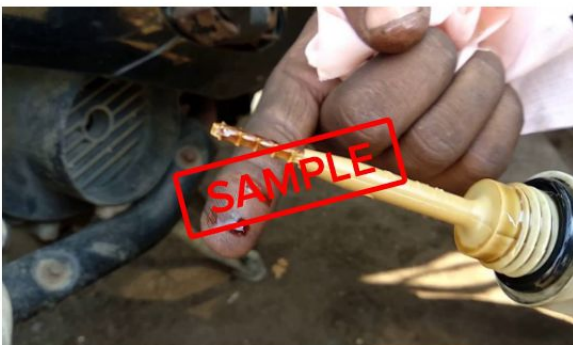
ENGINE OIL LEVEL

Engine Oil Needs Replacement

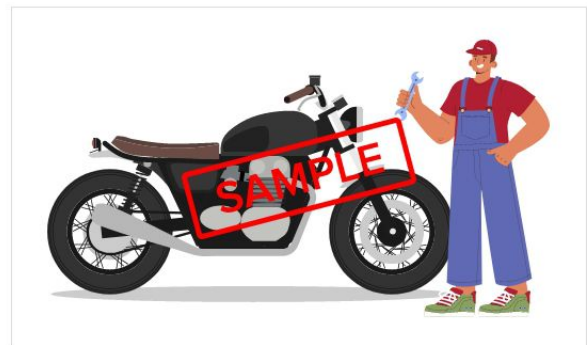
CHAIN LUBRICATED

Chain Performance Has Major Fault
