ECO INSPECTION REPORT

Audi A4 Premium Plus, 2019

Make	Audi	Transmission Type	Automatic
Model	A4	Registration Type	Private
Year	2019	Registration No.	DL10CG3657
Trim	Premium Plus	VIN/Chassis Number	16191
Exterior Color	Terra Gray	Kms Run	25105
Interior Color	Beige	Manufacturing Date	2022-05-20
Body Type	Sedan	Registration Date	2022-07-15
Fuel Type	Petrol	Insurance Expiry	2020-7-14
Engine CC	200	CNG Validity	2025-6-20
Engine No.	452390	Location	Janak Puri
Number of Owners	2	Engine Sound Link	Listen Engine Sound

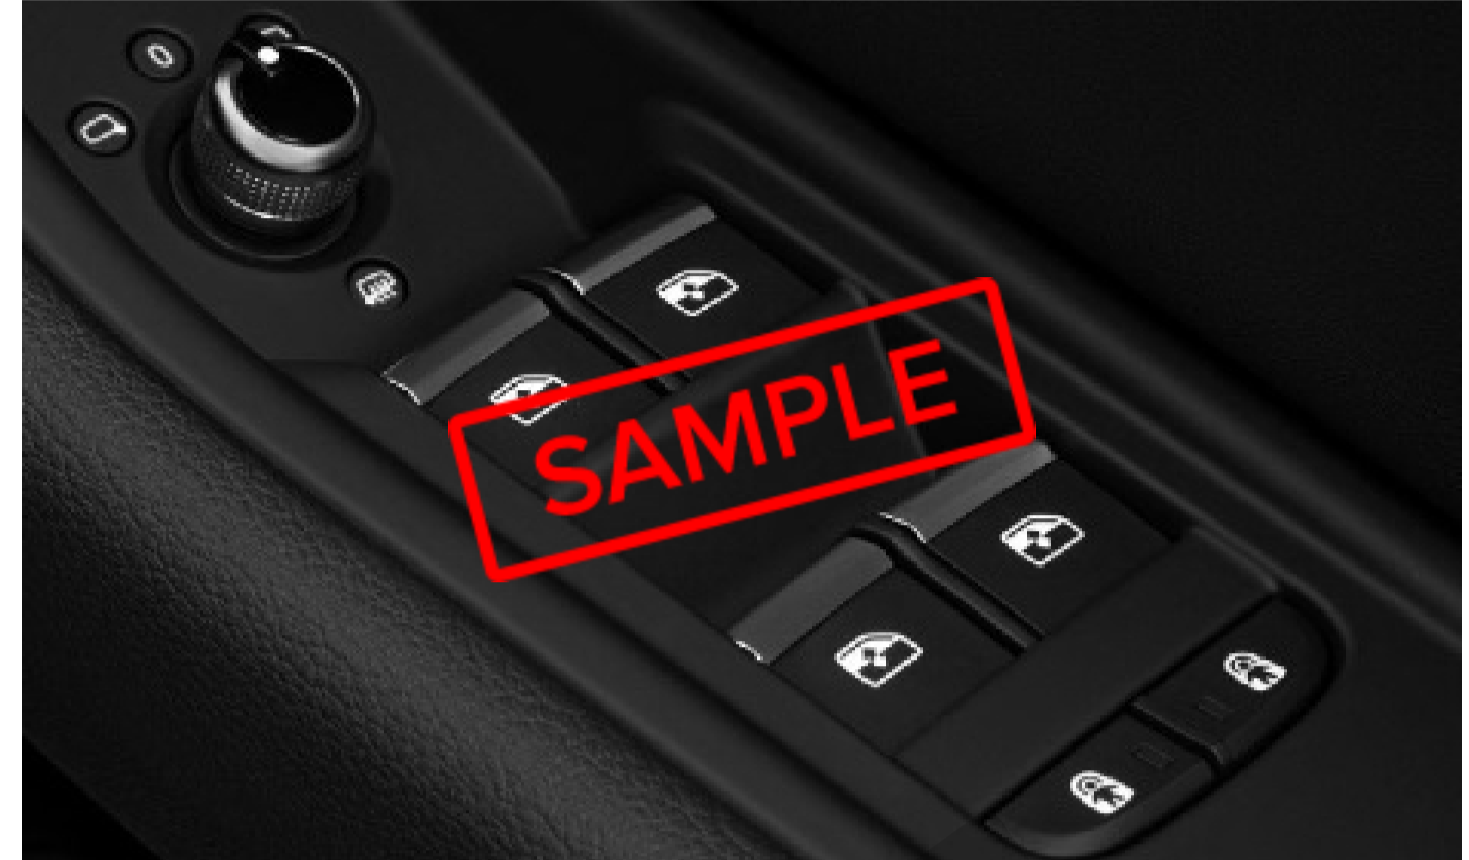
POWER WINDOW

Remarks: Power Window Not Working
Repair Estimate: ₹ 600

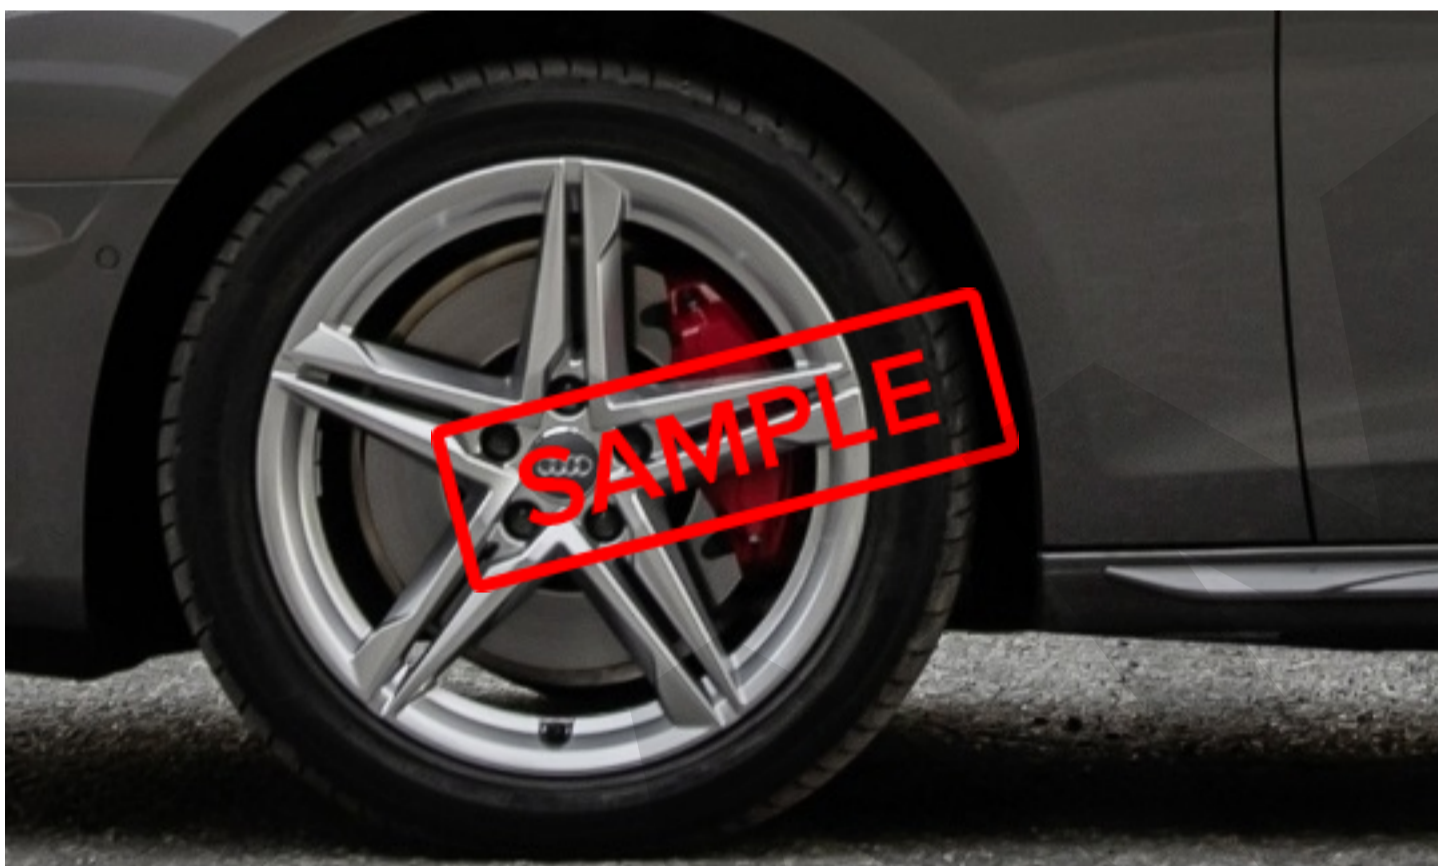
FRONT TYRES

Remarks: Front tyres are not in a good condition
Repair Estimate: ₹ 600

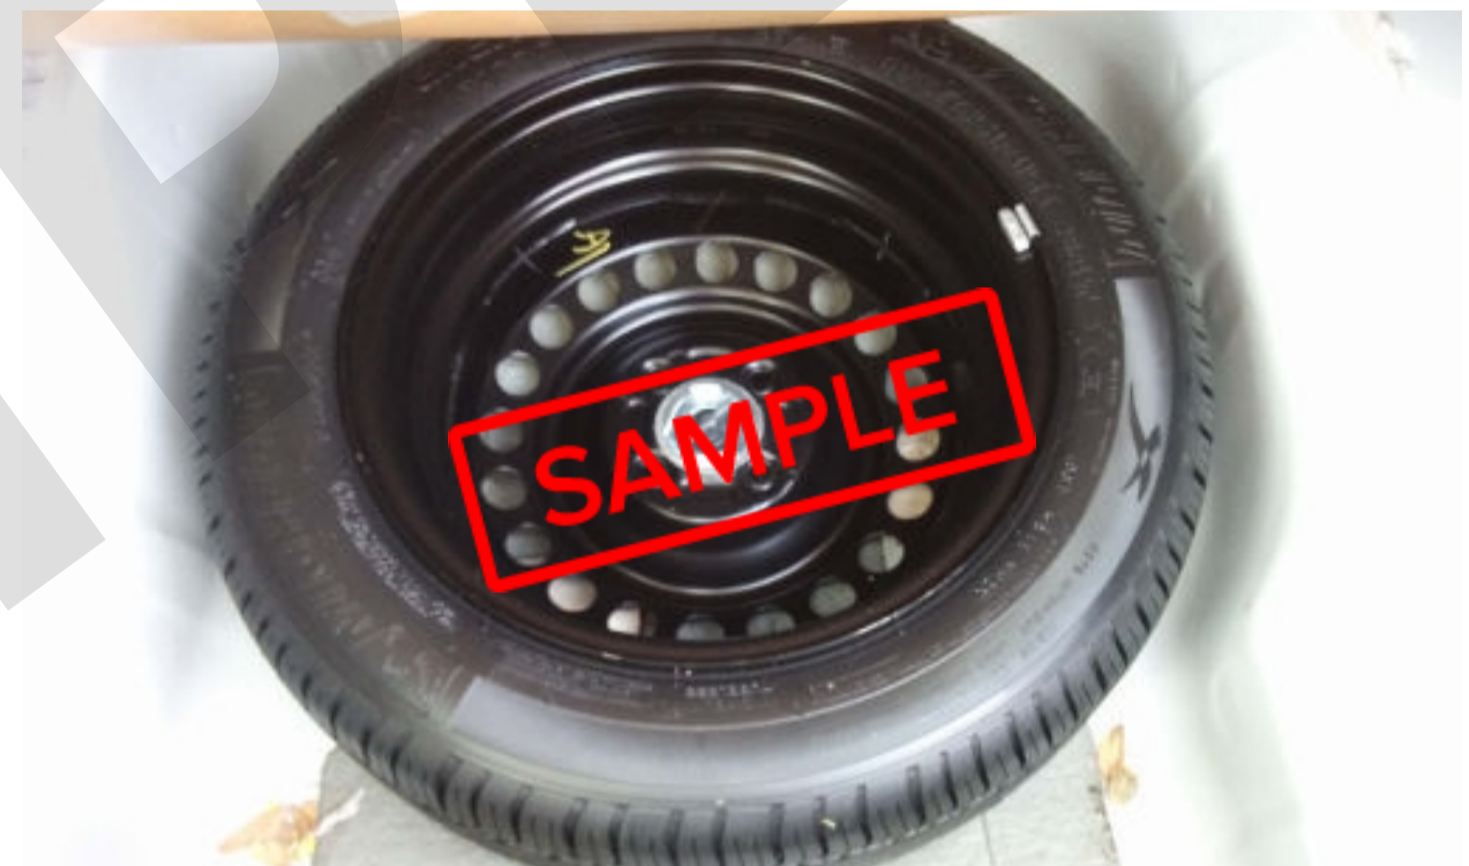
SPARE TYRES

Remarks: Spare tyres are not in a good condition
Repair Estimate: ₹ 600

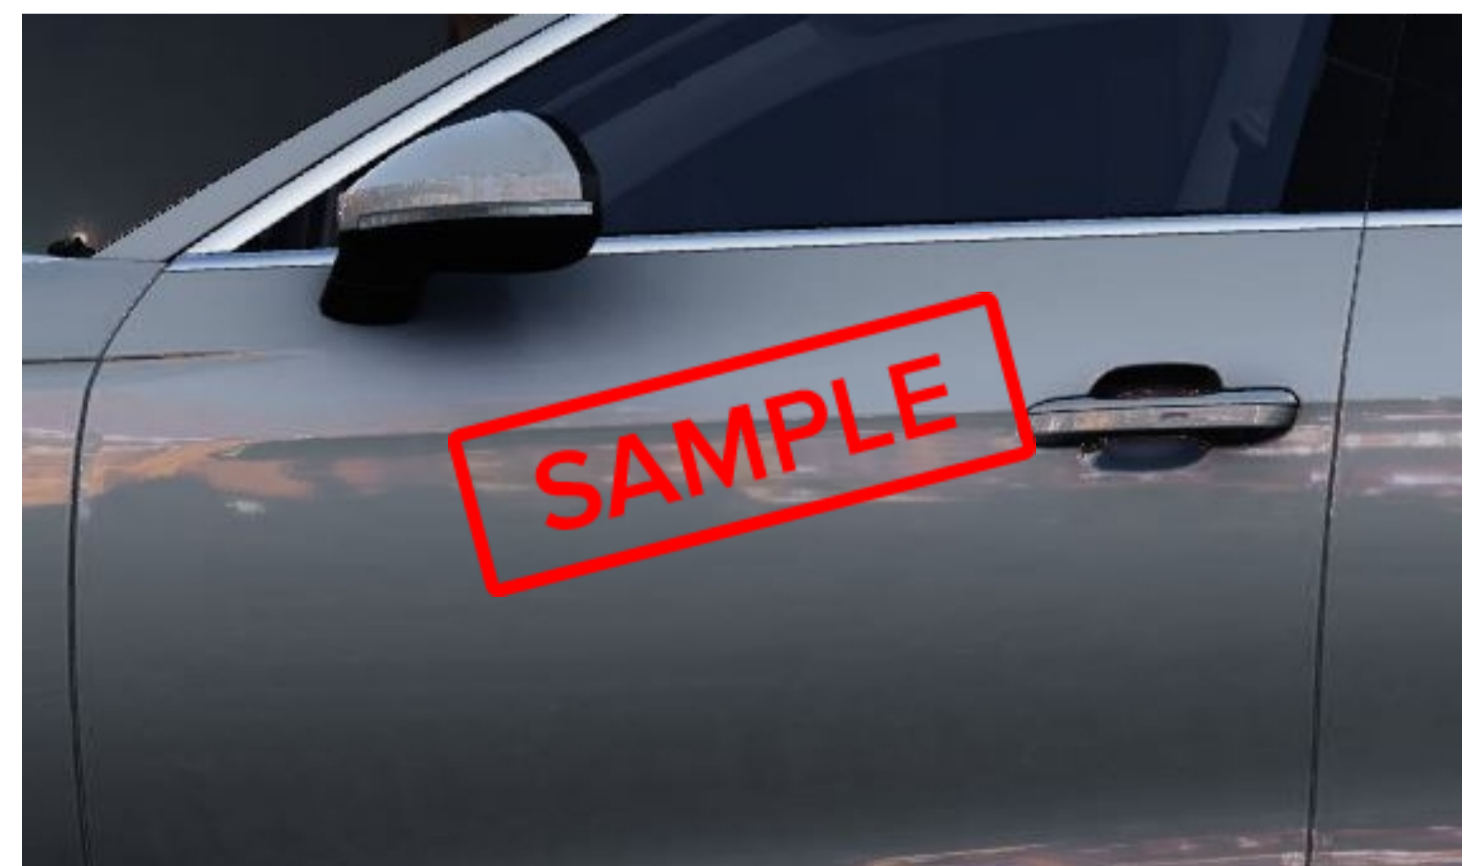
LEFT FRONT DOOR

Remarks: Scratches/Dents in Front Door
Repair Estimate: ₹ 900
