ECO INSPECTION REPORT

Audi A4 Premium Plus, 2019

Vehicle Information

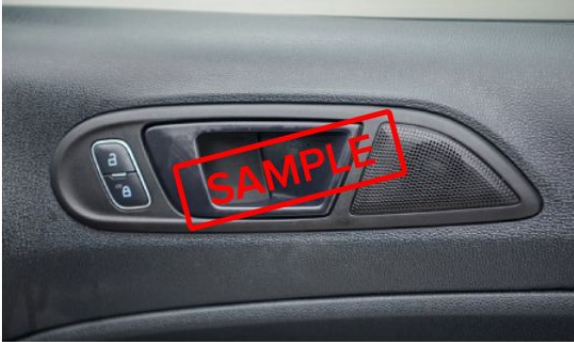
CENTRAL LOCK

Central Lock Not Working

₹ 600

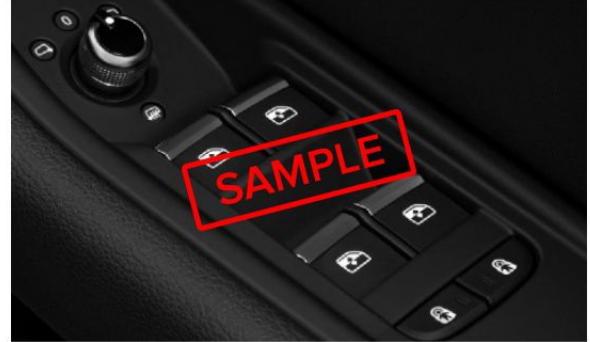
POWER WINDOW

Power Window Not Working

₹ 600

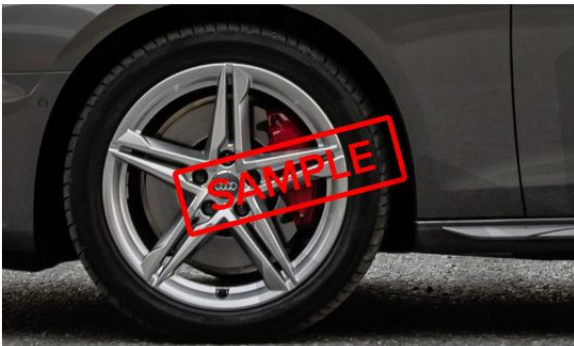
FRONT TYRES

Front tyres are not in a good condition

₹ 600

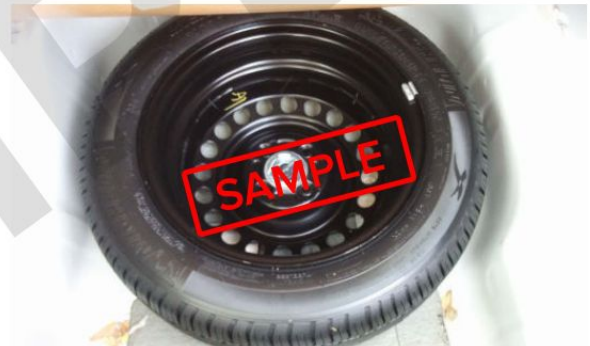
SPARE TYRES

Spare tyres are not in a good condition

₹ 600

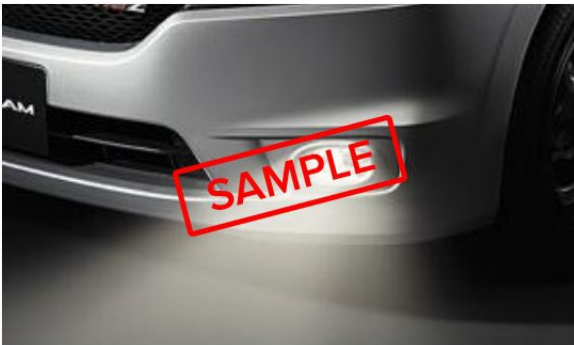
FOG LAMPS

Major cracks in Fog Lamps

₹ 900

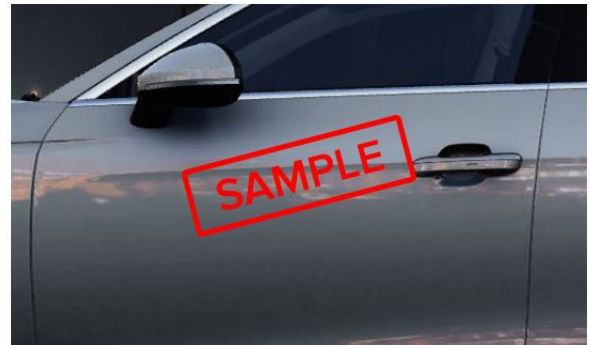
LEFT FRONT DOOR

Scratches/Dents in Front Door

₹ 900
