ECO INSPECTION REPORT

10 / 01 / 2021

Audi A4 Premium Plus, 2019

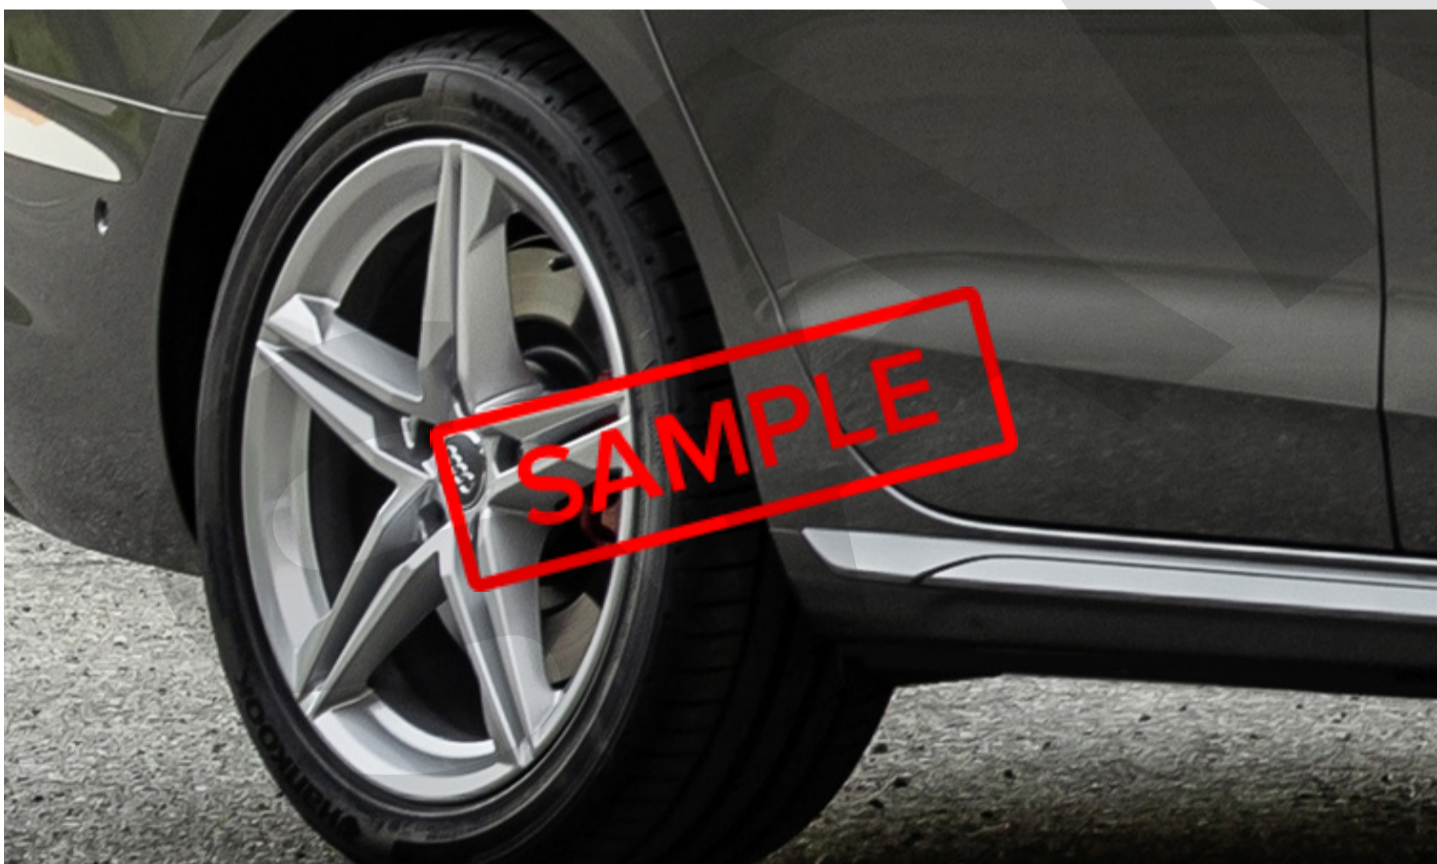
RIGHT FRONT TYRE

Remarks Tyre Tread Depth 6.3mm

Condition Good

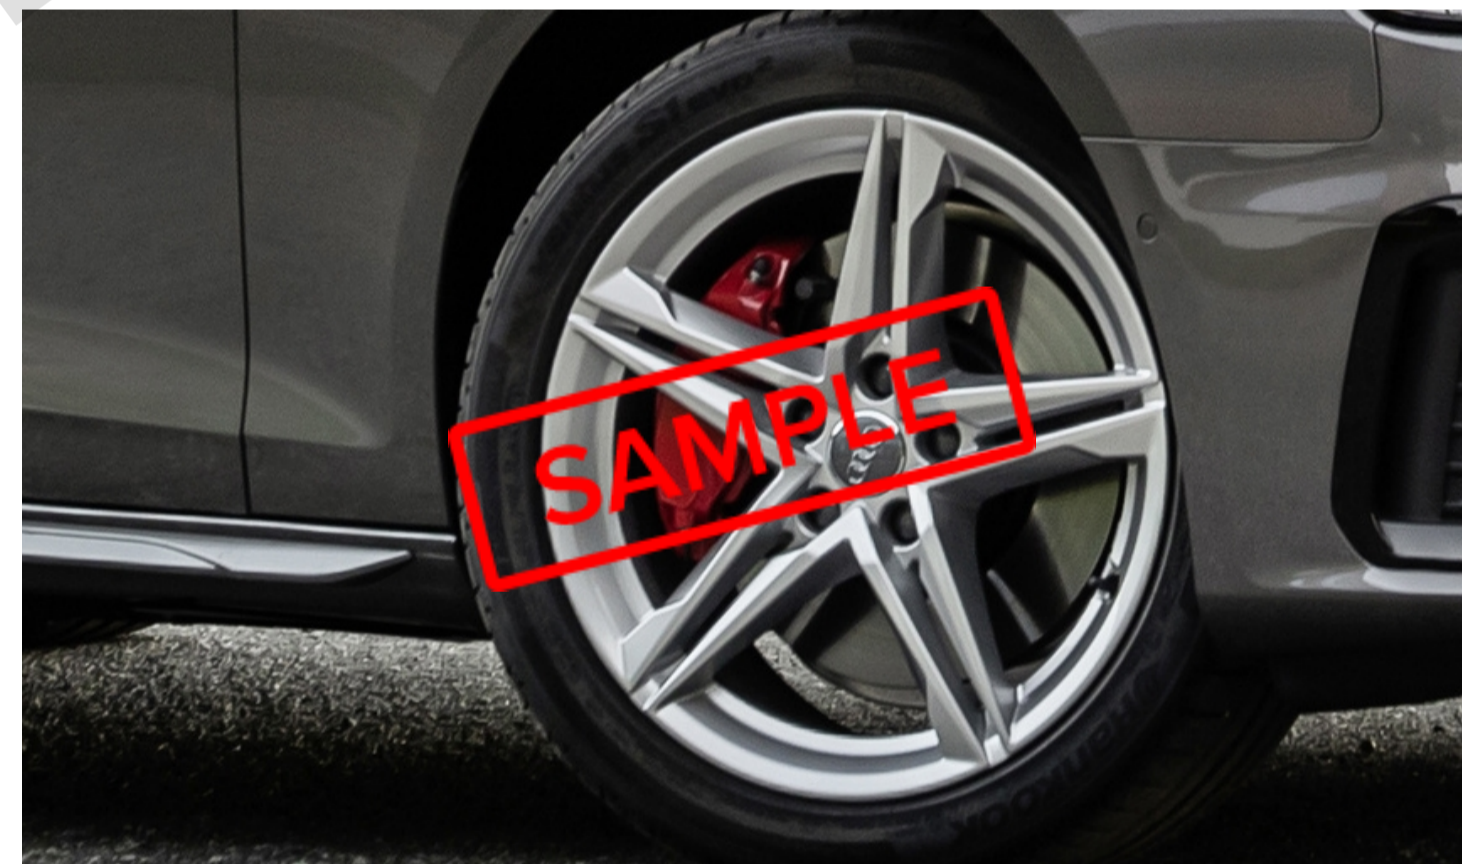
RIGHT REAR TYRE

Remarks Tyre Tread Depth 6.2mm

Condition Good

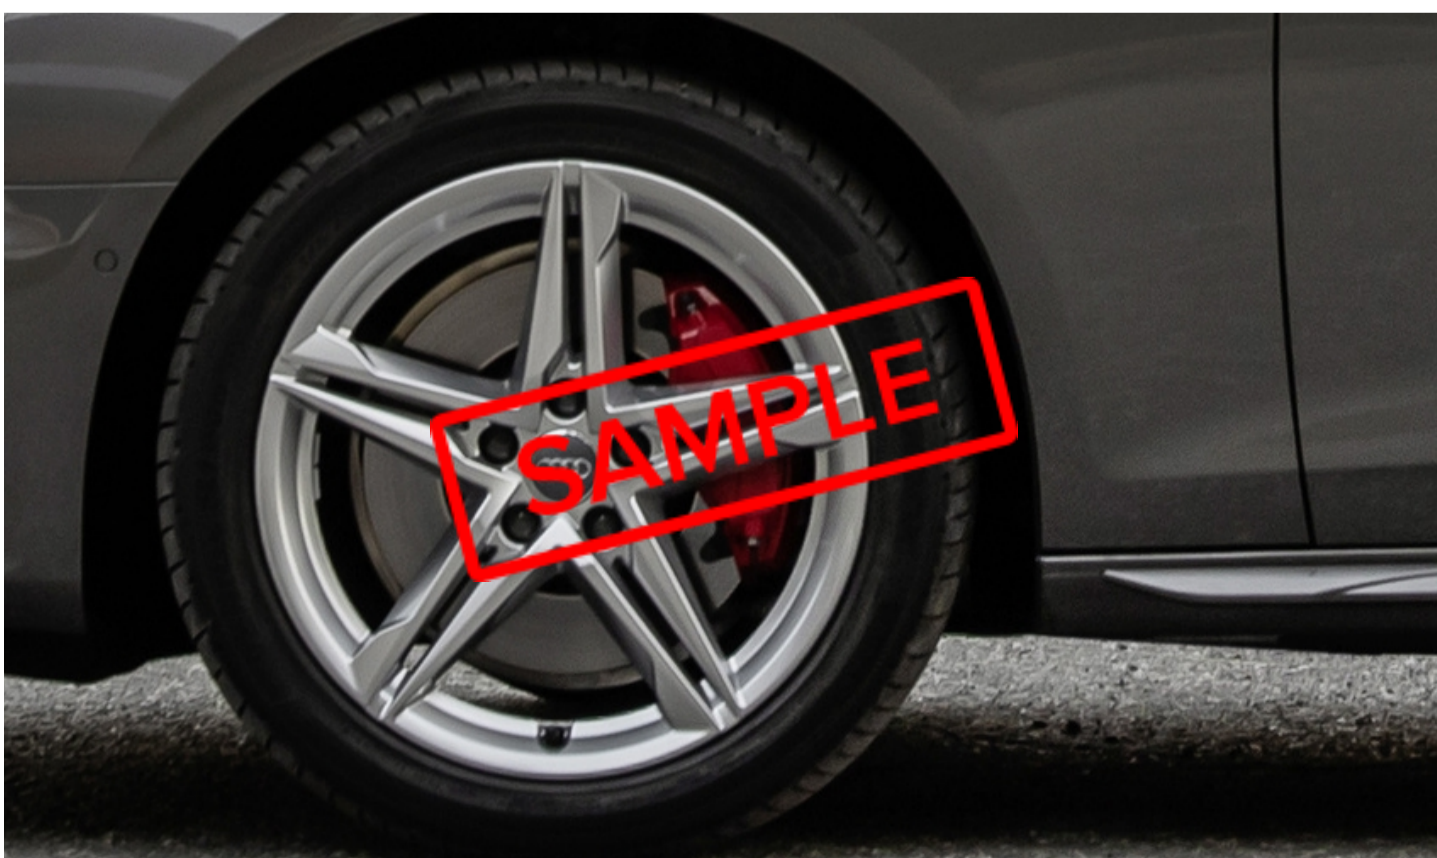
LEFT FRONT TYRE

Remarks Tyre Tread Depth 3.5mm

Condition Bad

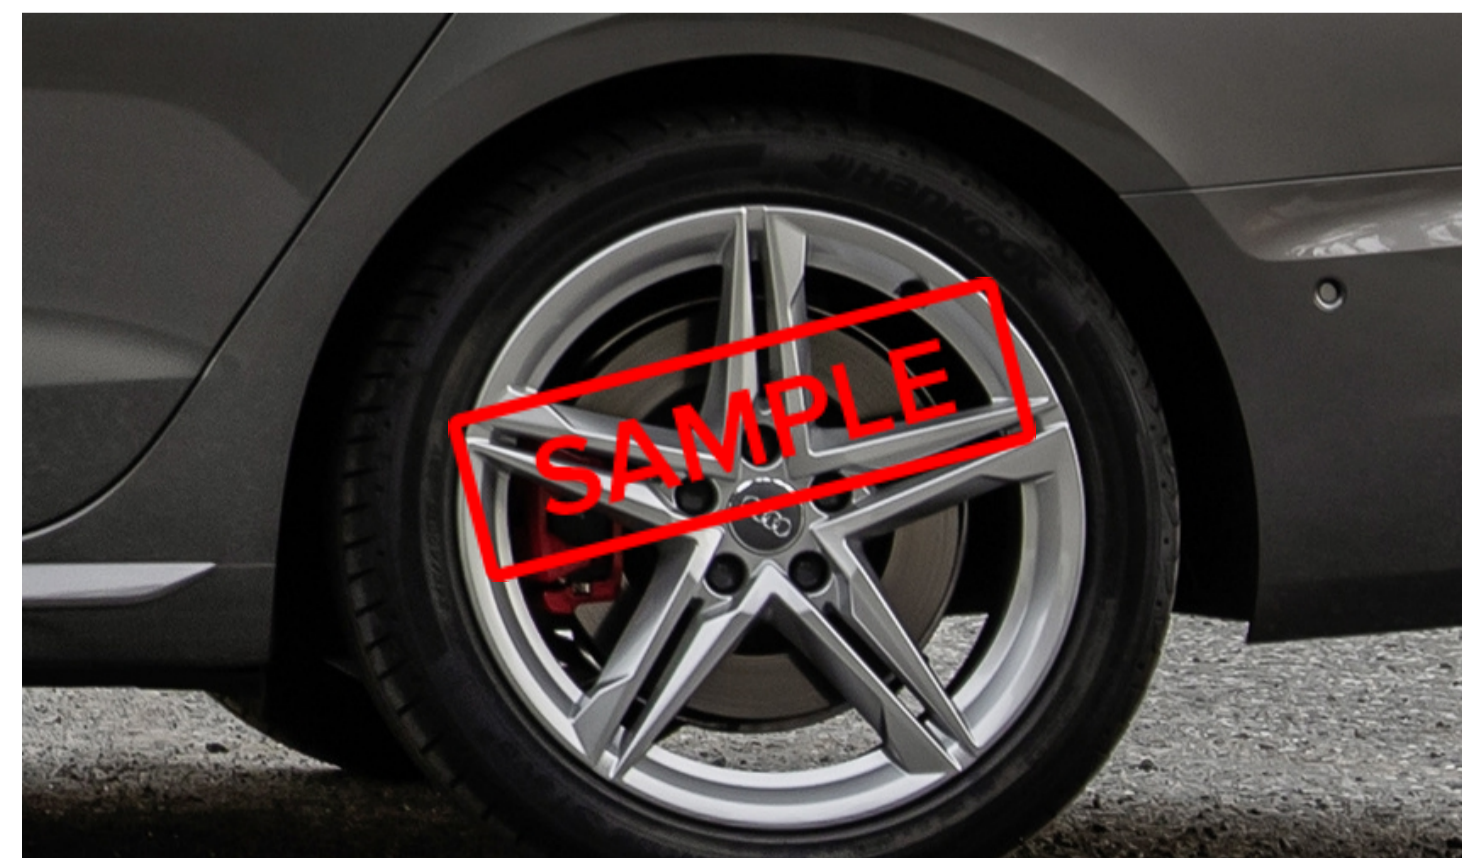
LEFT REAR TYRE

Remarks Tyre Tread Depth 6.3mm

Condition Good

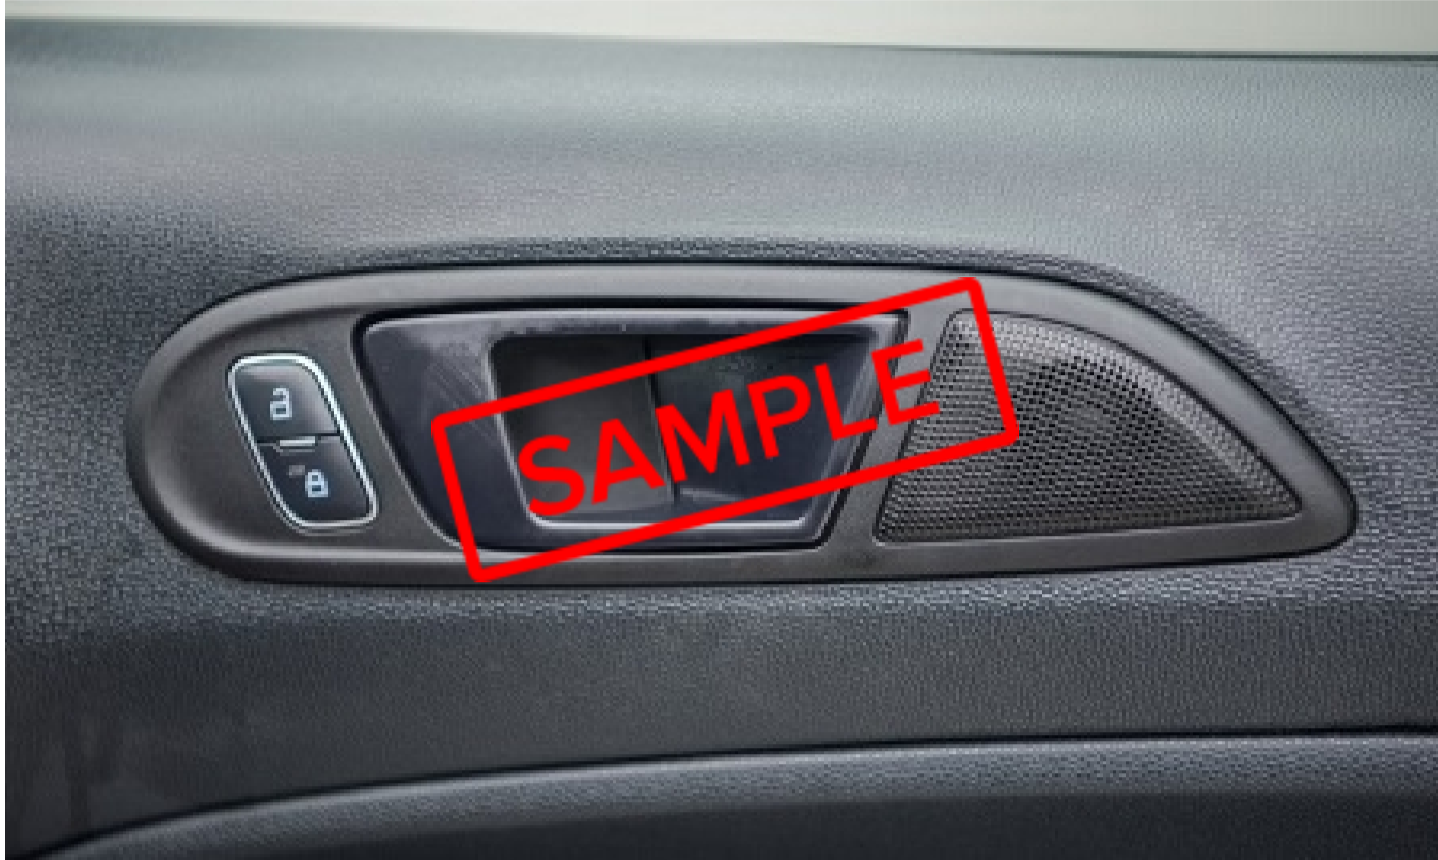
CENTRAL LOCK

Remarks: Central Lock Not Working
Repair Estimate: ₹ 600

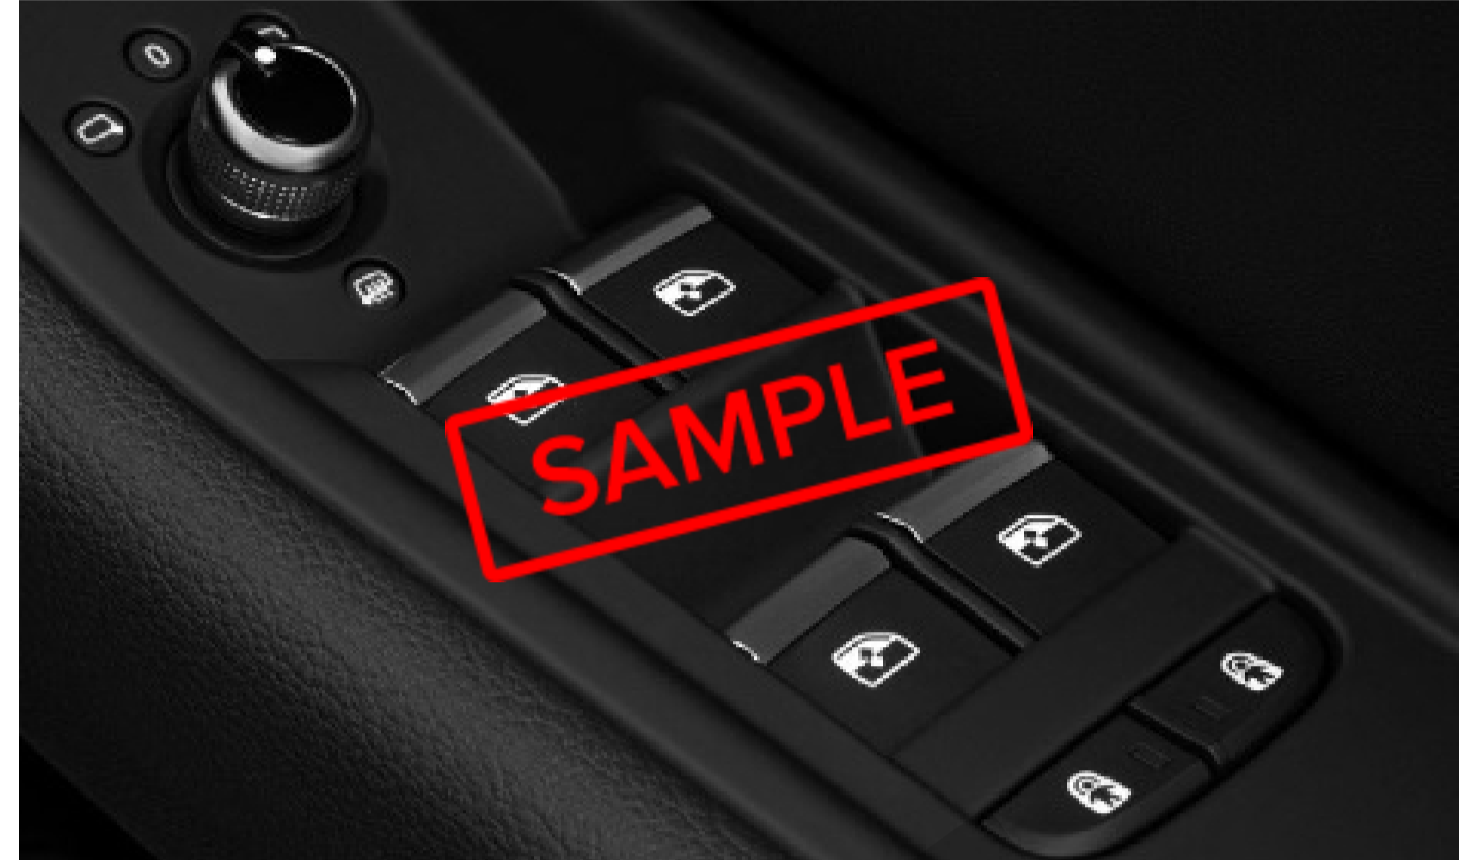
POWER WINDOW

Remarks: Power Window Not Working
Repair Estimate: ₹ 600

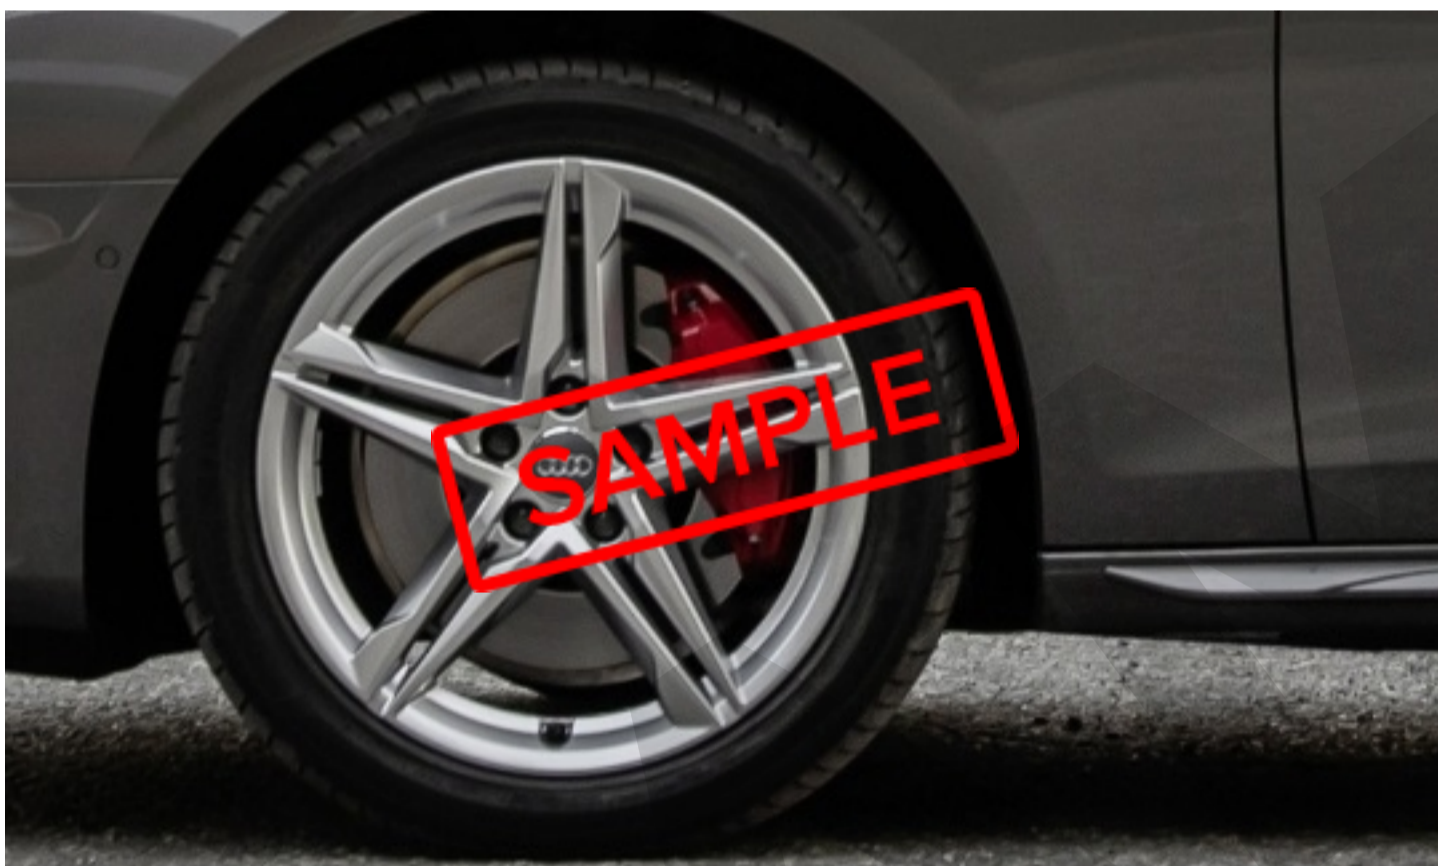
LEFT FRONT TYRE

Remarks: Left front tyre is not in a good condition
Repair Estimate: ₹ 600

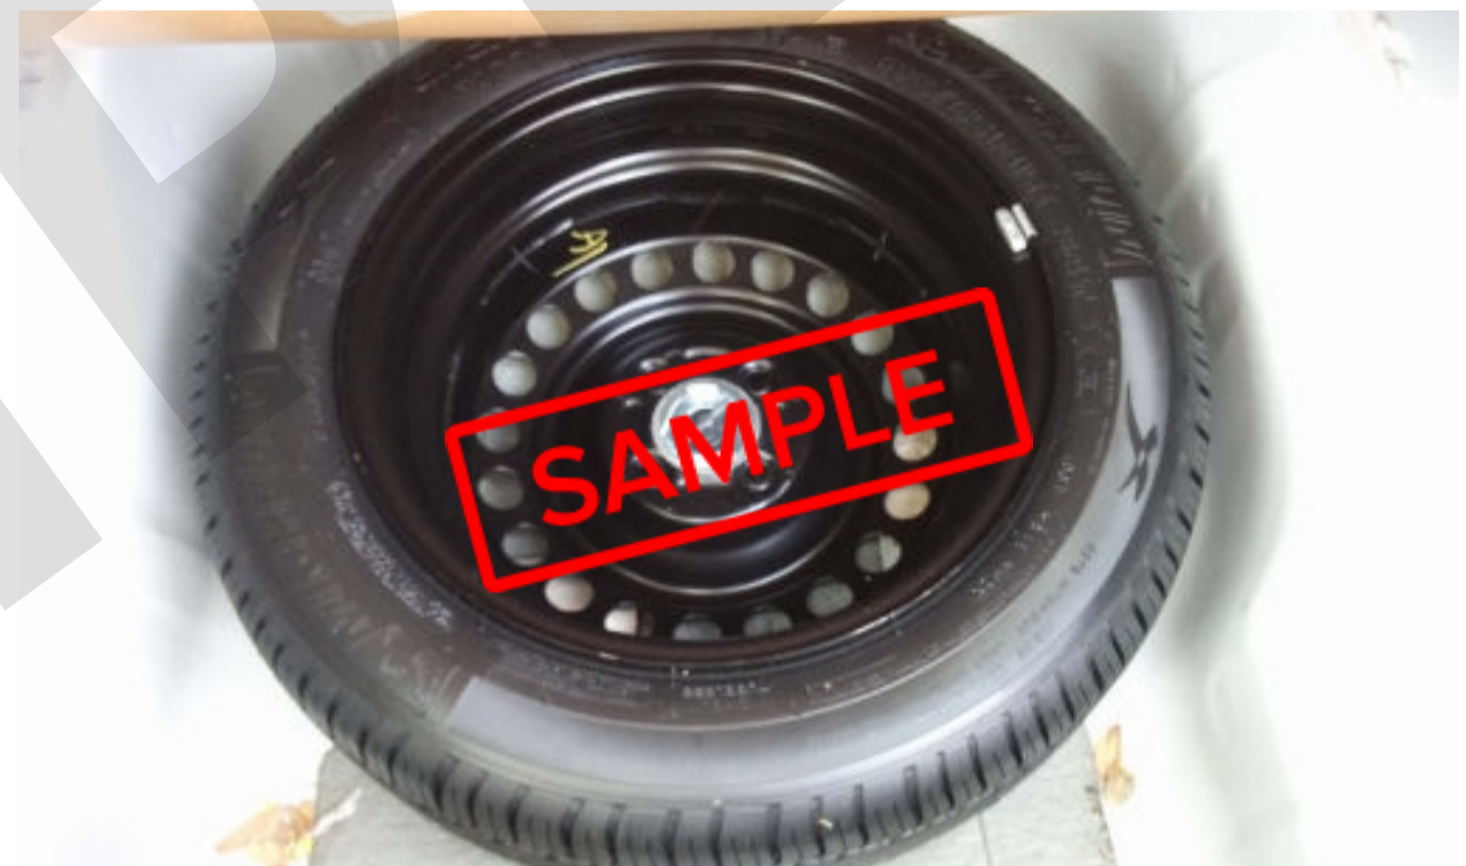
SPARE TYRE

Remarks: Spare tyre is not in a good condition
Repair Estimate: ₹ 600

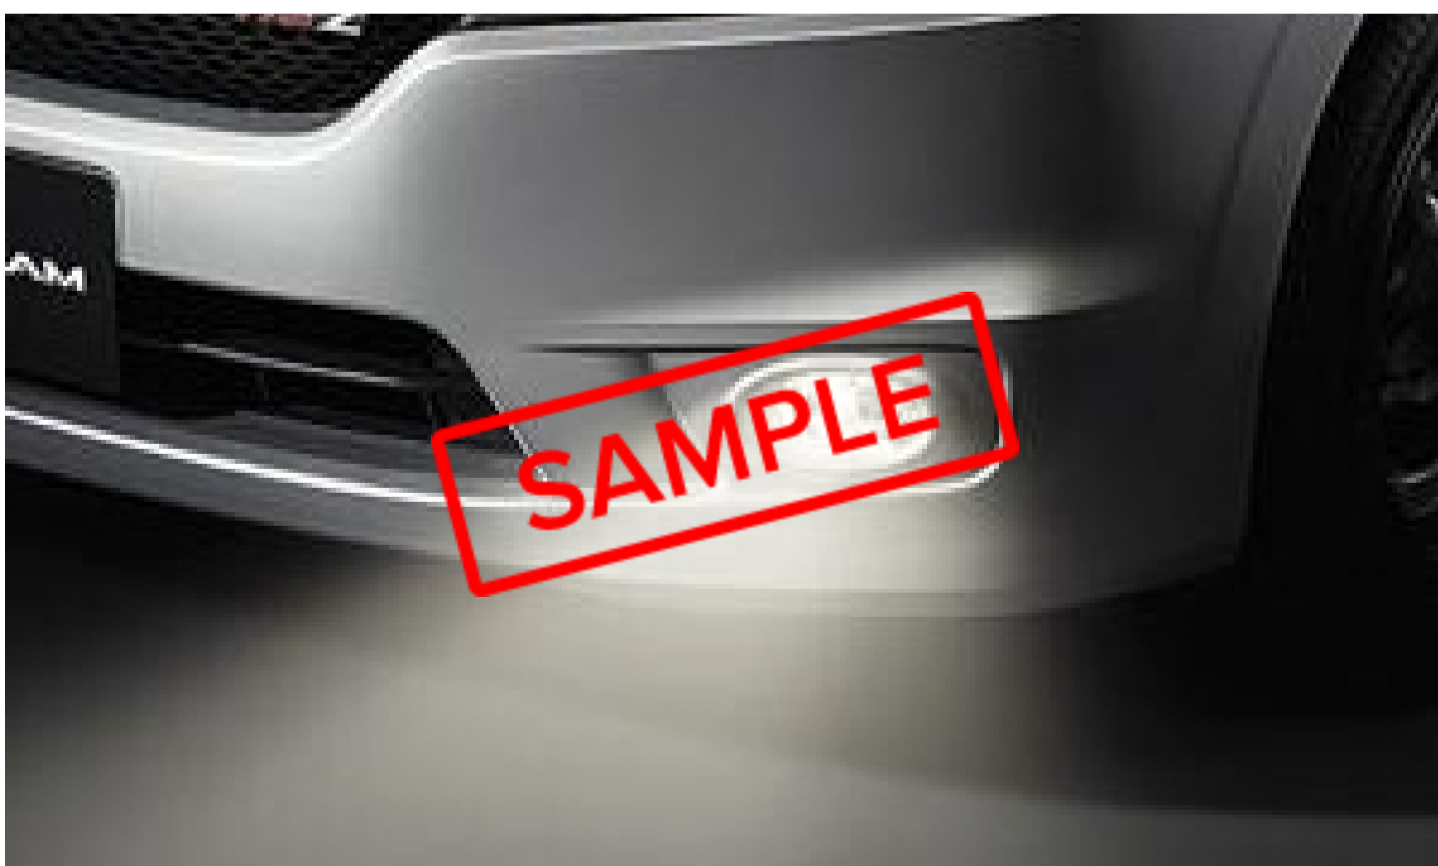
FOG LAMPS

Remarks: Major cracks in Fog Lamps
Repair Estimate: ₹ 900

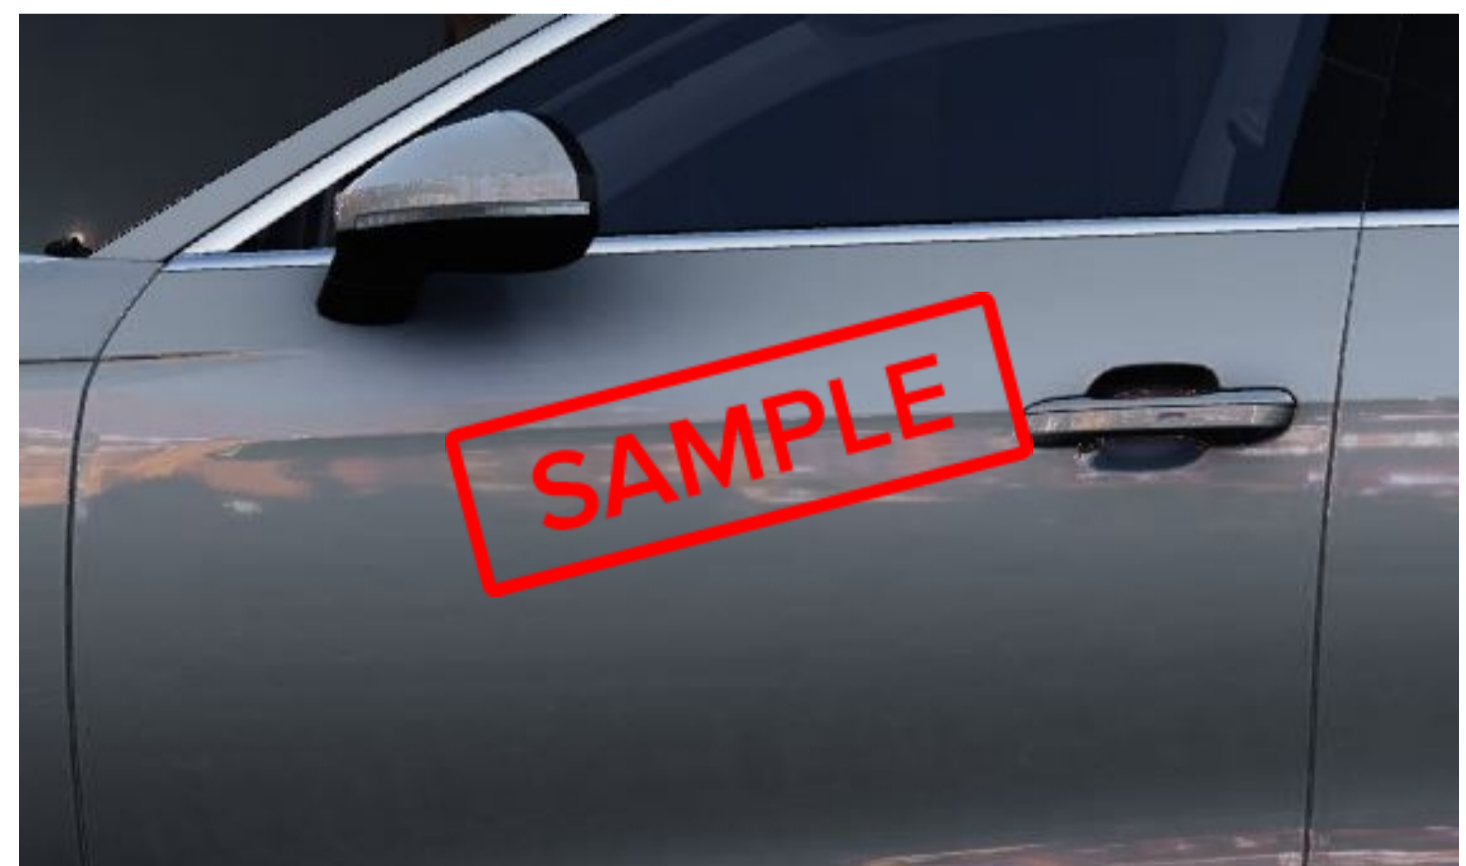
LEFT FRONT DOOR

Remarks: Scratches/Dents in Front Door
Repair Estimate: ₹ 900
