ECO INSPECTION REPORT

Ordered By

Anant Goel

Honda Activa 6G, 2021

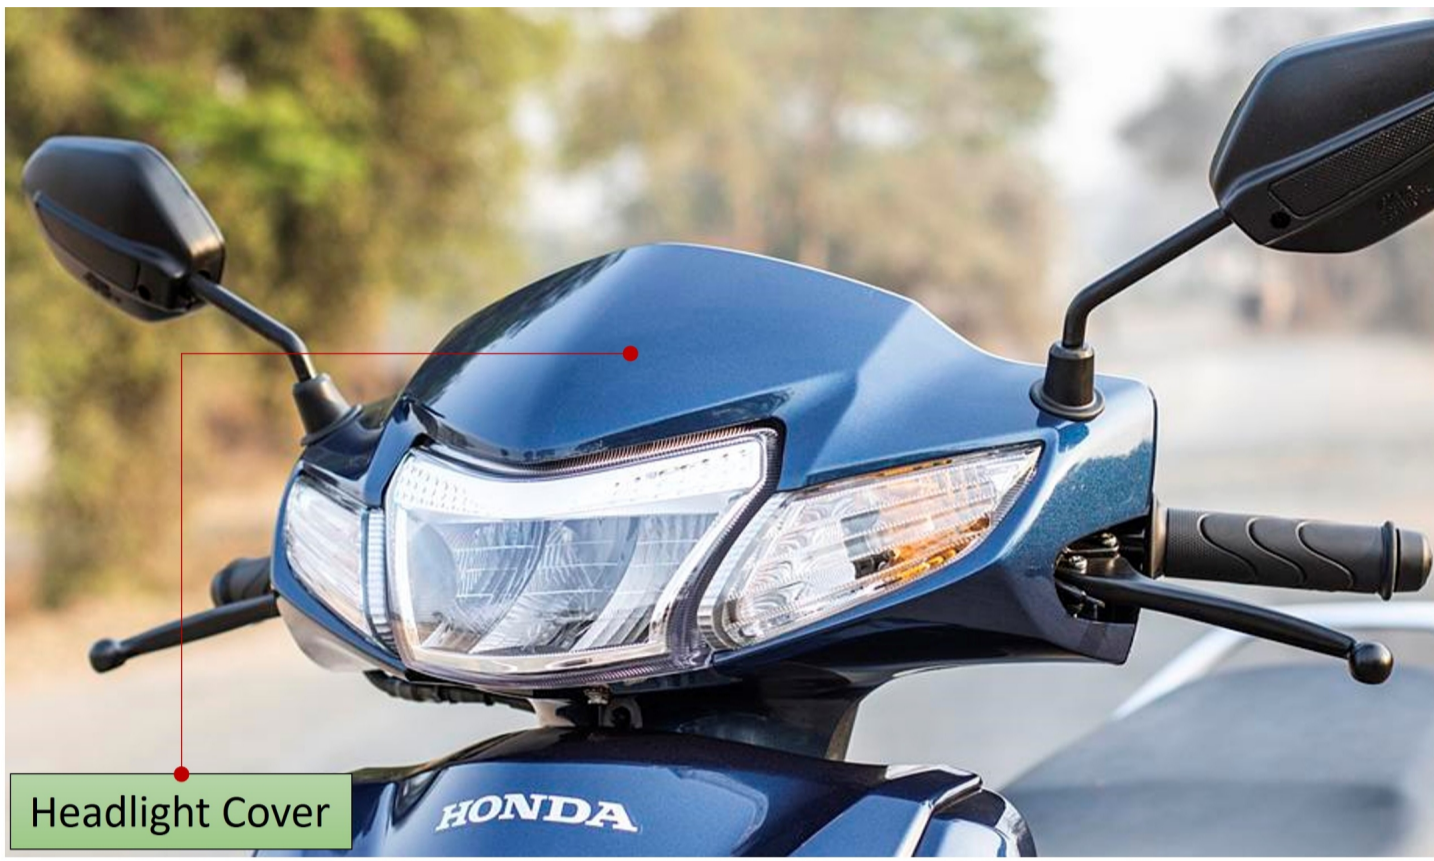
HEAD LIGHT COVER

Major dents/scratches

₹ 650

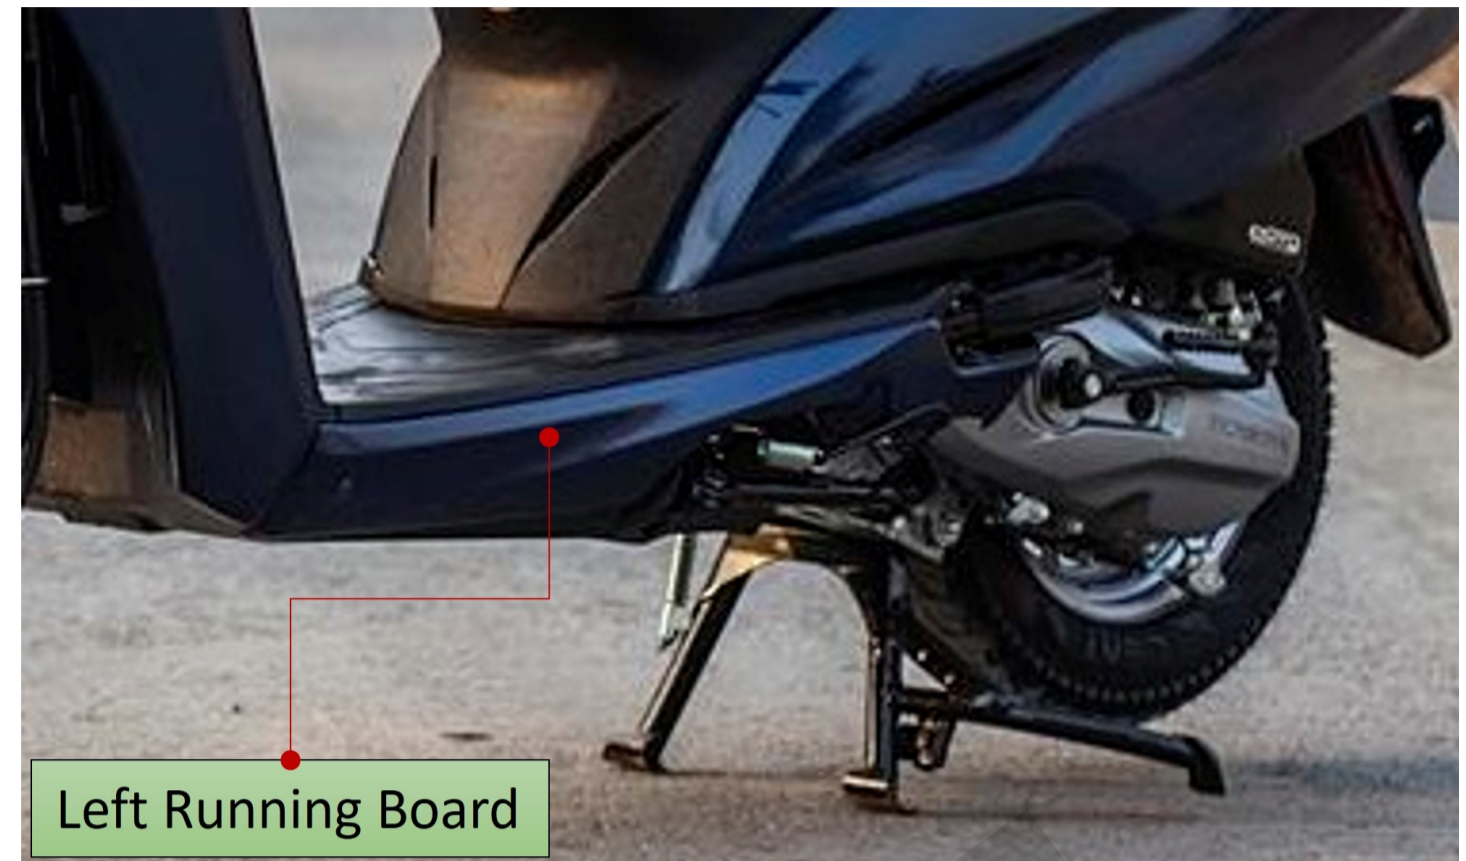
LEFT RUNNING BOARD

Major dents/scratches

₹ 600

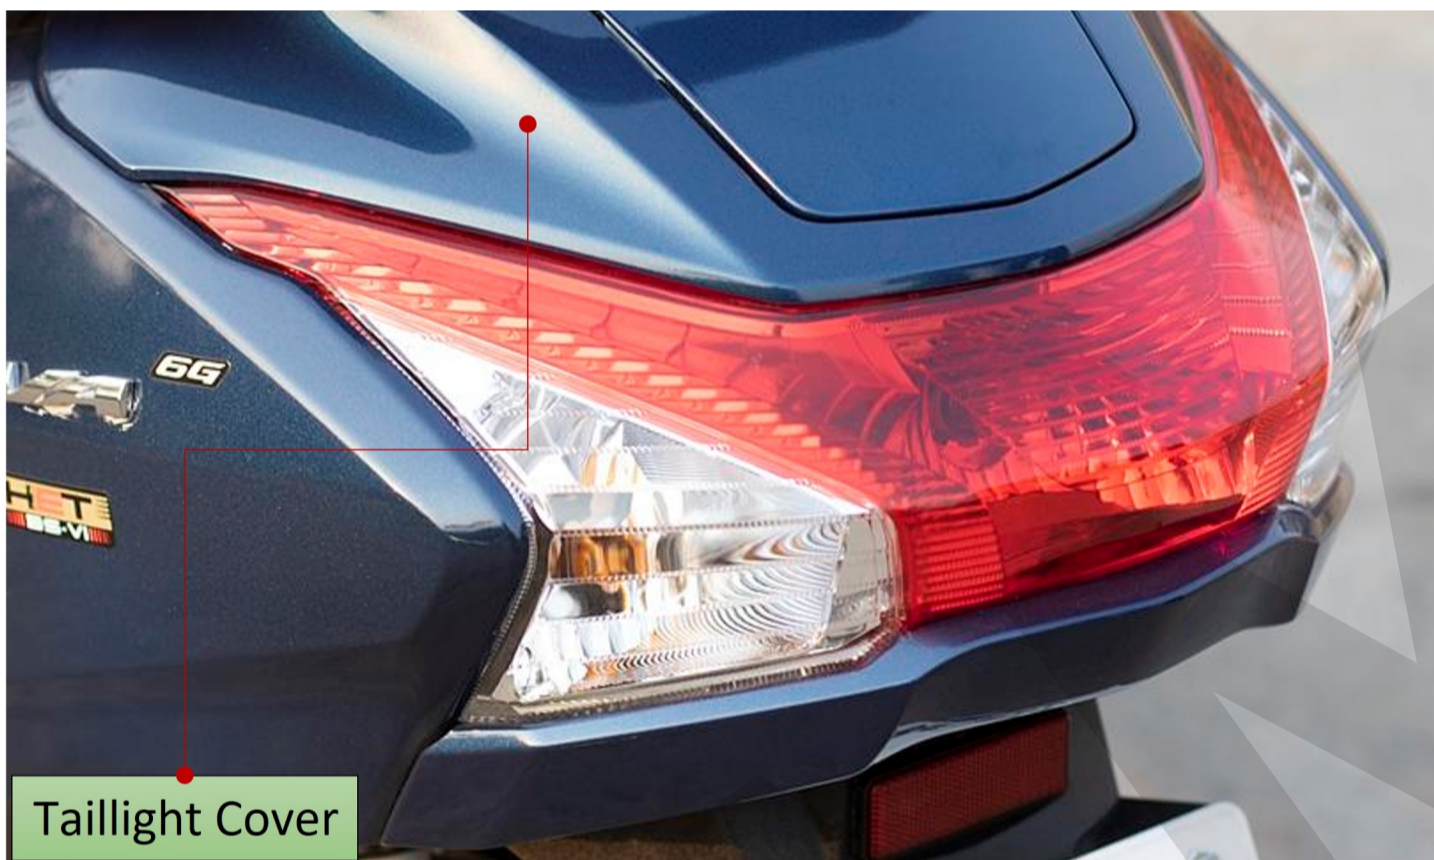
TAIL LIGHT COVER

Minor dents/scratches

₹ 175

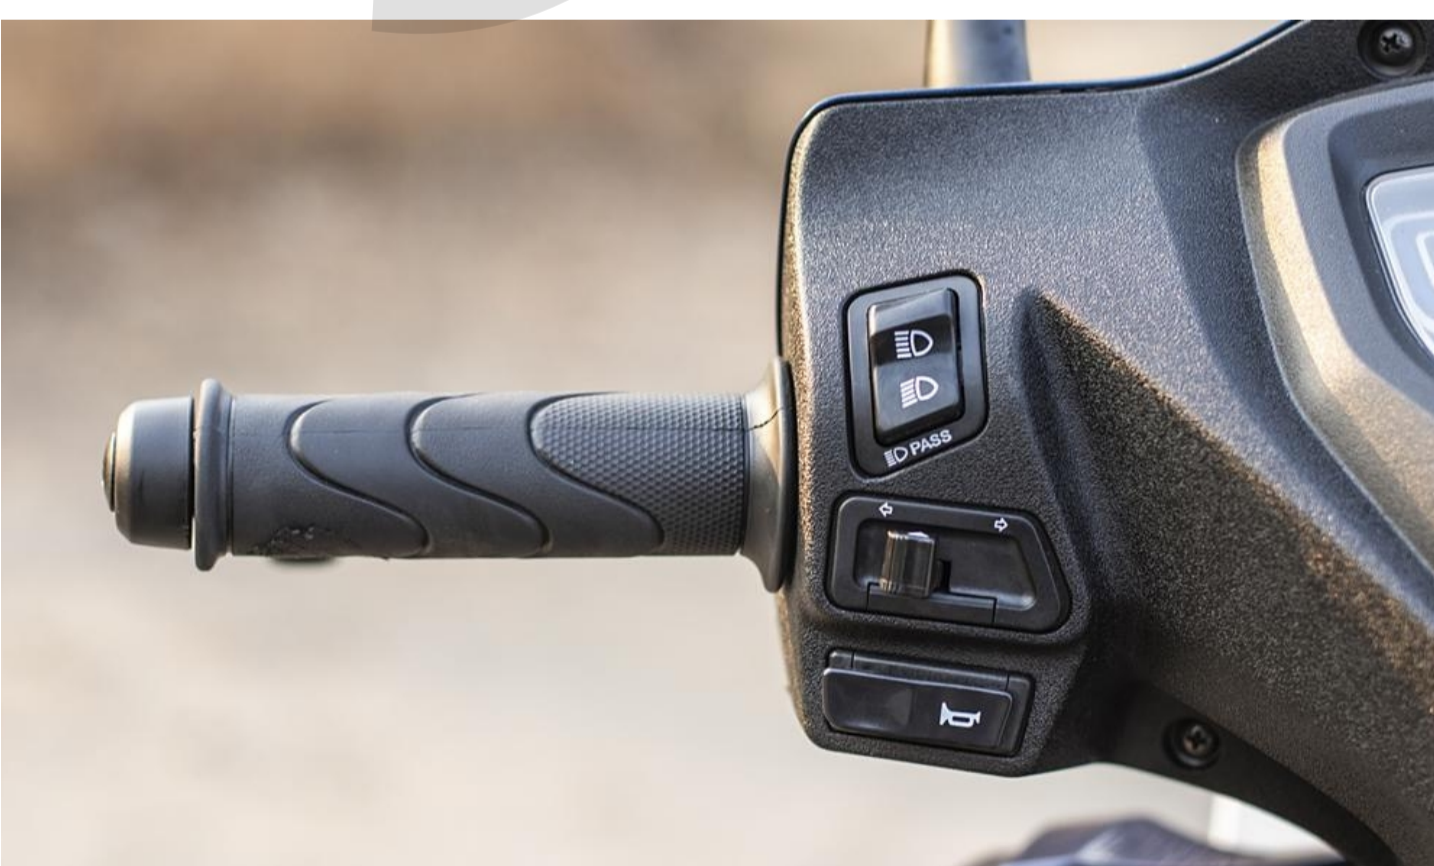
LH HANDLE GRIP

Slippery Grip

₹ 80

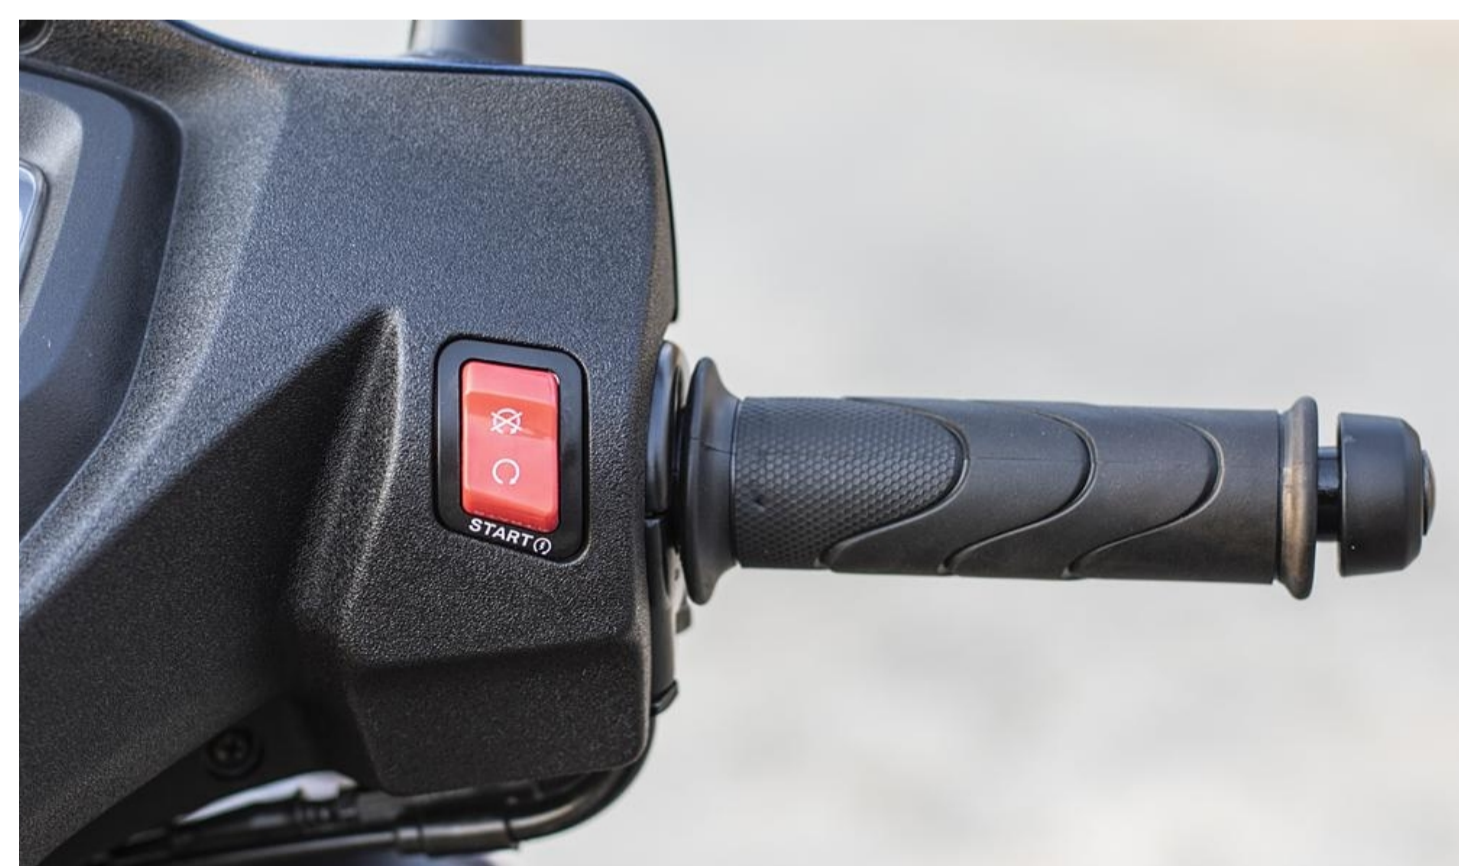
RH HANDLE GRIP

Slippery Grip

₹ 80

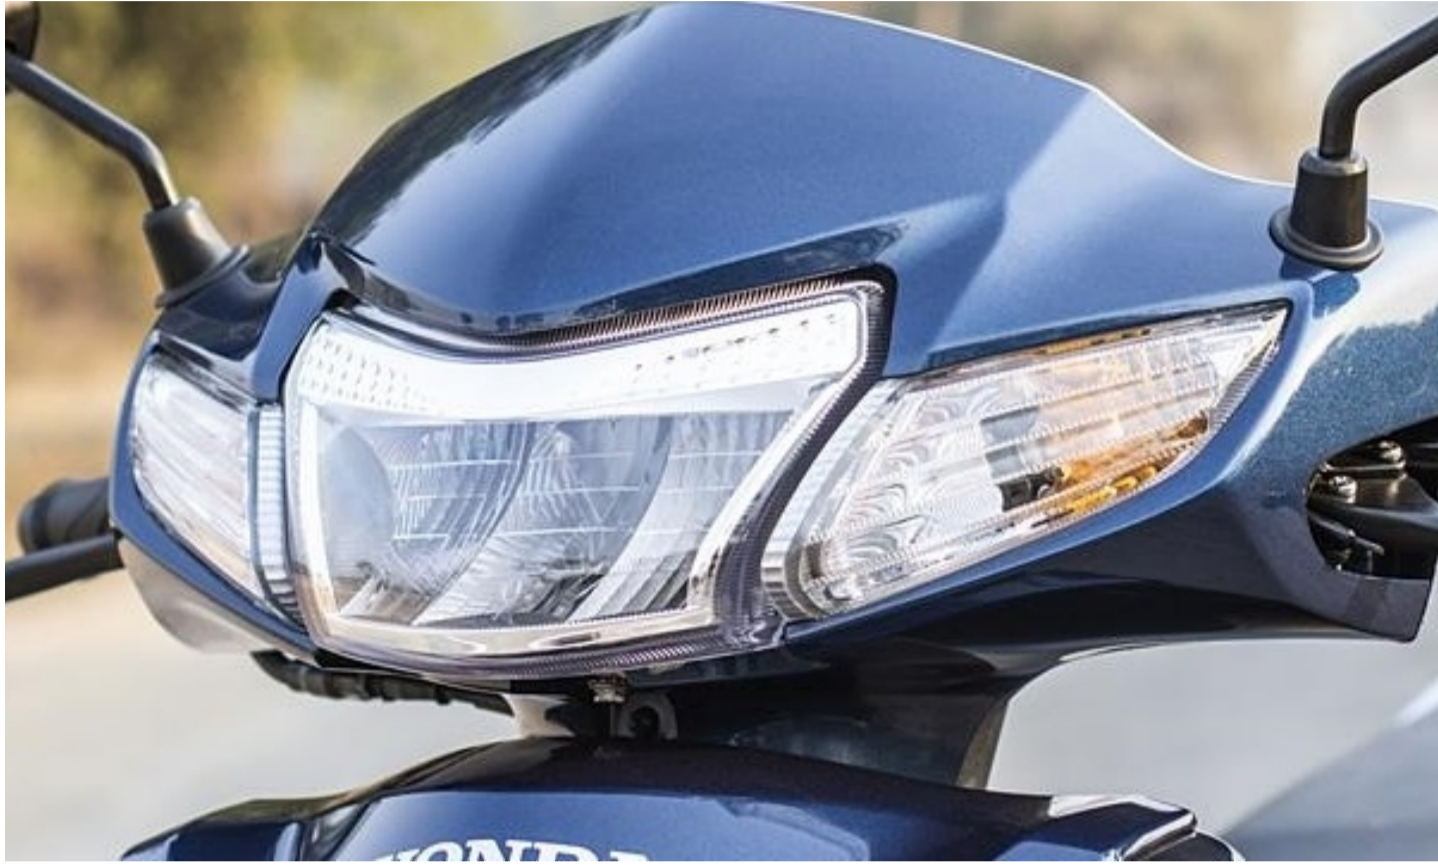
HEAD LIGHT

Remarks: Broken/cracked
Repair Estimate: ₹ 2000

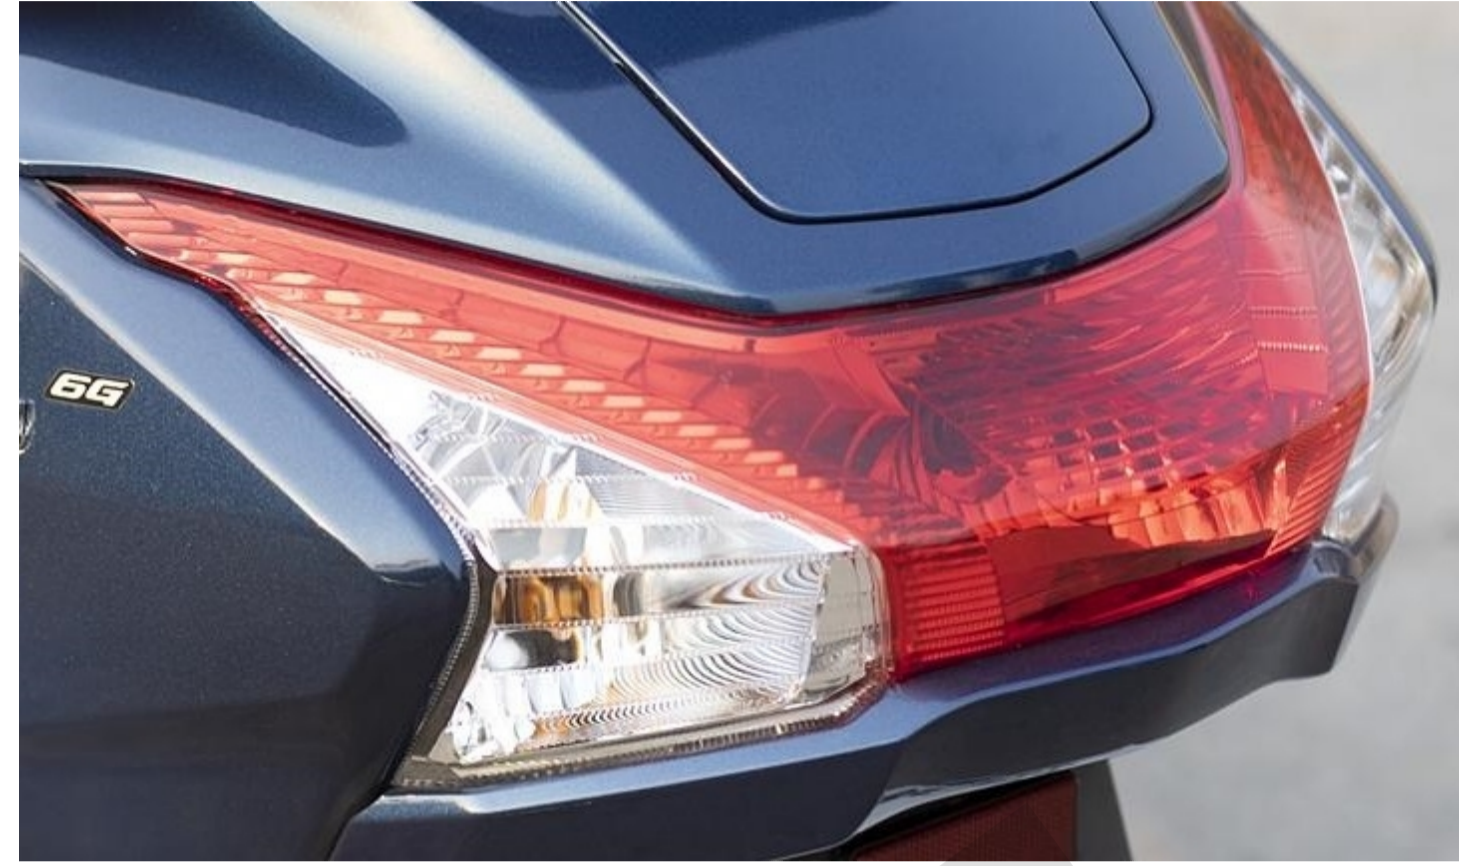
TAIL LIGHT

Remarks: Broken/cracked
Repair Estimate: ₹ 1800

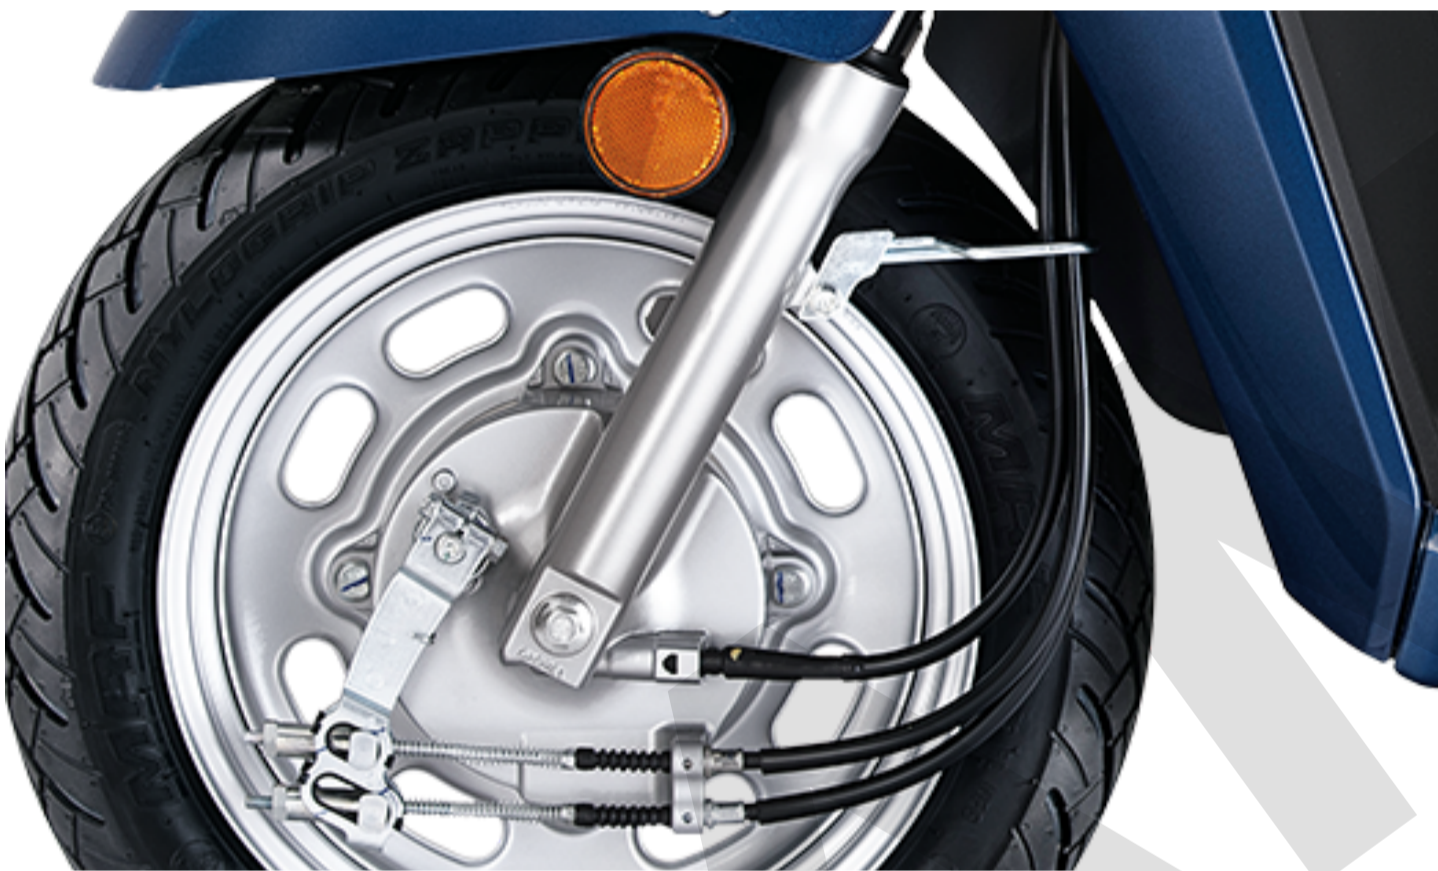
FRONT SUSPENSION

Remarks: Fluid leakage/seepage
Repair Estimate: ₹ 500

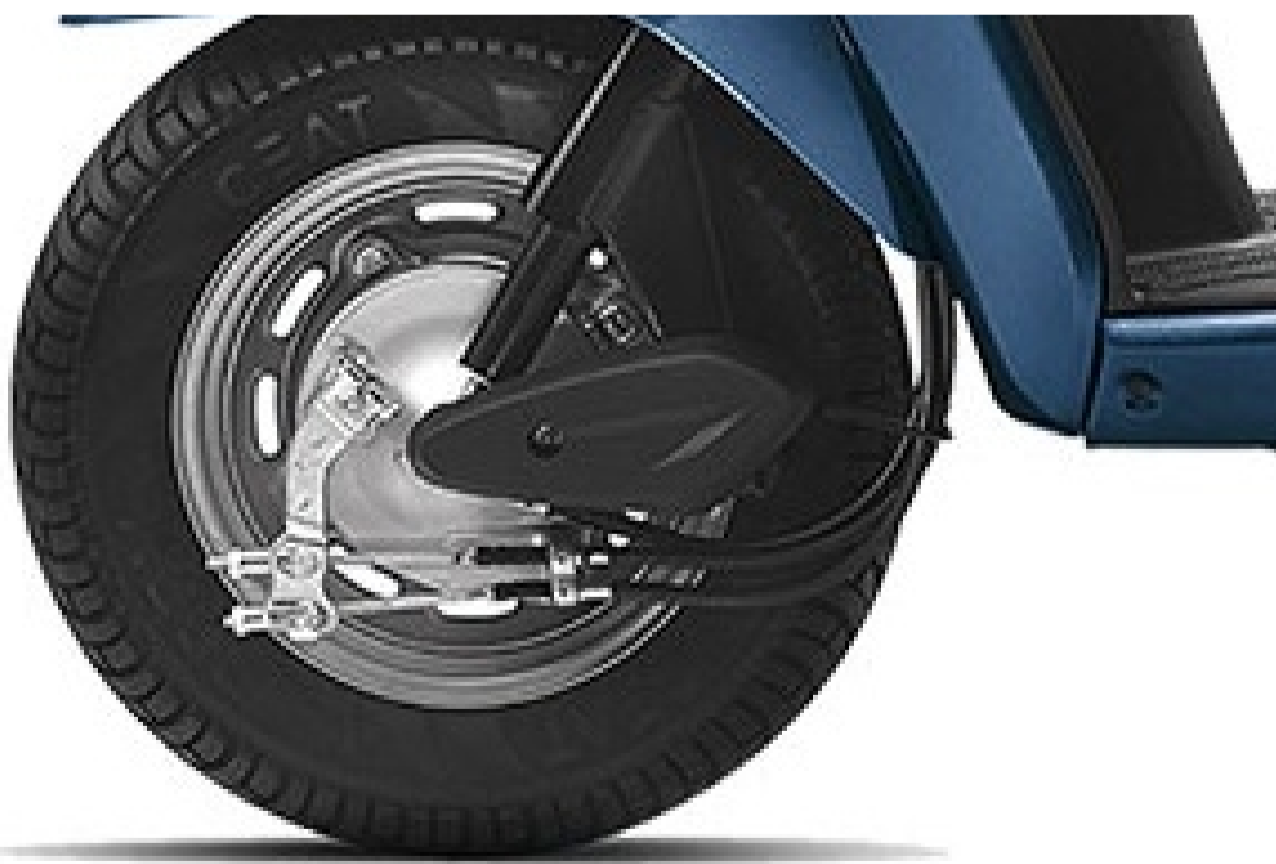
FRONT TYRE

Remarks: No air pressure
Repair Estimate: ₹ 1200
