ECO INSPECTION REPORT

Order ID : 20426

Volkswagen Vento Highline Diesel, 2014

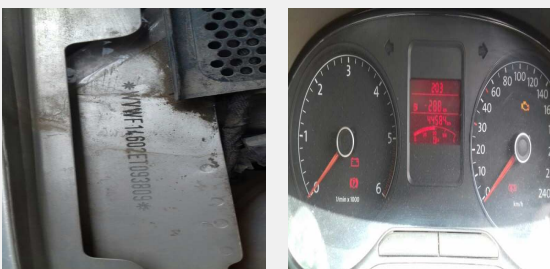
INSPECTION CHECKPOINTS	SCORE(X/10)	REMARKS/COMMENTS	OPTIONAL SPEND EST. (RS)
STEERING PERFORMANCE	7	GOOD	0
BRAKE PERFORMANCE	7	GOOD	0
CLUTCH PERFORMANCE	7	GOOD	0
ENGINE NOISE	6	TUARBO SOUND	7000
IGNITION SYSTEM	7	GOOD	0
SUSPENSION PERFORMANCE	7	GOOD	0
SUSPENSION FRONT SHOCKS	7	GOOD	0
SUSPENSION REAR SHOCKS	7	GOOD	0
TRANSMISSION ENGAGE	7	GOOD	0
REAR PARKING SENSORS	7	GOOD	0
CRUISE CONTROL	0	NO	0
REAR VIEW CAMERA	0	NO	0

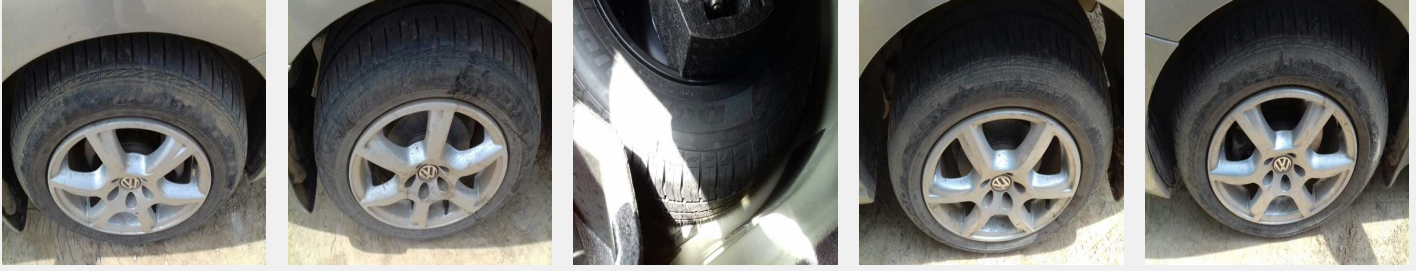
INSPECTION CHECKPOINTS	SCORE(X/10)	REMARKS/COMMENTS	OPTIONAL SPEND EST. (RS)
TYRES	6	AVERAGE	0
SPARE TYRE	9	GOOD	0
WHEEL ASSEMBLY (ALLOY RIM)	7	GOOD	0

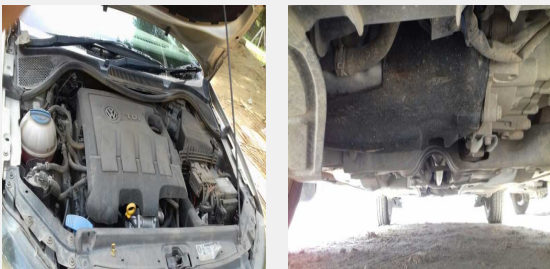
INSPECTION CHECKPOINTS	SCORE(X/10)	REMARKS/COMMENTS	OPTIONAL SPEND EST. (RS)
LH APRON	7	GOOD	0
RH APRON	7	GOOD	0
RADIATOR	7	GOOD	0
WIRING	7	GOOD	0
BATTERY	7	GOOD	0
BRAKE FLUID LEVEL	7	GOOD	0
BRAKE & COOLANT HOSE PIPES	7	GOOD	0
UNDERCARRIAGE	7	GOOD	0
EXHAUST SYSTEM	7	GOOD	0
ENGINE OIL	5	AVERAGE	0
COOLANT LEVEL	5	AVERAGE	0

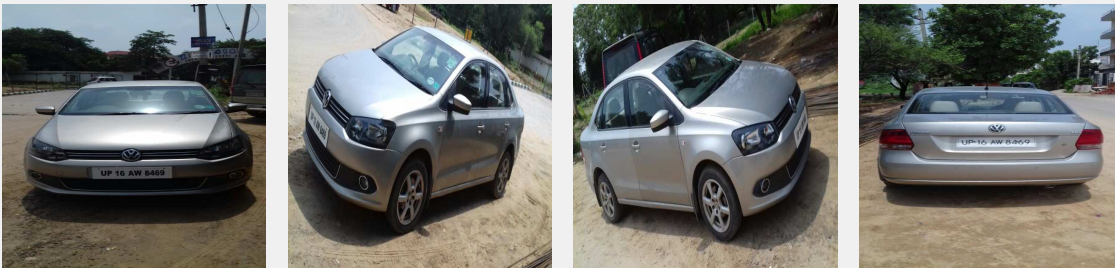
INSPECTION CHECKPOINTS	SCORE(X/10)	REMARKS/COMMENTS	OPTIONAL SPEND EST. (RS)
RH QUARTER PANEL	5	PAINTED	0
RH RUNNING BOARD	5	PAINTED	0
RH REAR DOOR	5	PAINTED	0
RH FRONT DOOR	5	PAINTED	0
RH FENDER	5	PAINTED	0

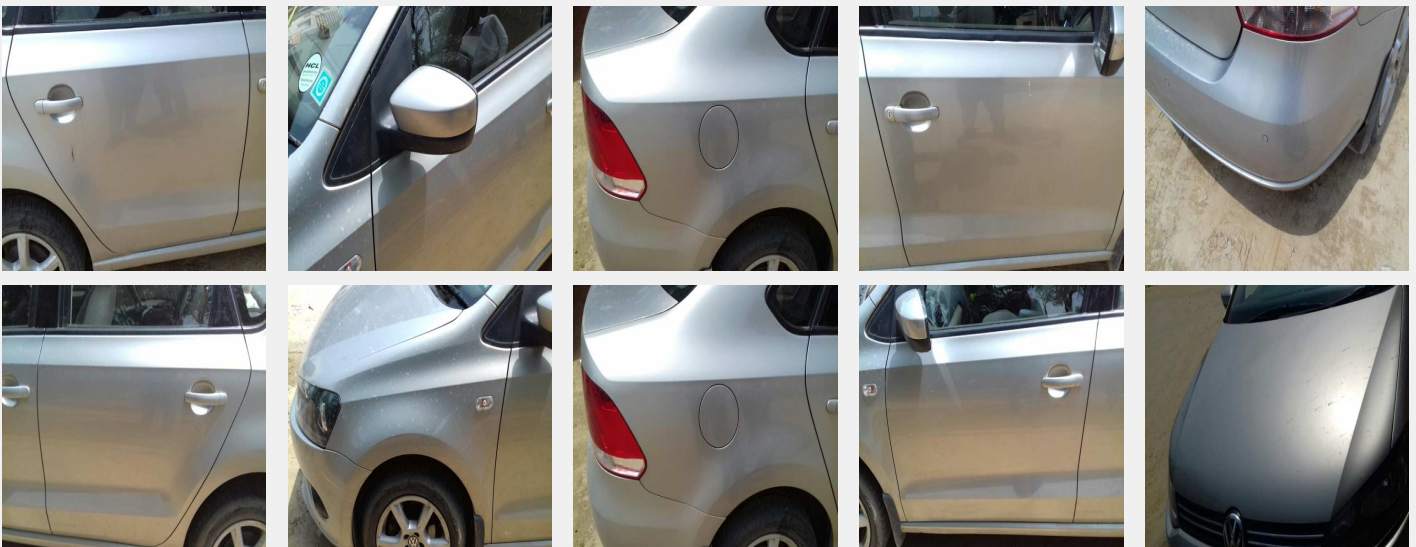
NEED ATTENTION ⚠️

INSPECTION CHECKPOINTS	SCORE(X/10)	REMARKS/COMMENTS	OPTIONAL SPEND EST. (RS)
LICENSE PLATE	7	GOOD	0
HEAD LIGHTS	7	GOOD	0
GRILLE	7	GOOD	0
TURN SIGNAL	7	GOOD	0
FOG LAMPS	7	GOOD	0
PILLAR	7	GOOD	0
FRONT WINDSHIELD	7	GOOD	0
REAR WINDSHIELD	7	GOOD	0
LUGGAGE COMPARTMENT LIGHT	7	GOOD	0
BODY RUST	7	GOOD	0
ROOF (REGULAR)	7	GOOD	0
PAINT CONDITION	6	PAINT CANDITION GOOD	0
FRONT BUMPER	5	PAINTED	0
HOOD	5	PAINTED	0
SIDE VIEW MIRRORS	5	PAINTED	0
LH FENDER	5	PAINTED	0
LH FRONT DOOR	5	PAINTED	0
LH REAR DOOR	5	PAINTED	0
LH RUNNING BOARD	5	PAINTED	0
LH QUARTER PANEL	5	PAINTED	0
FUEL LID	5	PAINTED	0
REAR BUMPER	5	PAINTED	0
TAIL LIGHT	3	LEFT SIDE NOT WORKING	500
TRUNK LID/TAIL GATE	5	PAINTED	0

car better candition car is painted but paint bettar candition tuarb sound
