ECO INSPECTION REPORT Premium

Order ID : 20764

Ordered By : Manoj | Inspection Date : 2018-07-30 | Valid Till : 2018-10-30

Tata Manza Aura Safire Bs-Iv, 2009

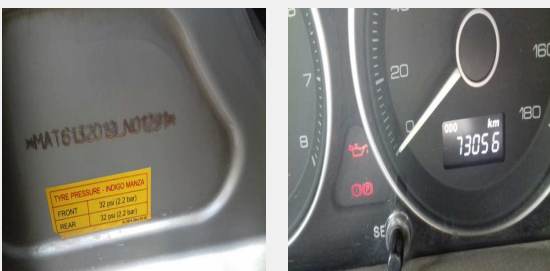
INSPECTION CHECKPOINTS	SCORE(X/10)	REMARKS/COMMENTS	OPTIONAL SPEND EST. (RS)
STEERING PERFORMANCE	6	GOOD	0
BRAKE PERFORMANCE	6	GOOD	0
CLUTCH PERFORMANCE	6	GOOD	0
IGNITION SYSTEM	6	GOOD	0
SUSPENSION FRONT SHOCKS	6	GOOD	0
SUSPENSION REAR SHOCKS	6	GOOD	0
TRANSMISSION ENGAGE	6	GOOD	0
ENGINE NOISE	5	BAIRING SOUNDS	3000
SUSPENSION PERFORMANCE	5	MINOR SOUND	0
CRUISE CONTROL	0	NO	0
REAR PARKING SENSORS	0	NO	0
REAR VIEW CAMERA	0	NO	0

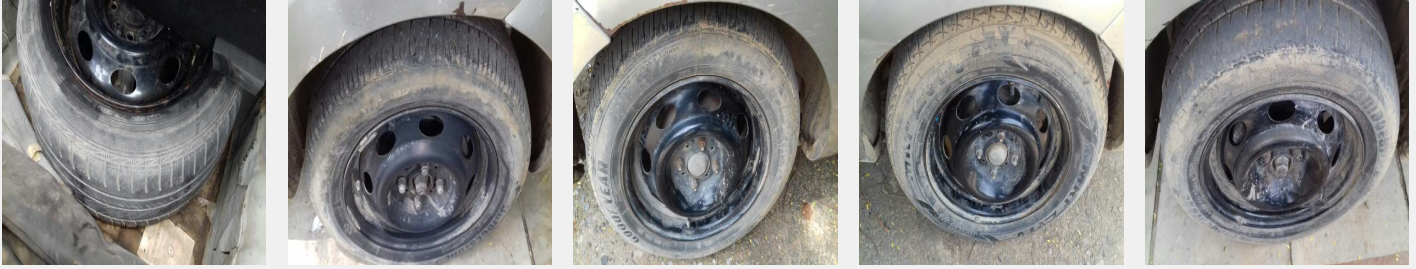
INSPECTION CHECKPOINTS	SCORE(X/10)	REMARKS/COMMENTS	OPTIONAL SPEND EST. (RS)
SPARE TYRE	6	AVERAGE	0
WHEEL ASSEMBLY (STEEL RIM)	6	GOOD	0
TYRES	3	BAD	15000

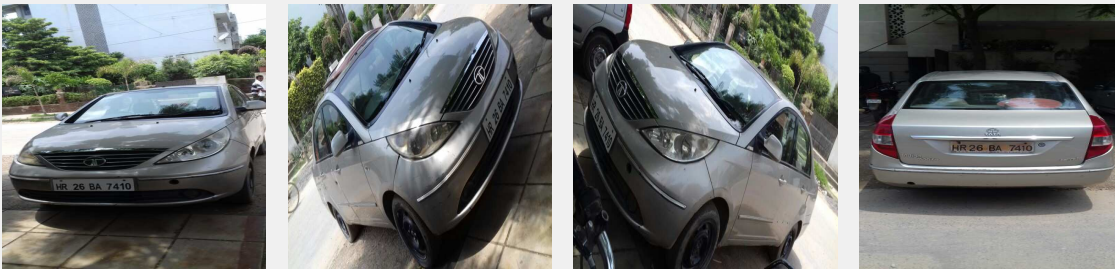
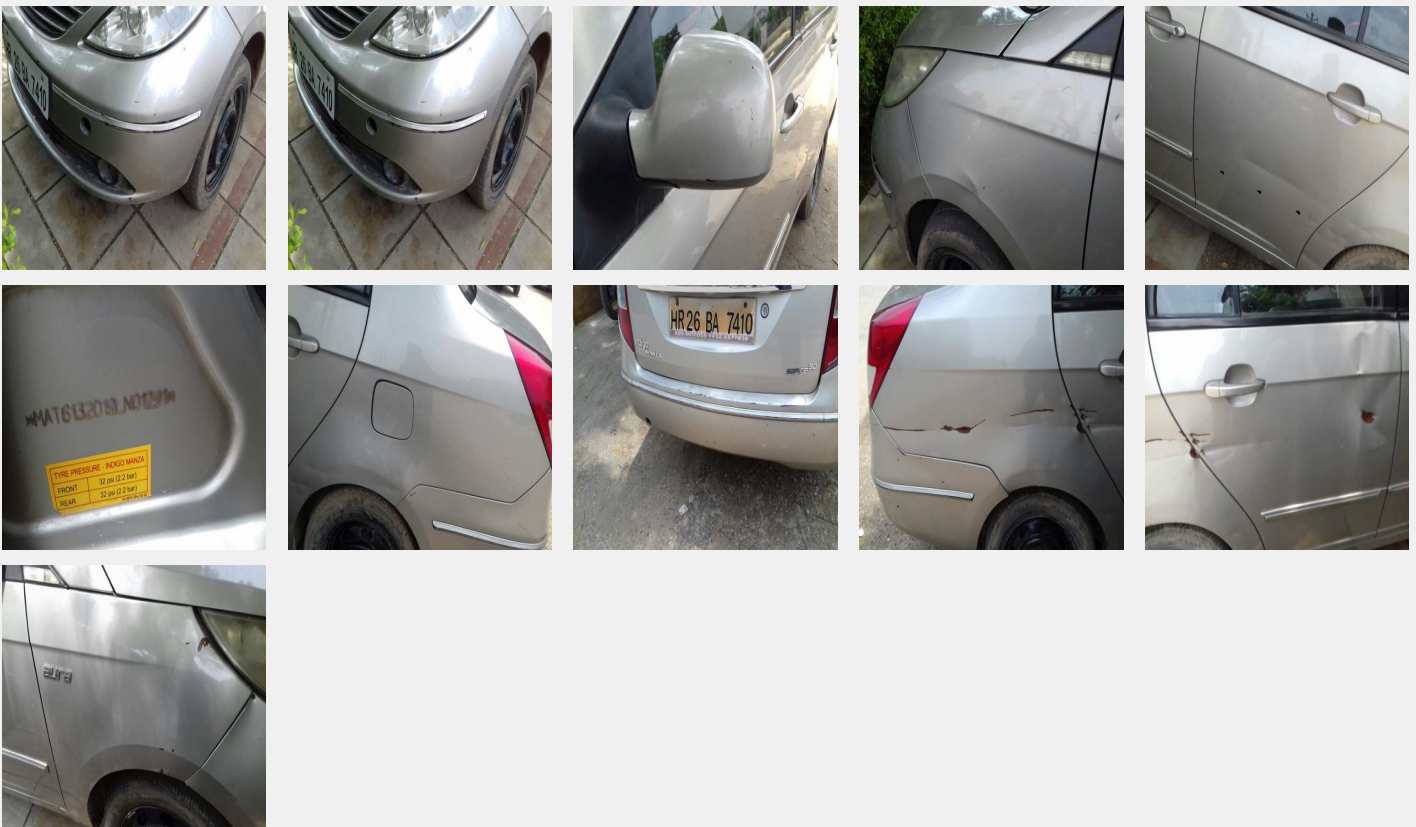
INSPECTION CHECKPOINTS	SCORE(X/10)	REMARKS/COMMENTS	OPTIONAL SPEND EST. (RS)
LICENSE PLATE	6	GOOD	0
HEAD LIGHTS	6	GOOD	0
GRILLE	6	GOOD	0
TURN SIGNAL	6	GOOD	0
HOOD	6	GOOD	0
PILLAR	6	GOOD	0
FRONT WINDSHIELD	6	GOOD	0
LH FRONT DOOR	6	GOOD	0
LH QUARTER PANEL	6	MINOR DENT	0
FUEL LID	6	GOOD	0
REAR WINDSHIELD	6	GOOD	0
TAIL LIGHT	6	GOOD	0
TRUNK LID/TAIL GATE	6	GOOD	0
LUGGAGE COMPARTMENT LIGHT	6	GOOD	0
RH RUNNING BOARD	6	PAINTED	0
RH FRONT DOOR	6	GOOD	0
BODY RUST	6	GOOD	0
ROOF (REGULAR)	6	GOOD	0
PAINT CONDITION	6	GOOD	0
FRONT BUMPER	3	SCRATCH	2500
FOG LAMPS	0	NO	0
SIDE VIEW MIRRORS	5	PAINTED	0
LH FENDER	5	DENT	500
LH REAR DOOR	5	DENT	1000

INSPECTION CHECKPOINTS	SCORE(X/10)	REMARKS/COMMENTS	OPTIONAL SPEND EST. (RS)
LH RUNNING BOARD	5	PAINTED	0
REAR BUMPER	5	SCRATCH	2500
RH QUARTER PANEL	4	MAJOR SCRATCH	3000
RH REAR DOOR	4	MAJOR SCRATCH	3000
RH FENDER	4	DENT	2500
