ECO INSPECTION REPORT Premium

Order ID : 21140

Audi A4 2.0 Tdi Premium Plus, 2013

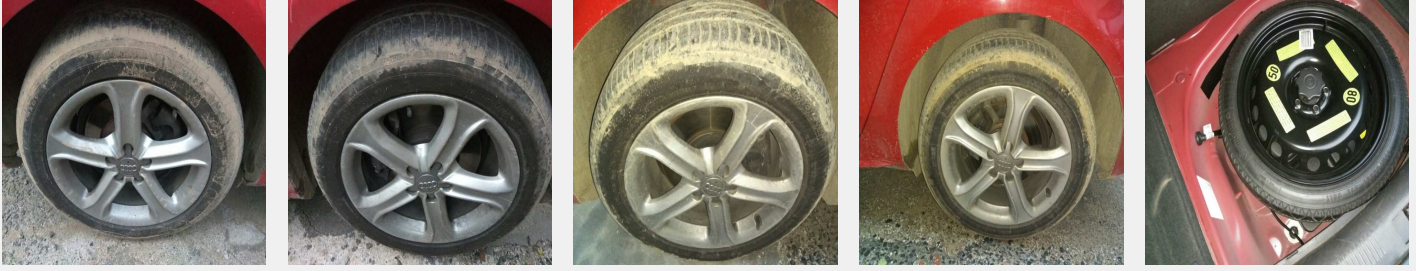
INSPECTION CHECKPOINTS	SCORE(X/10)	REMARKS/COMMENTS	OPTIONAL SPEND EST. (RS)
TYRES	6	AVERAGE	0
SPARE TYRE	6	AVERAGE	0
WHEEL ASSEMBLY (ALLOY RIM)	7	GOOD	0

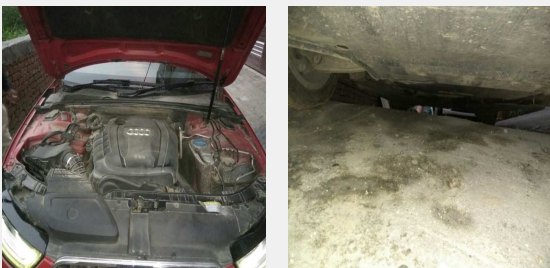
INSPECTION CHECKPOINTS	SCORE(X/10)	REMARKS/COMMENTS	OPTIONAL SPEND EST. (RS)
LH APRON	6	GOOD	0
RH APRON	6	GOOD	0
RADIATOR	7	GOOD	0
WIRING	6	GOOD	0
BATTERY	6	AVERAGE	0
BRAKE FLUID LEVEL	6	GOOD	0
ENGINE OIL	6	AVERAGE	0
COOLANT LEVEL	6	AVERAGE	0
BRAKE & COOLANT HOSE PIPES	6	AVERAGE	0
UNDERCARRIAGE	7	GOOD	0
EXHAUST SYSTEM	7	GOOD	0

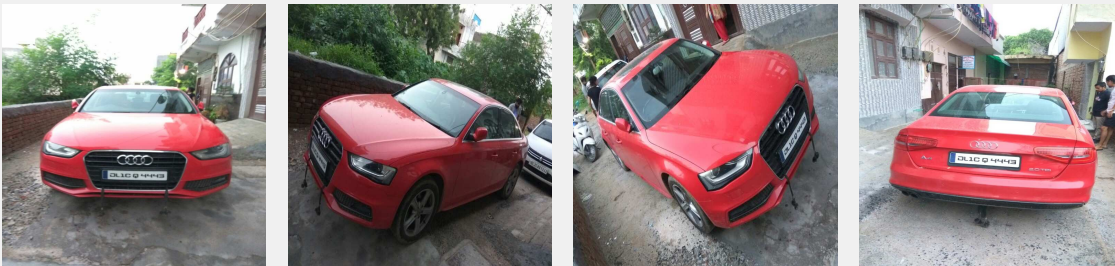
INSPECTION CHECKPOINTS	SCORE(X/10)	REMARKS/COMMENTS	OPTIONAL SPEND EST. (RS)
PAINT CONDITION	6	GOOD.	0
LH RUNNING BOARD	5	MINOR PAINT	0
REAR BUMPER	5	FULL. PAINTED	0
RH RUNNING BOARD	5	PAINTED	0
RH FENDER	5	FULL PAINTED	0

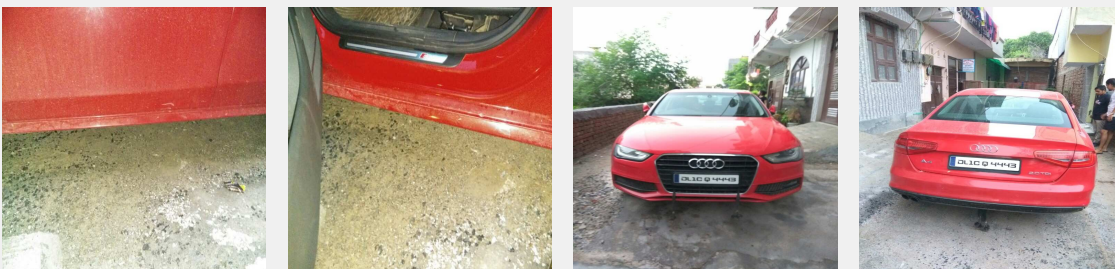
NEED ATTENTION ⚠️

1 car condition good 2 both bumper , both fender , running board painted
