ECO INSPECTION CERTIFICATE

Order ID : 48019

121 Points Vehicle Inspection Certificate

Mitsubishi Pajero SFX 2.8, 2011

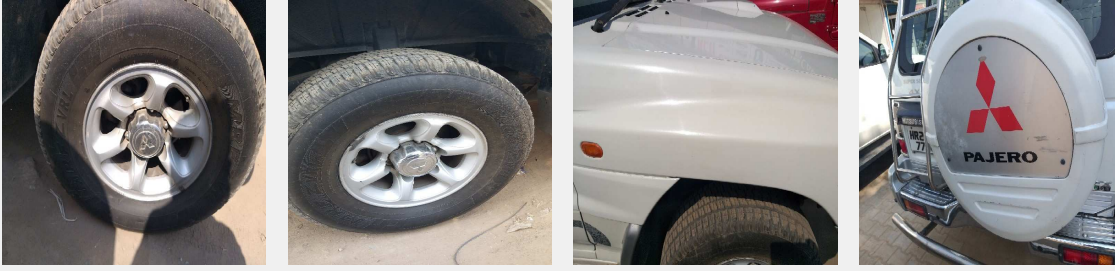
INSPECTION CHECKPOINTS	SCORE(X/10)	REMARKS/COMMENTS	OPTIONAL SPEND EST. (RS)
TYRES	7	GOOD CONDITION AND WORKING PROPERLY	0
SPARE TYRE (YES)	7	GOOD CONDITION AND WORKING PROPERLY	0
WHEEL ASSEMBLY (STEEL RIM)	7	GOOD	0

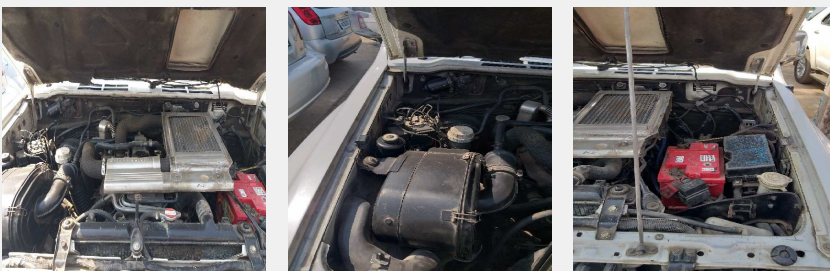
HOOD

INSPECTION CHECKPOINTS	SCORE(X/10)	REMARKS/COMMENTS	OPTIONAL SPEND EST. (RS)
LH APRON	7	GOOD	0
RH APRON	7	GOOD	0
RADIATOR	7	GOOD	0
WIRING	7	GOOD	0
BATTERY	7	GOOD CONDITION AND WORKING PROPERLY	0
BRAKE FLUID LEVEL	7	MAXIMUM	0
ENGINE OIL	7	MAXIMUM	0
COOLANT LEVEL	7	MAXIMUM	0
BRAKE & COOLANT HOSE PIPES	7	GOOD	0
UNDERCARRIAGE	7	GOOD	0
EXHAUST SYSTEM	7	GOOD	0

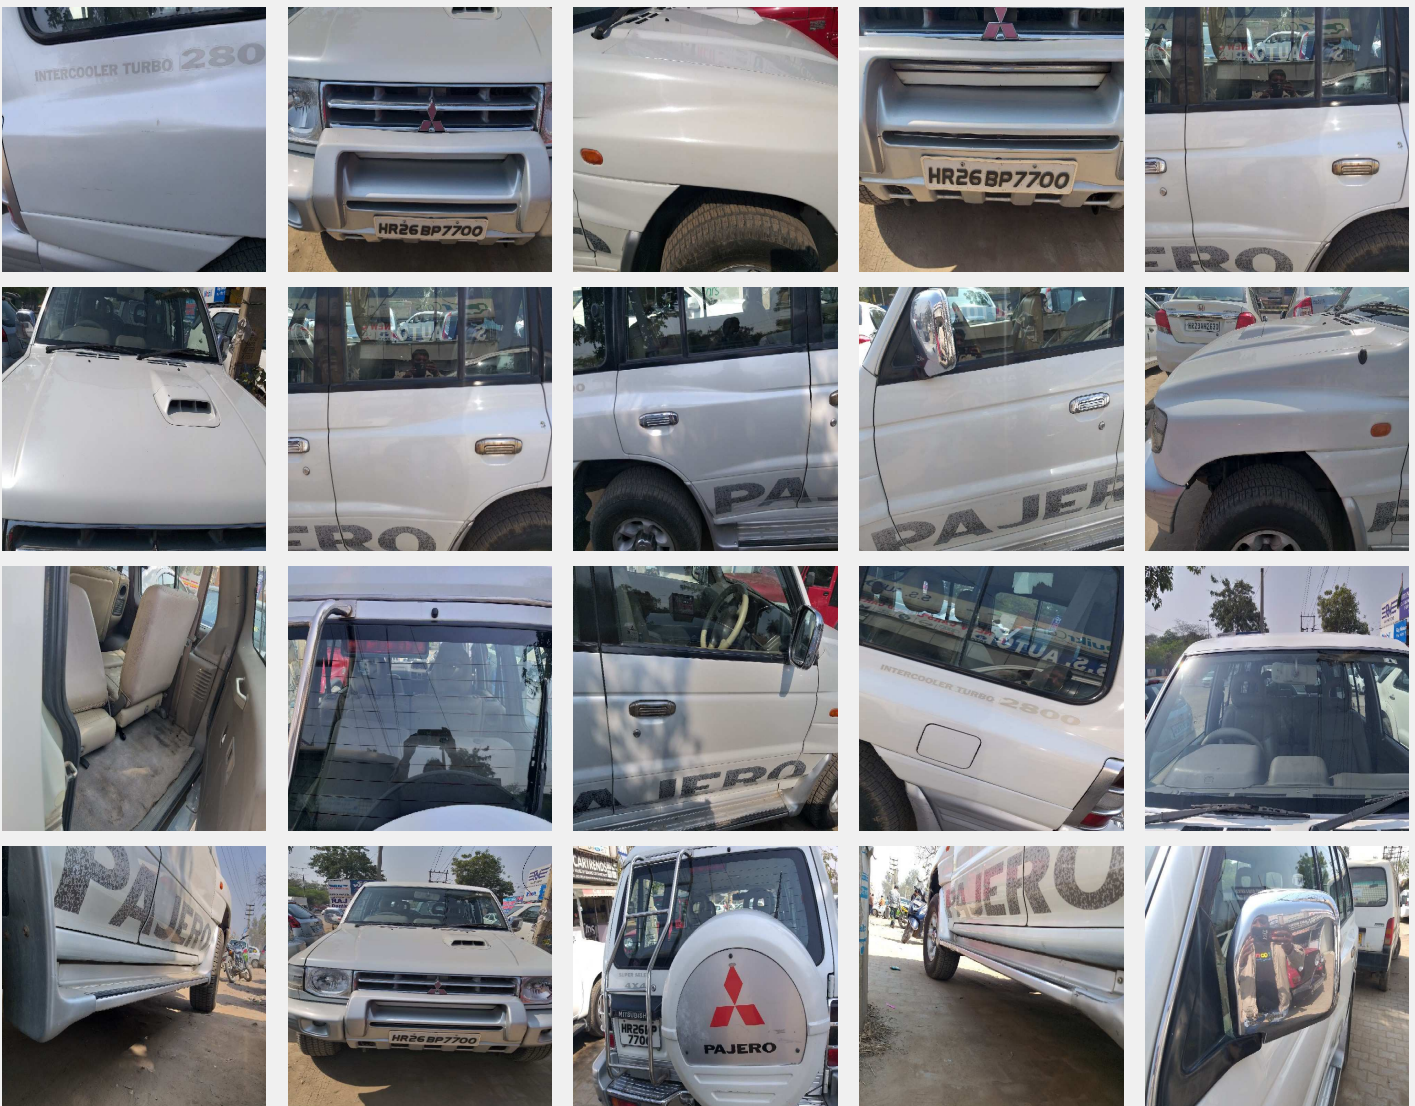
EXTERIOR (CONTINUED)

RH QUARTER PANEL	6	MINORS SCRATCHES	500
RH RUNNING BOARD	7	GOOD	0
RH REAR DOOR	7	GOOD	0

INSPECTION CHECKPOINTS	SCORE(X/10)	REMARKS/COMMENTS	OPTIONAL SPEND EST. (RS)
RH FRONT DOOR	7	GOOD	0
RH FENDER	7	GOOD	0
BODY RUST	6		0
ROOF (REGULAR)	7	GOOD	0
PAINT CONDITION	7	GOOD	0

minor scratches minor dent
