ECO INSPECTION CERTIFICATE

121 Points Vehicle Inspection Certificate

Inspection Date :
2019-04-15

Fiat Linea Dynamic 1.4, 2011

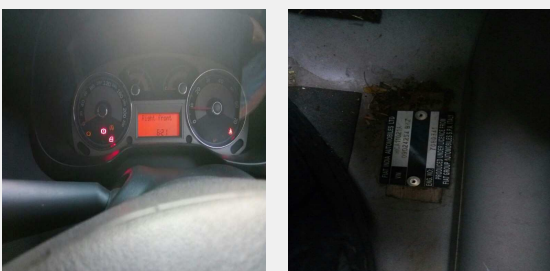
TEST DRIVE

INSPECTION CHECKPOINTS	SCORE(X/10)	REMARKS/COMMENTS	OPTIONAL SPEND EST. (RS)
STEERING PERFORMANCE	6	GOOD	0
BRAKE PERFORMANCE	6	GOOD	0
CLUTCH PERFORMANCE	6	GOOD	0
ENGINE NOISE	6	GOOD	0
IGNITION SYSTEM	6	GOOD	0
SUSPENSION PERFORMANCE	7	GOOD	0
SUSPENSION FRONT SHOCKS	6	GOOD	0
SUSPENSION REAR SHOCKS	6	GOOD	0
TRANSMISSION ENGAGE	6	GOOD	0
CRUISE CONTROL (NO)	10		0
REAR PARKING SENSORS (NO)	10		0
REAR VIEW CAMERA (NO)	10		0

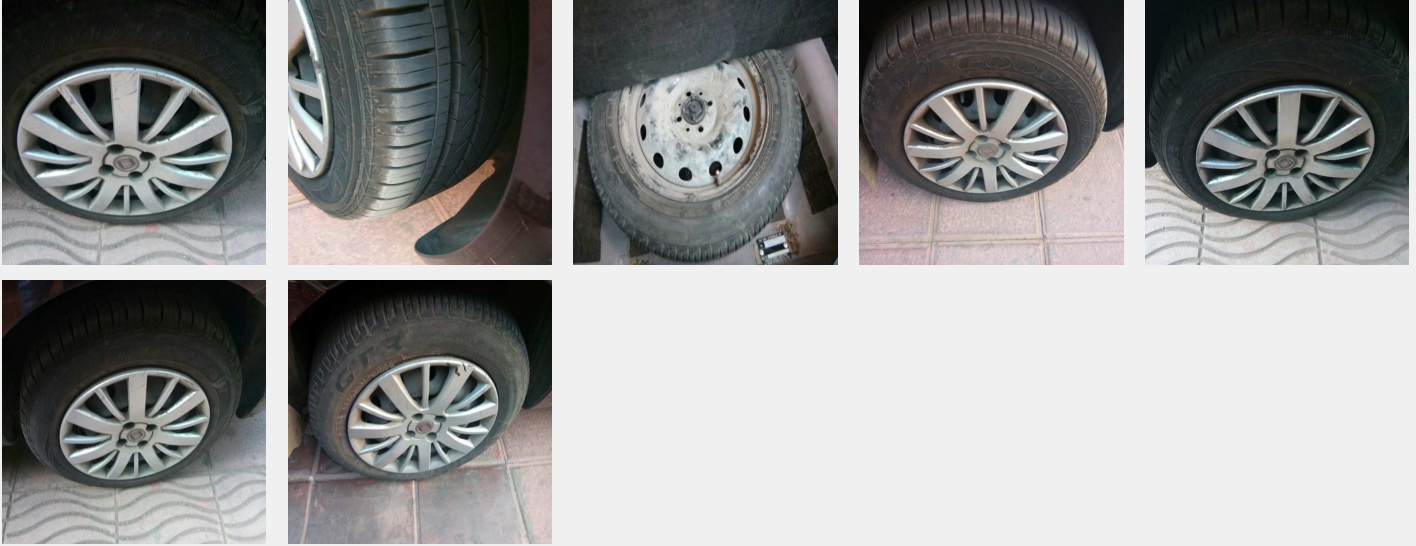
INSPECTION CHECKPOINTS	SCORE(X/10)	REMARKS/COMMENTS	OPTIONAL SPEND EST. (RS)
TYRES	6	GOOD	0
SPARE TYRE (YES)	7	GOOD	0
WHEEL ASSEMBLY (STEEL RIM)	6	GOOD	0

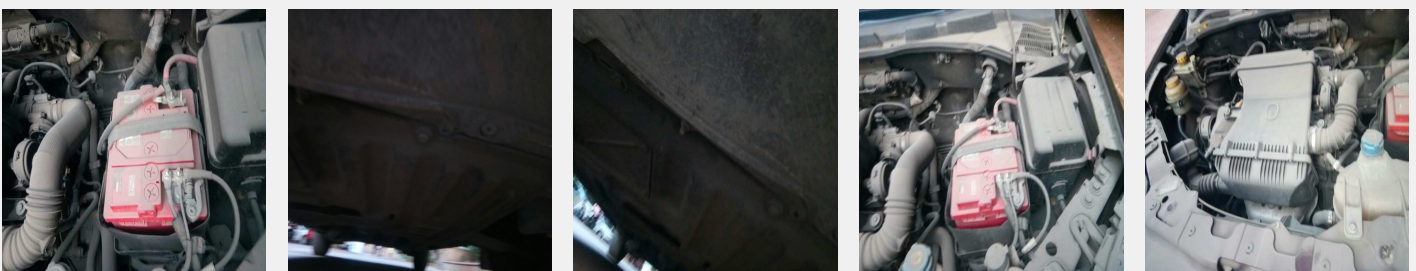
HOOD

INSPECTION CHECKPOINTS	SCORE(X/10)	REMARKS/COMMENTS	OPTIONAL SPEND EST. (RS)
LH APRON	7	GOOD	0
RH APRON	7	GOOD	0
RADIATOR	6	GOOD	0
WIRING	6	GOOD	0
BATTERY	7	GOOD	0
BRAKE FLUID LEVEL	6	GOOD	0
ENGINE OIL	7		0
COOLANT LEVEL	7	GOOD	0
BRAKE & COOLANT HOSE PIPES	7	GOOD	0
UNDERCARRIAGE	7	GOOD	0
EXHAUST SYSTEM	7	GOOD	0

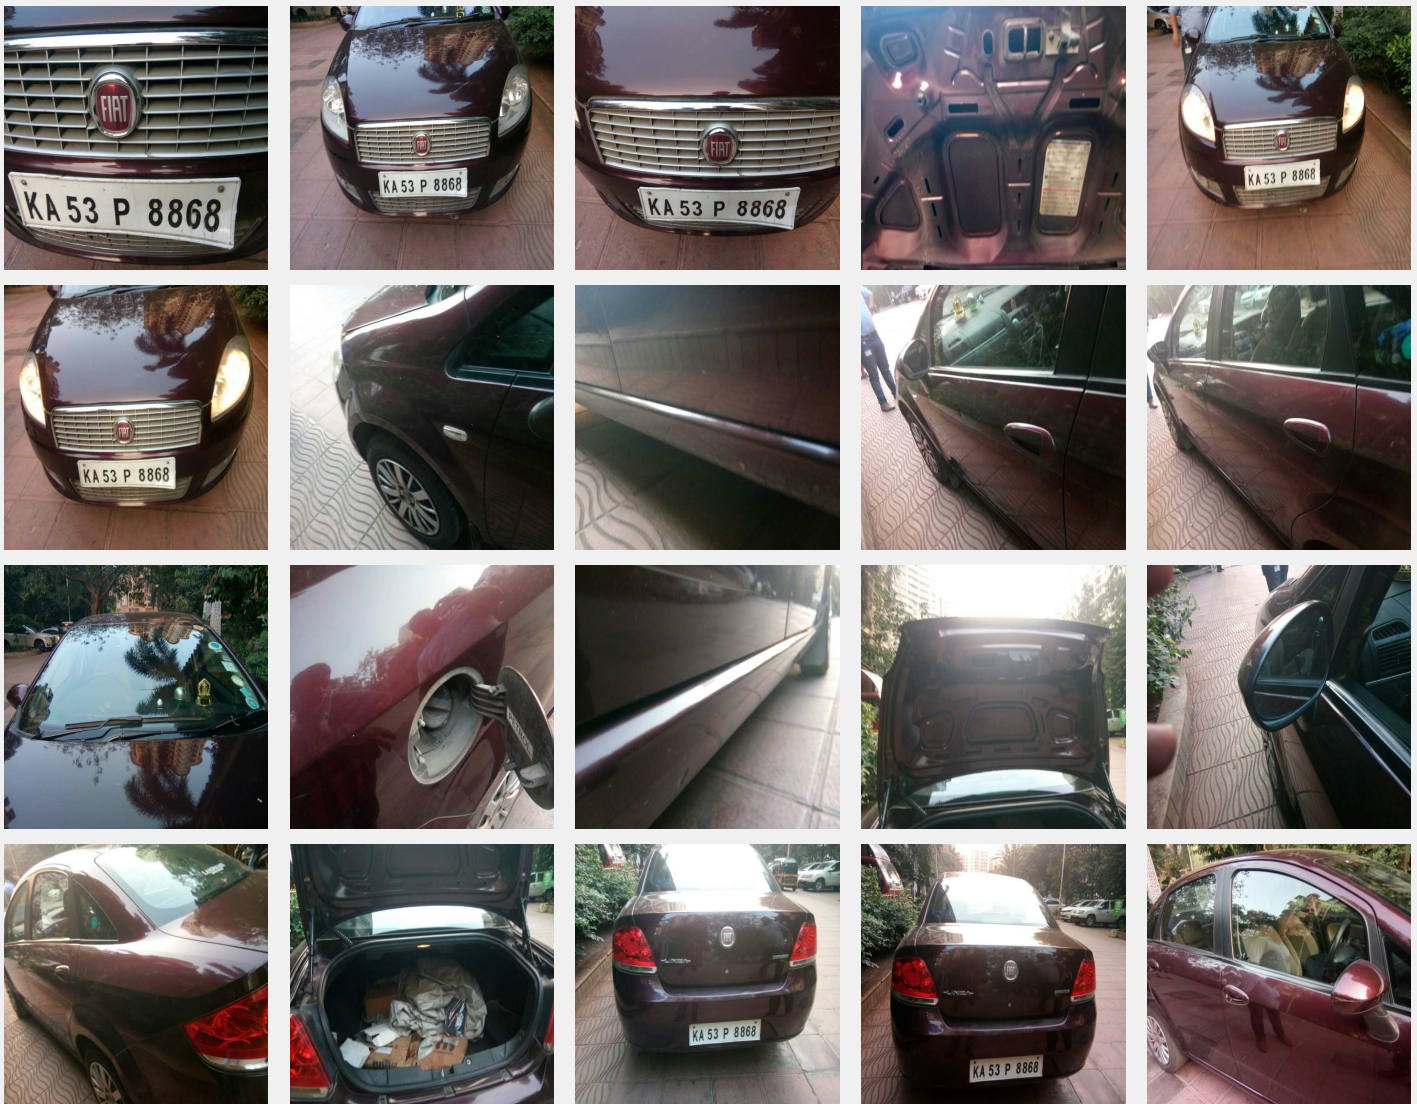
EXTERIOR (CONTINUED)

INSPECTION CHECKPOINTS	SCORE(X/10)	REMARKS/COMMENTS	OPTIONAL SPEND EST. (RS)
ROOF (REGULAR)	6	GOOD	0
PAINT CONDITION	7	GOOD	0
FOG LAMPS	3	NOT OK	500
RH QUARTER PANEL	3	NOT OK	1500
RH FENDER	3	MEJOR SCTACHES	1500

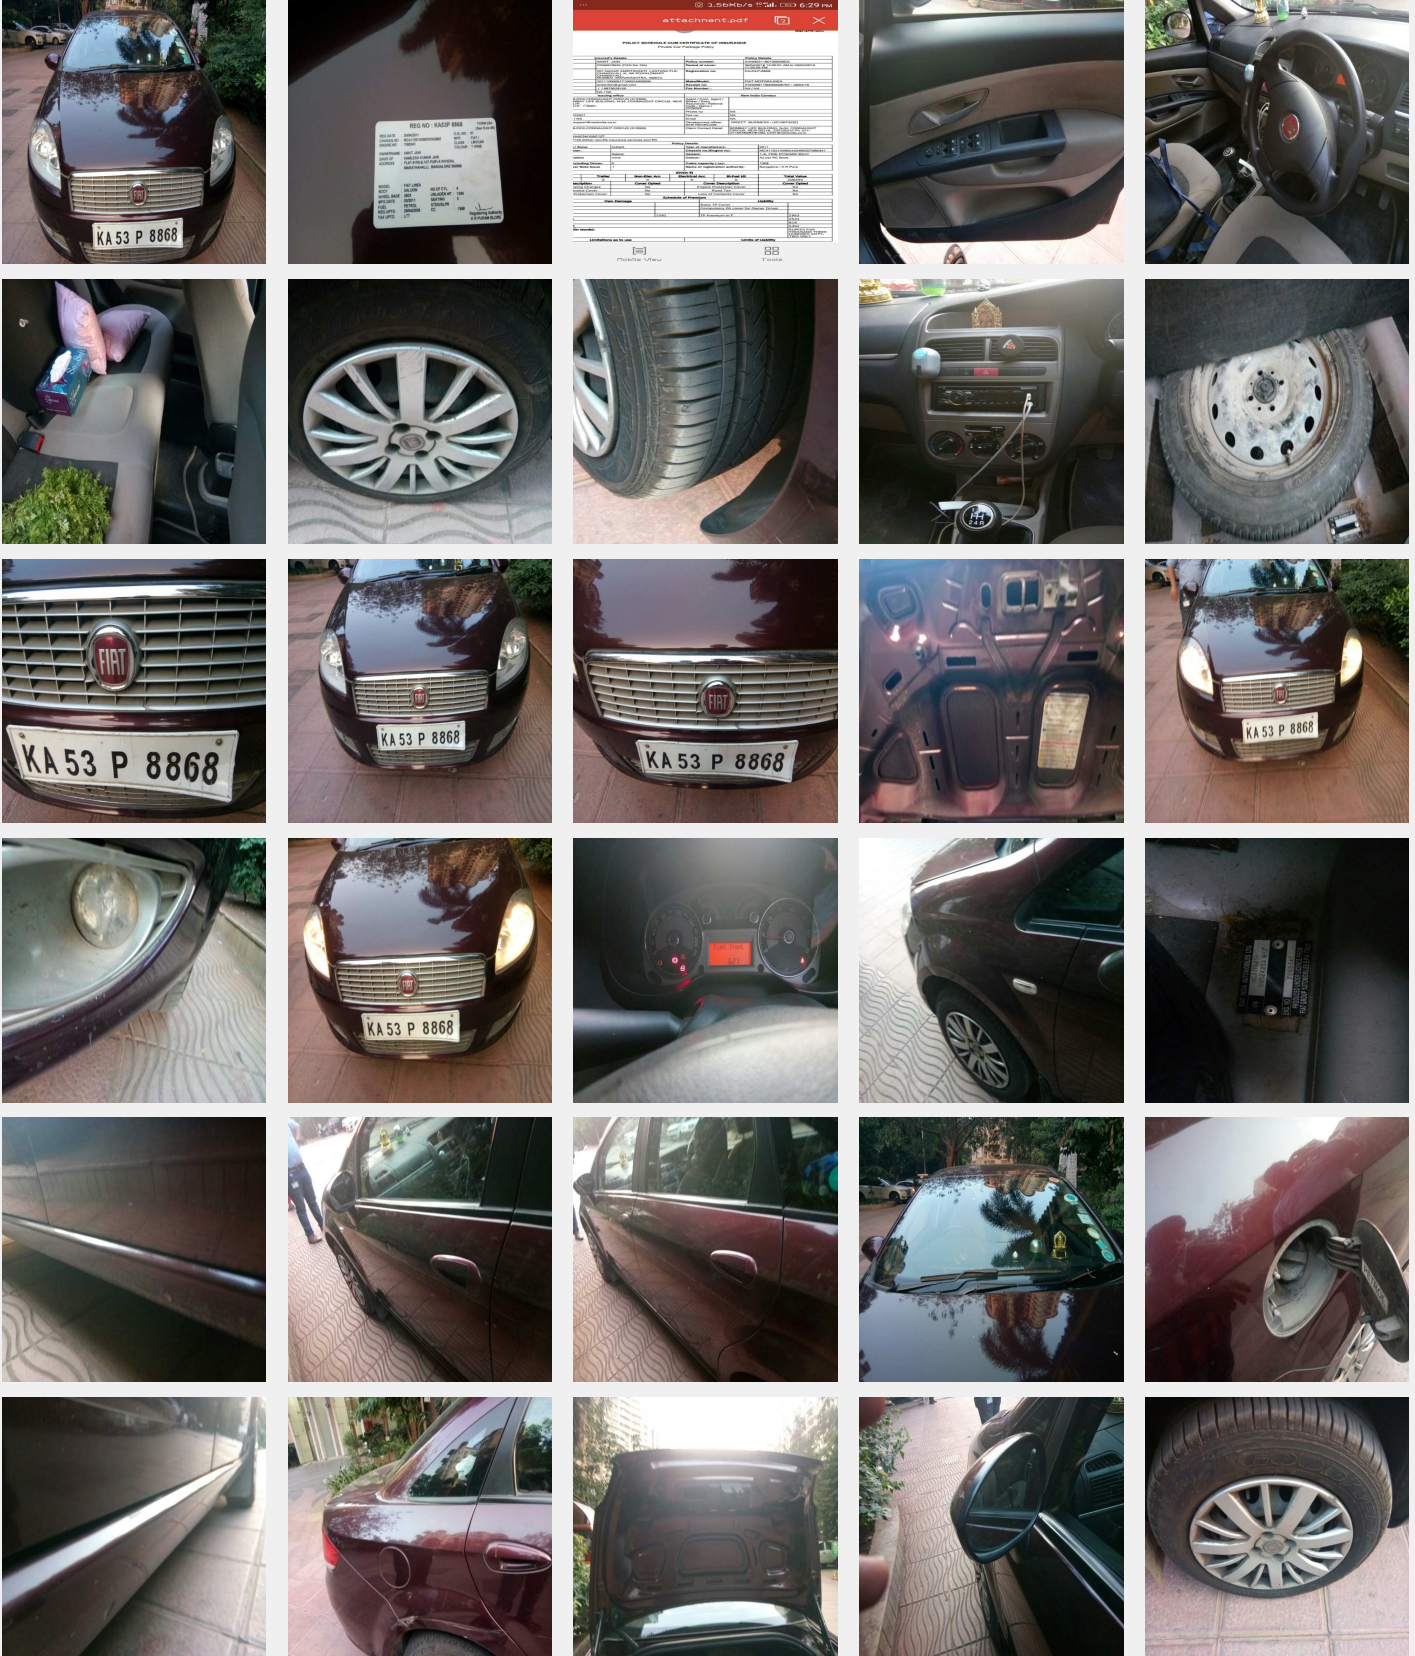
NEED ATTENTION

normal scraches. door glass not working
