ECO INSPECTION CERTIFICATE

Order ID : 75112

121 Points Vehicle Inspection Certificate

Volkswagen Vento HIGHLINE PETROL AT, 2018

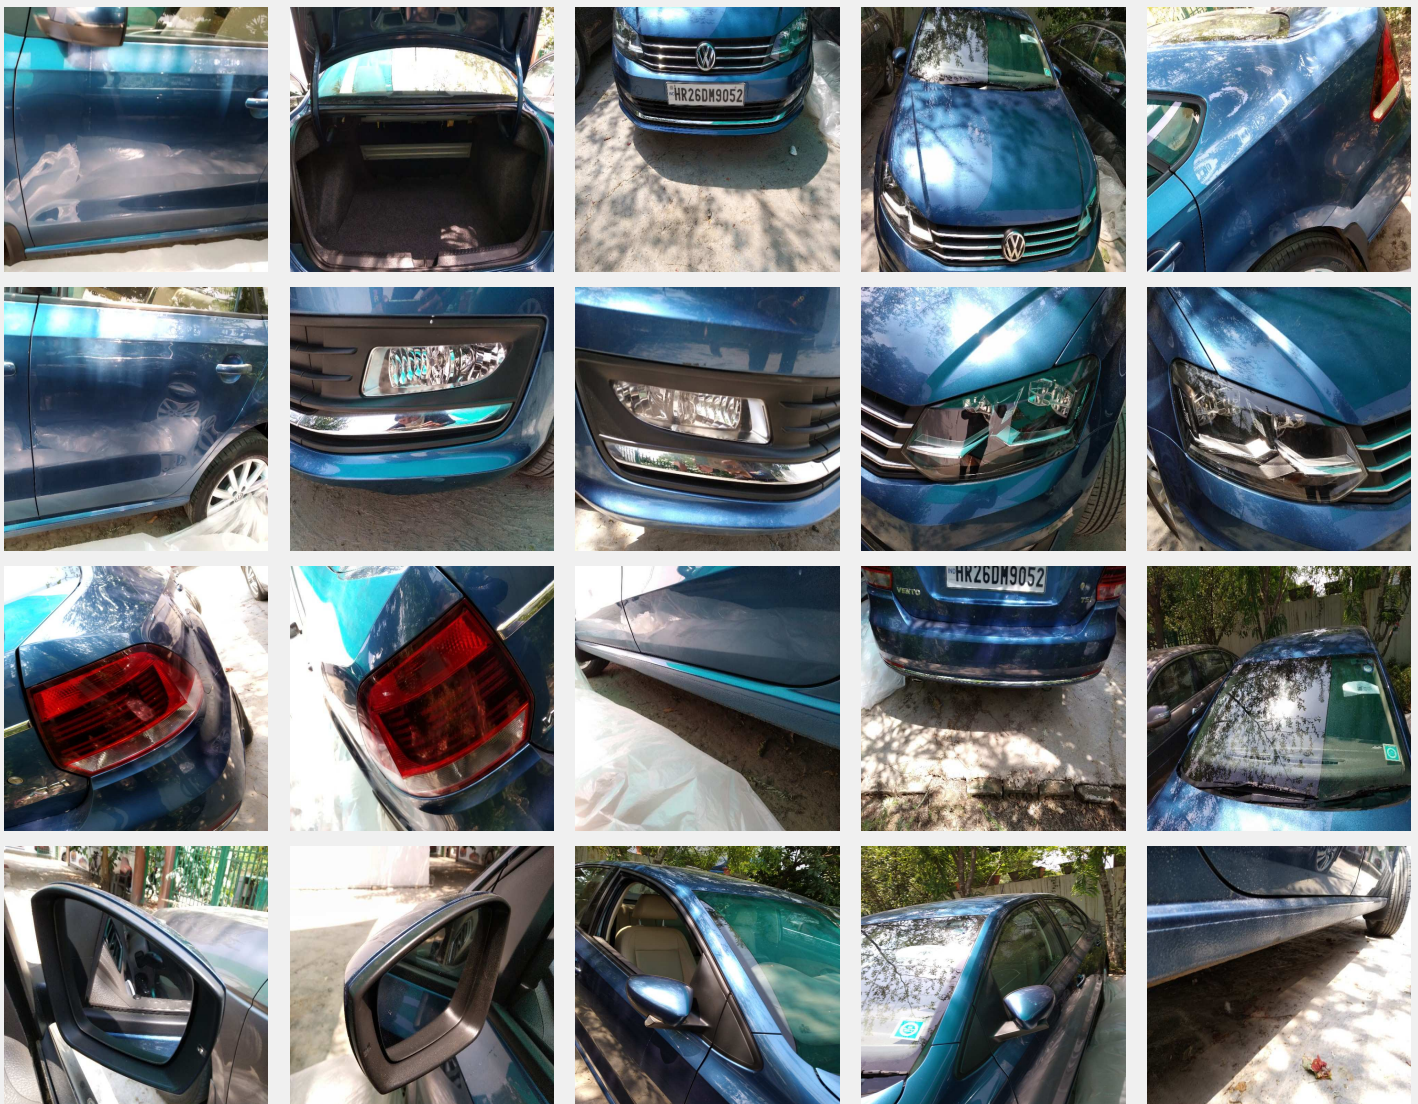
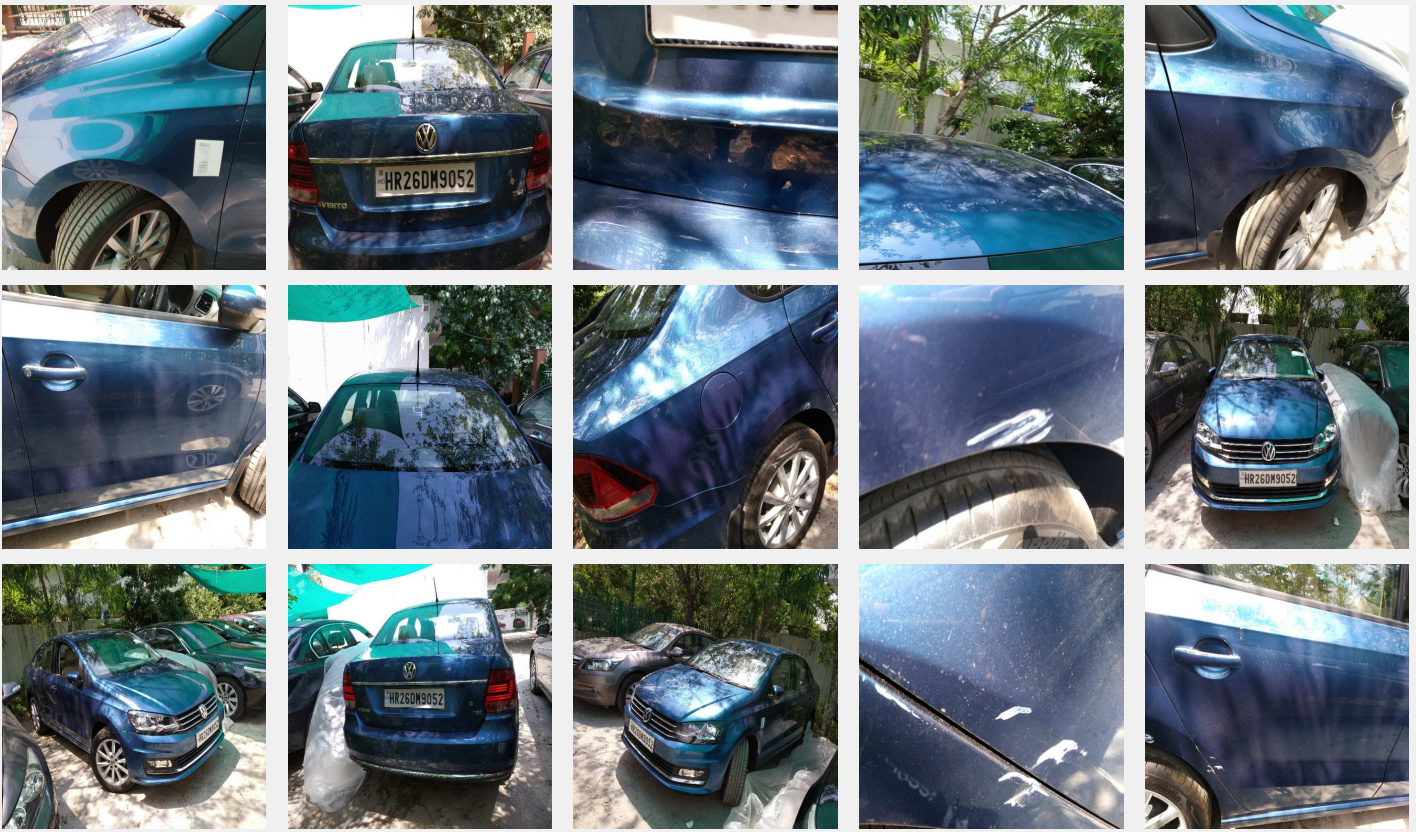
INSPECTION CHECKPOINTS	SCORE(X/10)	REMARKS/COMMENTS	OPTIONAL SPEND EST. (RS)
LICENSE PLATE	8		0
FRONT BUMPER	8		0
HEAD LIGHTS	8		0
GRILLE	8		0
TURN SIGNAL	8		0
FOG LAMPS	8		0
HOOD	8		0
PILLAR	8		0
FRONT WINDSHIELD	8		0
SIDE VIEW MIRRORS	8		0
LH FENDER	8		0
LH FRONT DOOR	8		0
LH REAR DOOR	8		0
LH RUNNING BOARD	8		0
LH QUARTER PANEL	8		0
FUEL LID	8		0
REAR WINDSHIELD	8		0
REAR BUMPER	8		0
TAIL LIGHT	8		0
TRUNK LID/TAIL GATE	6	MINOR PAINT REMOVE	500
LUGGAGE COMPARTMENT LIGHT	8		0
RH QUARTER PANEL	6	MINOR SCRATCHES	500
RH RUNNING BOARD	8		0
RH REAR DOOR	6	MINOR SCRATCHES	500

minor scratches and minor dent
