# ECO INSPECTION CERTIFICATE

Order ID : 75041

121 Points Vehicle Inspection Certificate

## Toyota Etios Liva GD, 2013

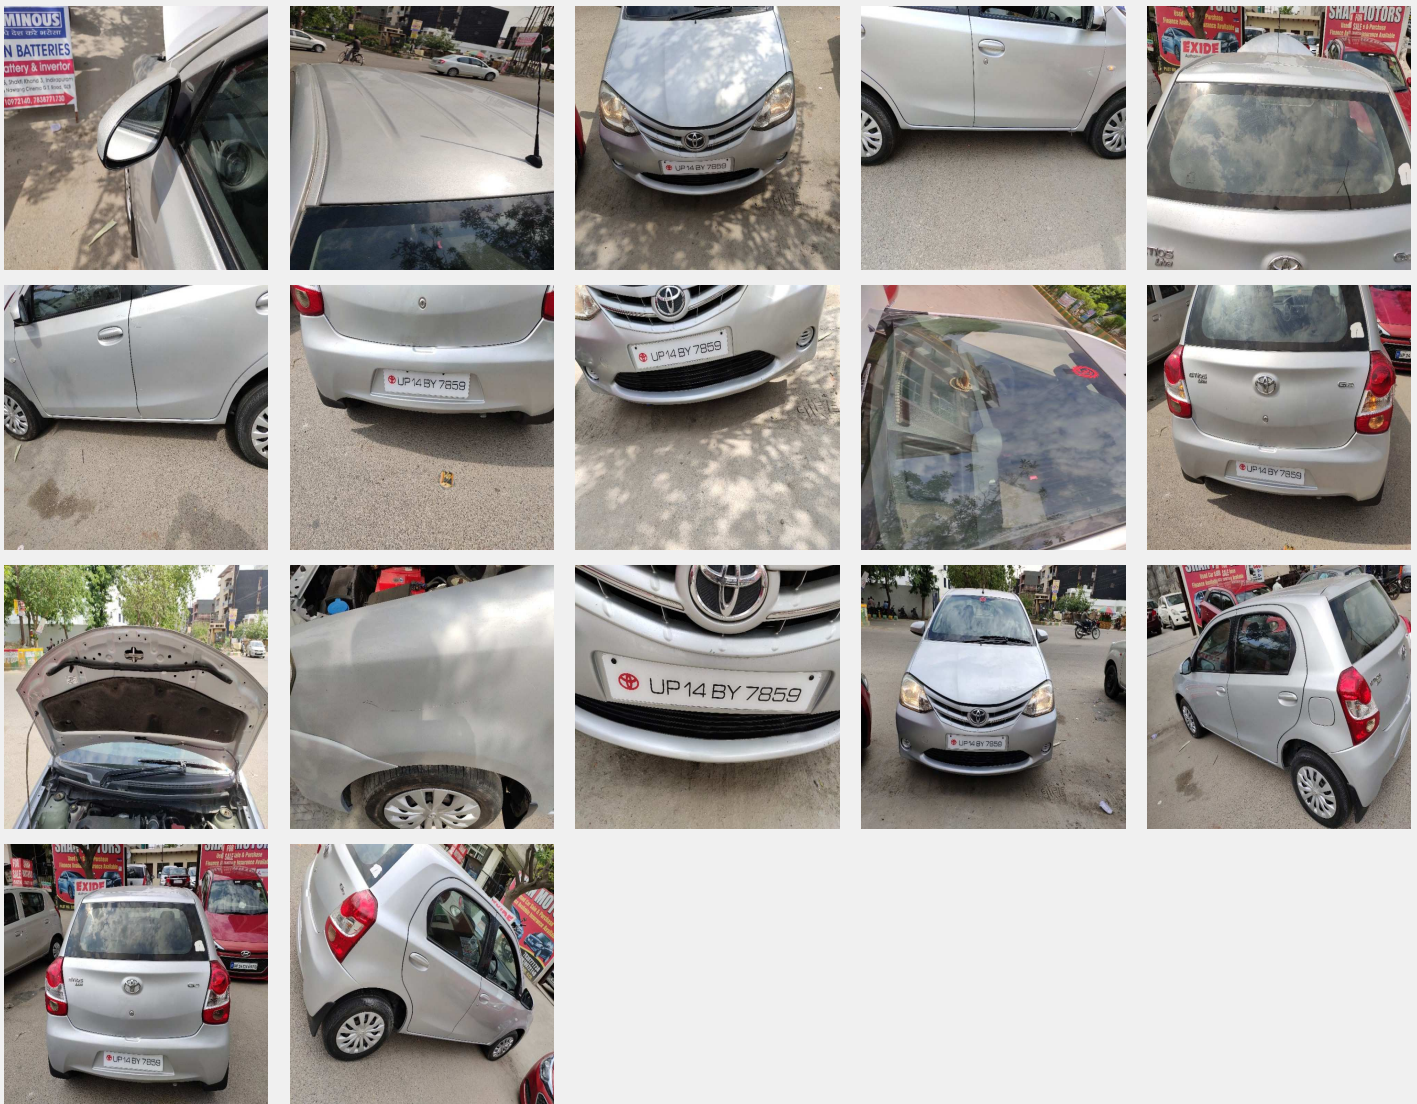
INSPECTION CHECKPOINTS	SCORE(X/10)	REMARKS/COMMENTS	OPTIONAL SPEND EST. (RS)
RH FENDER	7		0
BODY RUST	7		0
ROOF (REGULAR)	7		0
PAINT CONDITION	7		0
FOG LAMPS	0	NA	0
