# ECO INSPECTION CERTIFICATE

Order ID : 76343

121 Points Vehicle Inspection Certificate

## Honda Brio Vx Mt, 2017

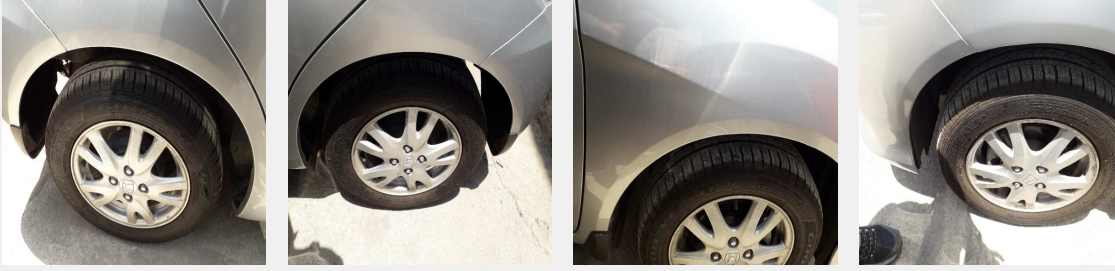
IMAGES

INSPECTION CHECKPOINTS	SCORE(X/10)	REMARKS/COMMENTS	OPTIONAL SPEND EST. (RS)
TYRES	7	GOOD TREAD	0
SPARE TYRE (YES)	7	GOOD TREAD	0
WHEEL ASSEMBLY (ALLOY RIM)	7	GOOD CONDITION	0

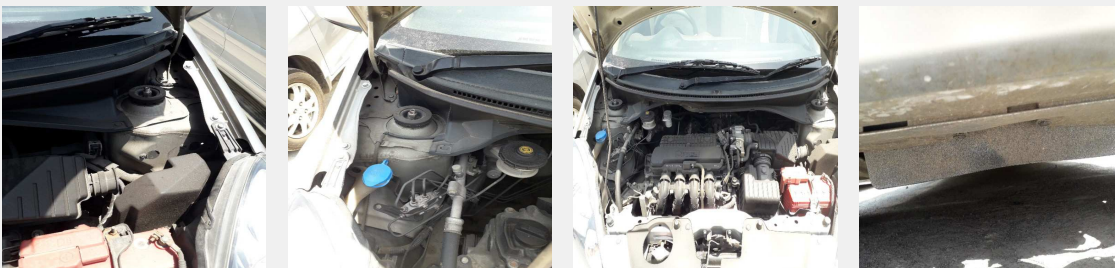
IMAGES

INSPECTION CHECKPOINTS	SCORE(X/10)	REMARKS/COMMENTS	OPTIONAL SPEND EST. (RS)
LH APRON	7	GOOD PASTING	0
RH APRON	7	GOOD PASTING	0
RADIATOR	7	WORKING	0
WIRING	7	GOOD CONDITION	0
BATTERY	7	FULLY CHARGED	0
BRAKE FLUID LEVEL	7	MAXIMUM LEVEL	0
ENGINE OIL	7	GOOD OIL	0
COOLANT LEVEL	7	MAXIMUM LEVEL	0
BRAKE & COOLANT HOSE PIPES	7	GOOD CONDITION	0
UNDERCARRIAGE	7	GOOD CONDITION	0
EXHAUST SYSTEM	7	NO SMOKE	0

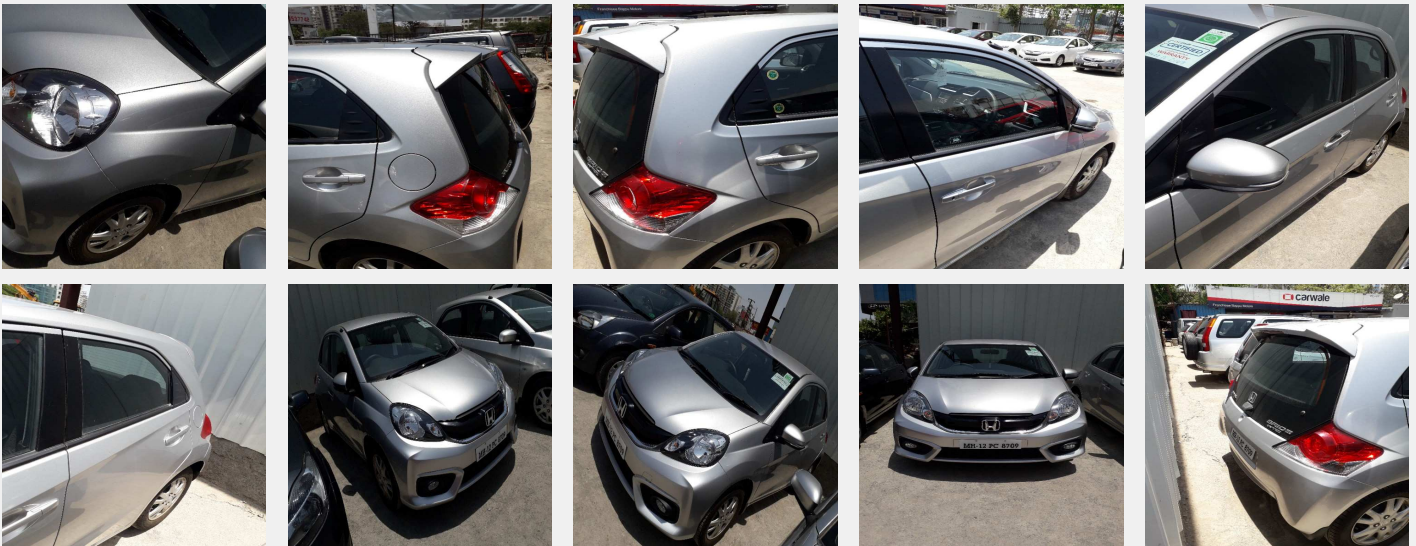
## IMAGES

INSPECTION CHECKPOINTS	SCORE(X/10)	REMARKS/COMMENTS	OPTIONAL SPEND EST. (RS)
RH FRONT DOOR	7	GOOD CONDITION	0
RH FENDER	7	GOOD CONDITION	0
BODY RUST	7	NO BODY RUST	0
ROOF (REGULAR)	7	GOOD CONDITION	0
PAINT CONDITION	7	GOOD CONDITION	0
