# ECO INSPECTION CERTIFICATE

121 Points Vehicle Inspection Certificate

## Hyundai Verna 1.6 CRDI SX, 2012

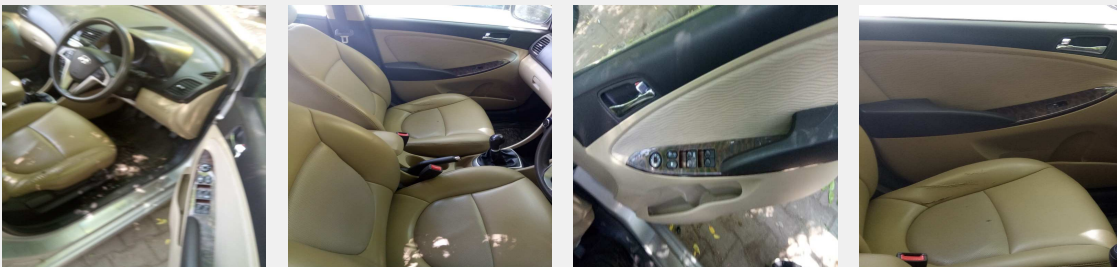
INSPECTION CHECKPOINTS	SCORE(X/10)	REMARKS/COMMENTS	OPTIONAL SPEND EST. (RS)
DOOR PANEL	7	GOOD	0
DOOR HINGES	7	GOOD	0
CARPET & FLOOR MAT	7	GOOD	0
SEAT & SEAT BELT	7	GOOD	0
DASHBOARD & INSTRUMENT PANEL	7	GOOD	0
HORN	7	GOOD	0
SPEAKERS & MUSIC SYSTEM	7	GOOD	0
HANDBRAKE	7	GOOD	0
STEERING-MOUNTED CONTROLS	7	GOOD	0
PEDALS	7	GOOD	0
CENTRAL LOCK	7	GOOD	0
A/C VENTS & HEATER	7	GOOD	0
CUP HOLDERS	7	GOOD	0
NAVIGATION (NO)	10		0
ODOMETER	7	GOOD	0
POWER WINDOWS (YES)	7	GOOD	0
HAZARD LIGHT	7	GOOD	0

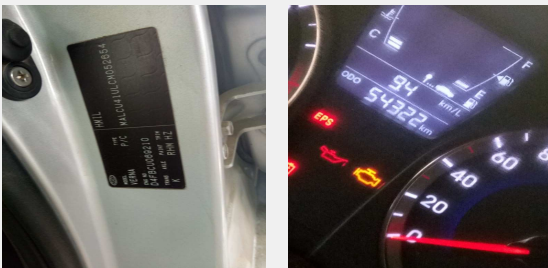
INSPECTION CHECKPOINTS	SCORE(X/10)	REMARKS/COMMENTS	OPTIONAL SPEND EST. (RS)
STEERING PERFORMANCE	7	SMOOTHLY ROTATE BOTH SIDE	0
BRAKE PERFORMANCE	7	GOOD	0
CLUTCH PERFORMANCE	7	GOOD	0
ENGINE NOISE	7	GOOD	0
IGNITION SYSTEM	7	GOOD	0
SUSPENSION PERFORMANCE	7	GOOD	0
SUSPENSION FRONT SHOCKS	7	GOOD	0
SUSPENSION REAR SHOCKS	7	GOOD	0
TRANSMISSION ENGAGE	7	GOOD	0
CRUISE CONTROL (YES)	7	GOOD	0
REAR PARKING SENSORS (YES)	7	GOOD	0
REAR VIEW CAMERA (NO)	10		0

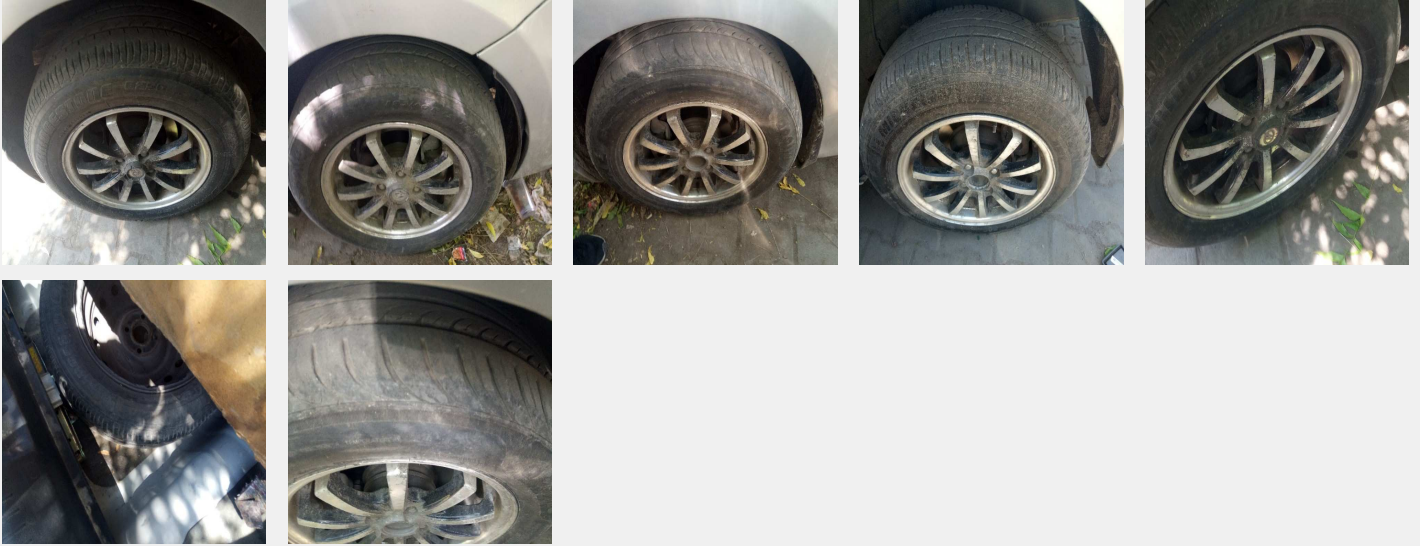
INSPECTION CHECKPOINTS	SCORE(X/10)	REMARKS/COMMENTS	OPTIONAL SPEND EST. (RS)
TYRES	7	GOOD	0
SPARE TYRE (YES)	7	GOOD	0
WHEEL ASSEMBLY (ALLOY RIM)	7	GOOD	0

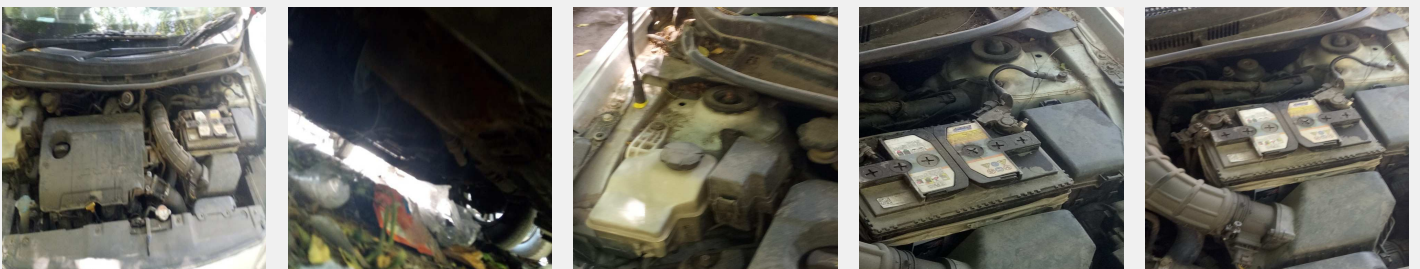
INSPECTION CHECKPOINTS	SCORE(X/10)	REMARKS/COMMENTS	OPTIONAL SPEND EST. (RS)
LH APRON	7	GOOD	0
RH APRON	7	GOOD	0
RADIATOR	7	GOOD	0
WIRING	7	GOOD	0
BATTERY	7	GOOD	0
BRAKE FLUID LEVEL	7	GOOD	0
ENGINE OIL	7	GOOD	0
COOLANT LEVEL	7	GOOD	0
BRAKE & COOLANT HOSE PIPES	7	GOOD	0
UNDERCARRIAGE	7	GOOD	0
EXHAUST SYSTEM	7	GOOD	0

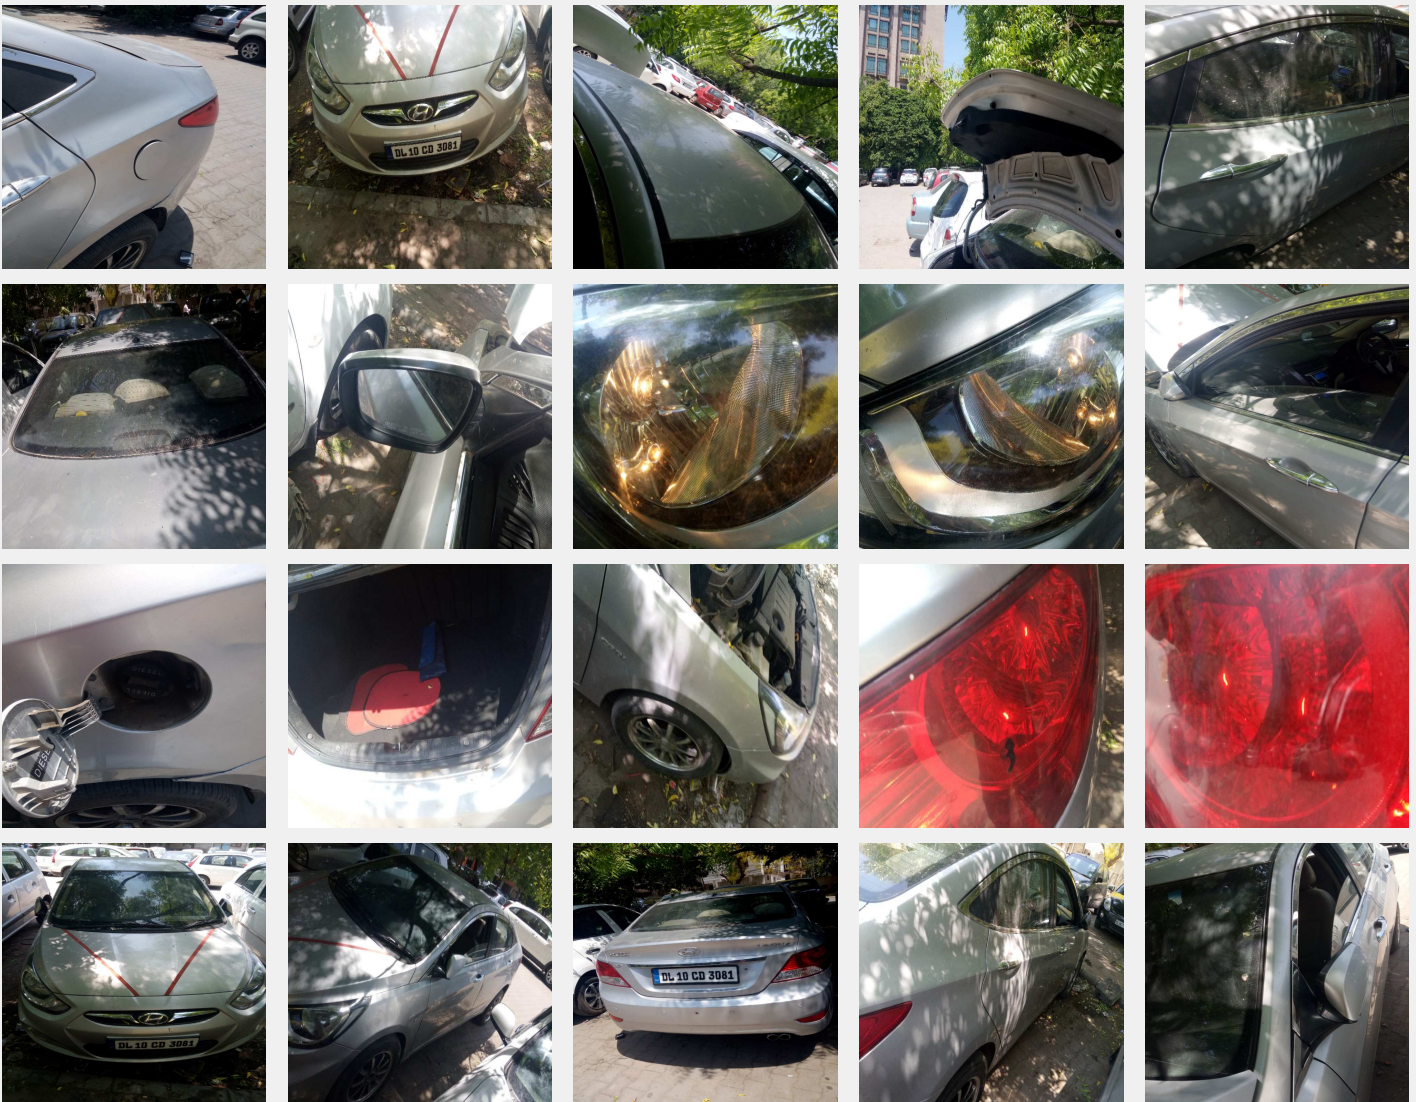
INSPECTION CHECKPOINTS	SCORE(X/10)	REMARKS/COMMENTS	OPTIONAL SPEND EST. (RS)
RH FENDER	7	GOOD	0
BODY RUST	7	GOOD	0
ROOF (REGULAR)	7	GOOD	0
PAINT CONDITION	7	GOOD	0
FOG LAMPS	5	L.S NOT WORKING NEED TO CHANGE FOGLAMB	600

**NEED ATTENTION**

L. S foglamb not working need to change
