ECO INSPECTION CERTIFICATE

Order ID : 49436

121 Points Vehicle Inspection Certificate

Fiat Linea ACTIVE 1.3, 2010

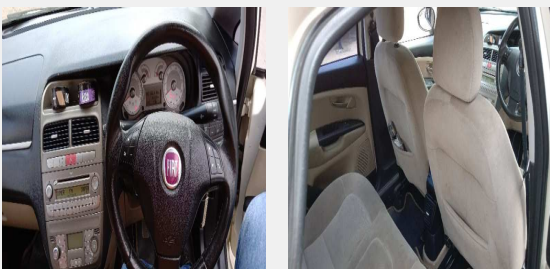
IMAGES

INSPECTION CHECKPOINTS	SCORE(X/10)	REMARKS/COMMENTS	OPTIONAL SPEND EST. (RS)
DOOR PANEL	6		0
DOOR HINGES	7		0
CARPET & FLOOR MAT	6		0
SEAT & SEAT BELT	7		0
DASHBOARD & INSTRUMENT PANEL	7		0
HORN	6		0
SPEAKERS & MUSIC SYSTEM	6		0
HANDBRAKE	7		0
STEERING-MOUNTED CONTROLS	7		0
PEDALS	7		0
CENTRAL LOCK	6		0
A/C VENTS & HEATER	7		0
CUP HOLDERS	6		0
NAVIGATION (NO)	10		0
ODOMETER	6		0
POWER WINDOWS (YES)	6		0
HAZARD LIGHT	7		0

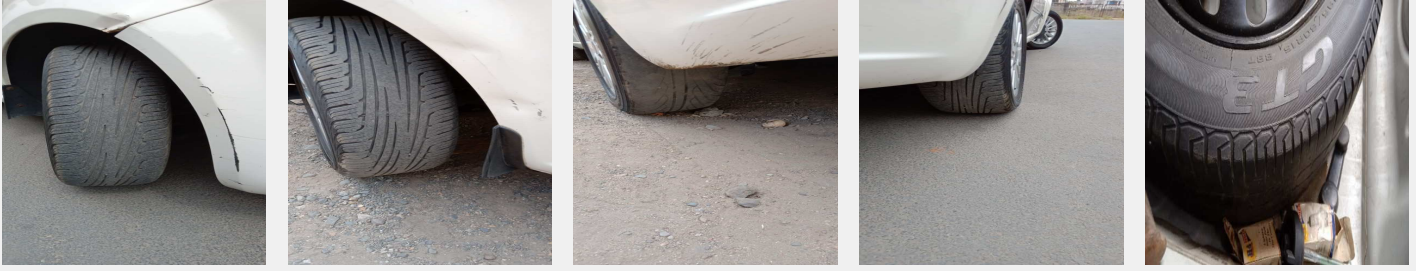
IMAGES

INSPECTION CHECKPOINTS	SCORE(X/10)	REMARKS/COMMENTS	OPTIONAL SPEND EST. (RS)
TYRES	6		0
SPARE TYRE (YES)	7		0
WHEEL ASSEMBLY (ALLOY RIM)	7		0

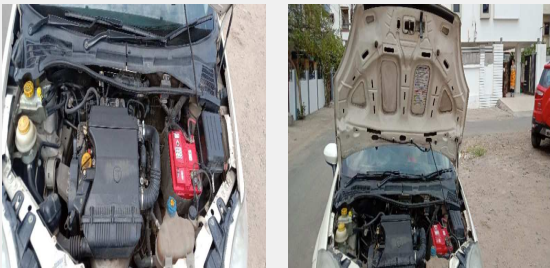
IMAGES

INSPECTION CHECKPOINTS	SCORE(X/10)	REMARKS/COMMENTS	OPTIONAL SPEND EST. (RS)
LH APRON	6		0
RH APRON	6		0
RADIATOR	6		0
WIRING	6		0
BATTERY	7	ON WARRANTY	0
BRAKE FLUID LEVEL	7		0
ENGINE OIL	6		0
COOLANT LEVEL	6		0
BRAKE & COOLANT HOSE PIPES	6		0
UNDERCARRIAGE	7		0
EXHAUST SYSTEM	6		0

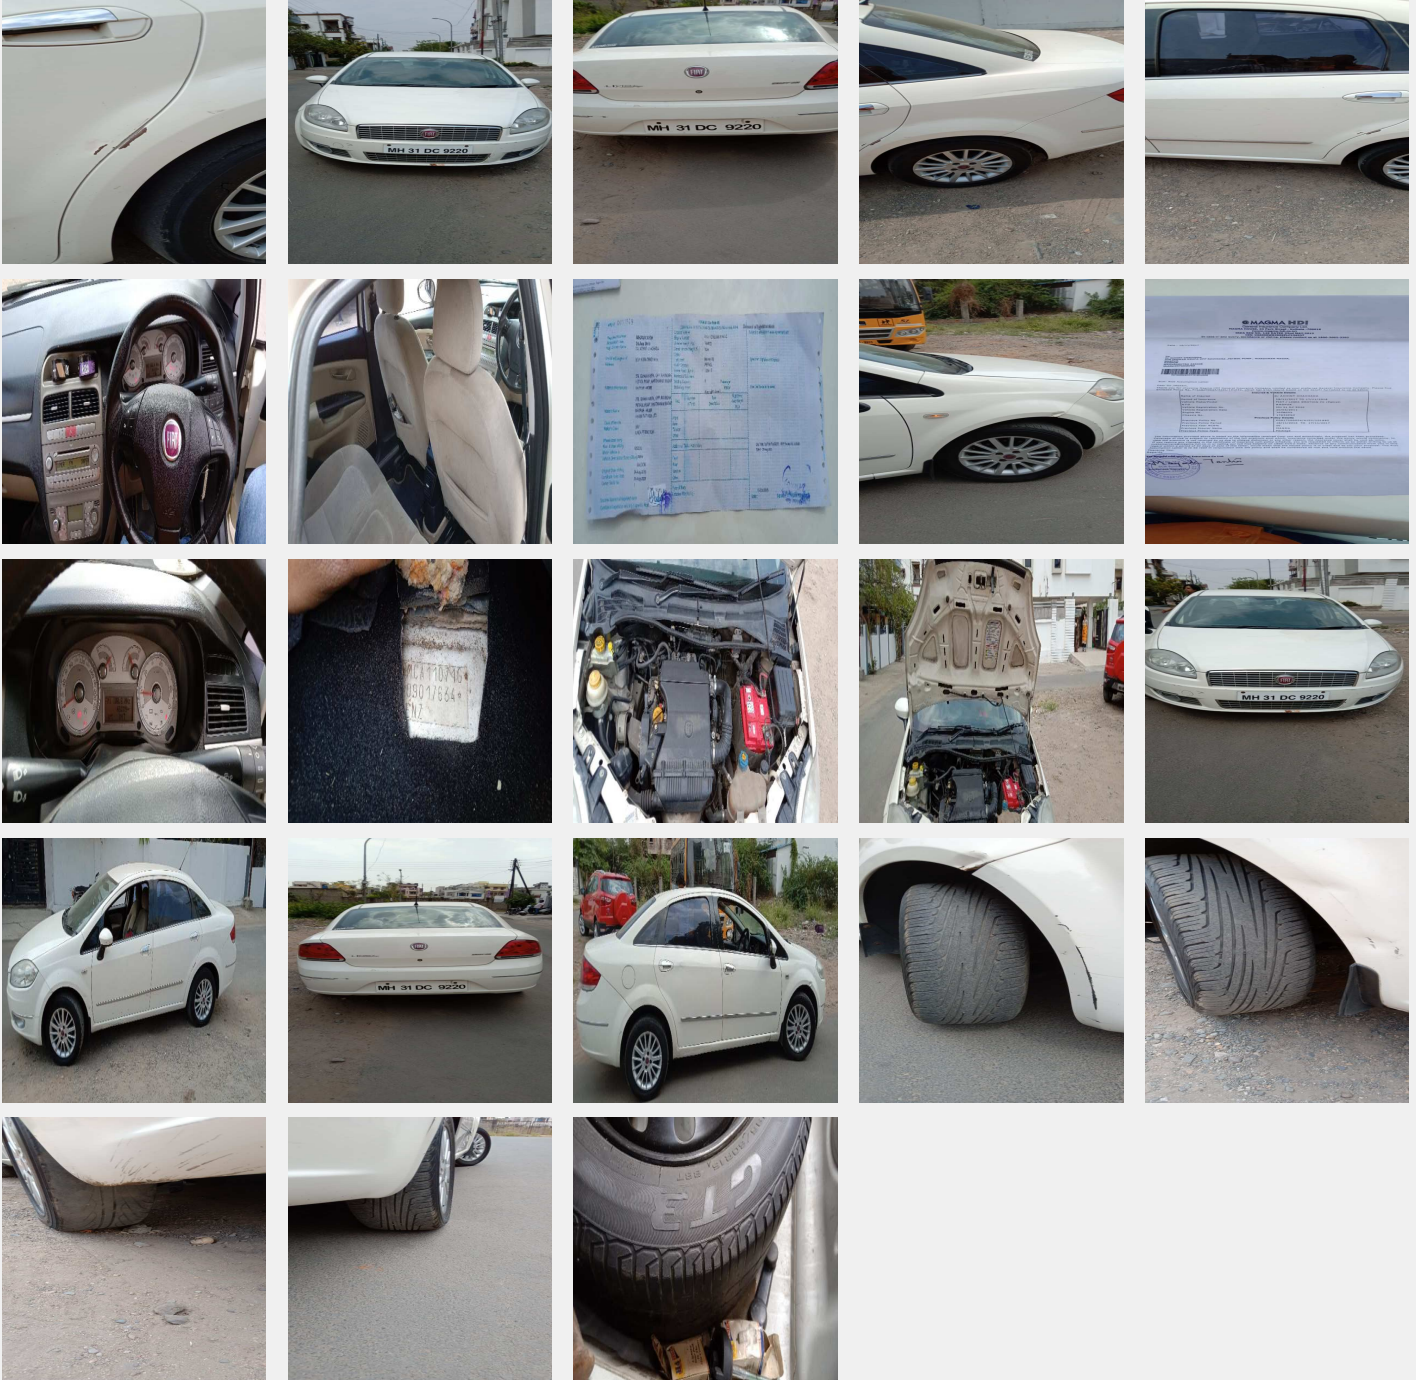
IMAGES

nice condition original paint and minor scratches
