ECO INSPECTION CERTIFICATE

Order ID : 46538

121 Points Vehicle Inspection Certificate

Tata Safari 4X4 VX DICOR BS IV, 2011

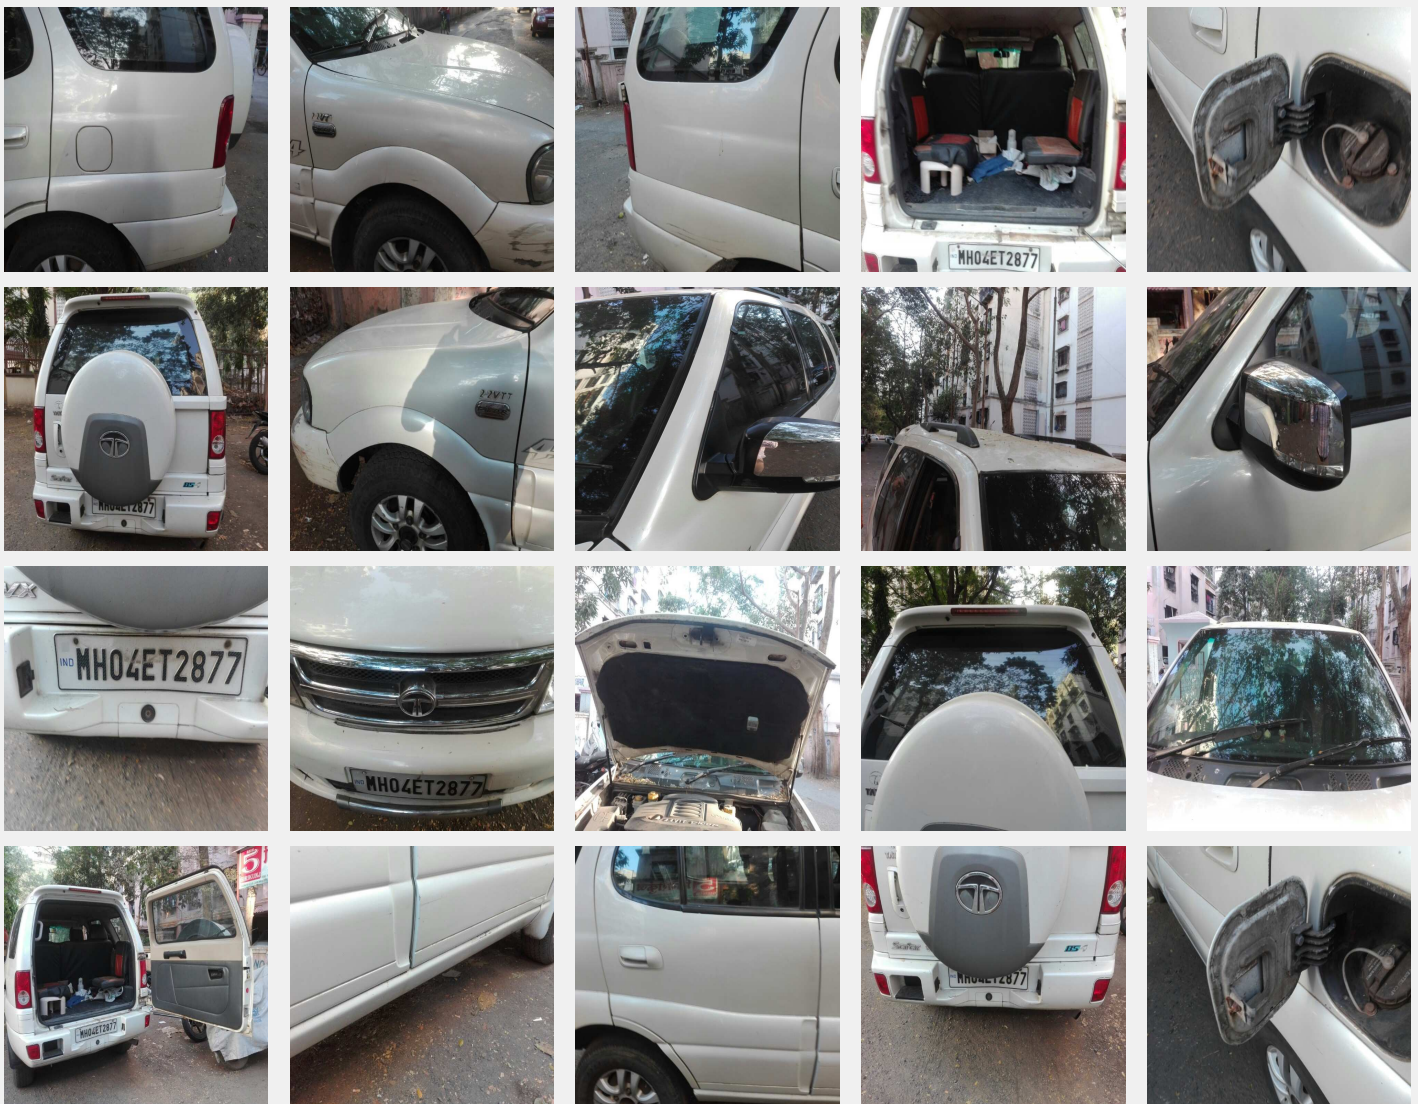
INSPECTION CHECKPOINTS	SCORE(X/10)	REMARKS/COMMENTS	OPTIONAL SPEND EST. (RS)
HEAD LIGHTS	5	RHS H/L RPL	2800
FOG LAMPS	4	NOT WORK NEED RPL	1000
LH FRONT DOOR	4	DAMAGE	1500
LH REAR DOOR	4	DAMAGE	1500
RH FRONT DOOR	5	MINOR SCRATCH	300

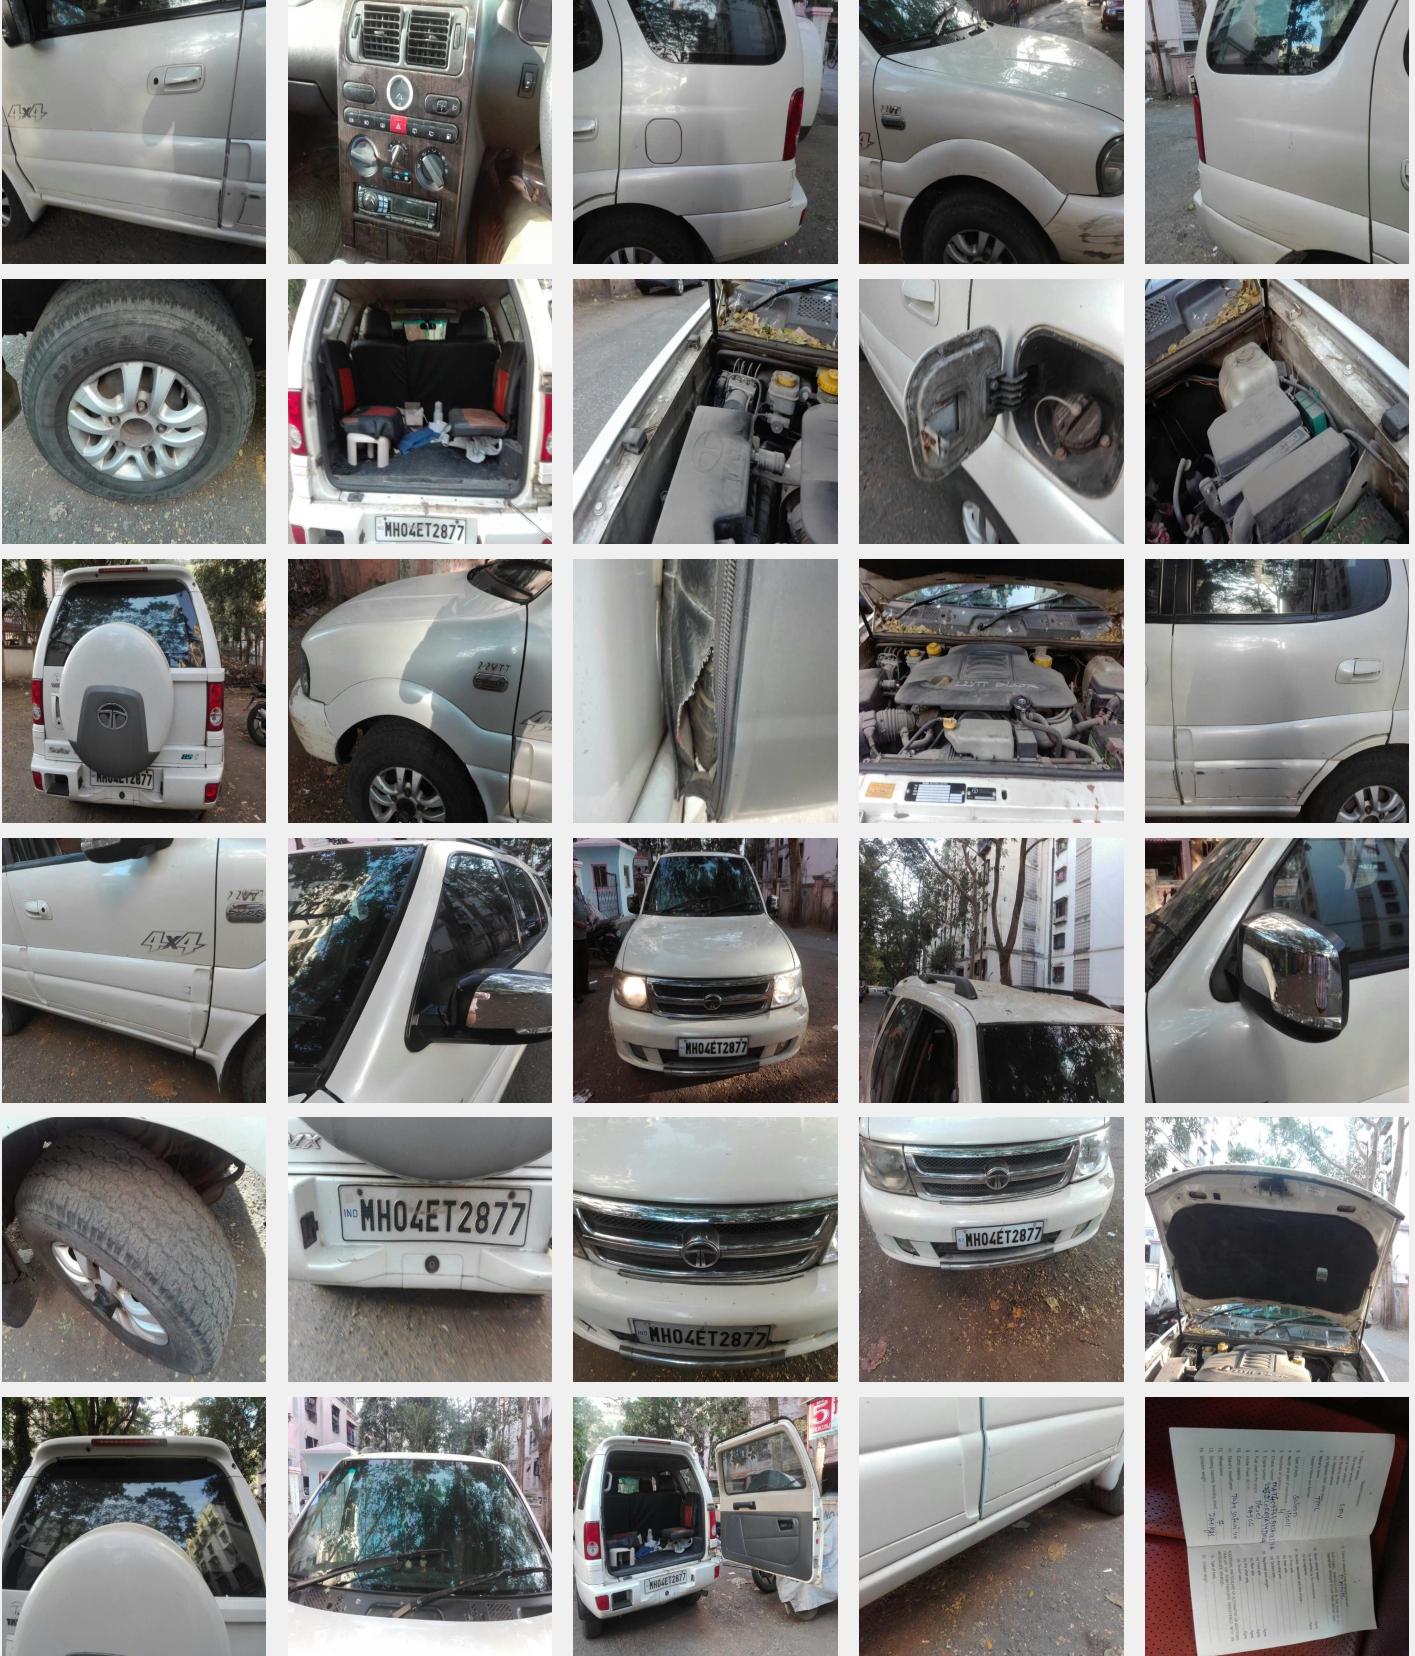
body dent& paint work required ,rhs head light rpl,all 5 tires rpl.engine balt noise. no insurance .
