# ECO INSPECTION CERTIFICATE

Order ID : 82604

121 Points Vehicle Inspection Certificate

## Maruti Suzuki Swift Dzire VDI, 2013

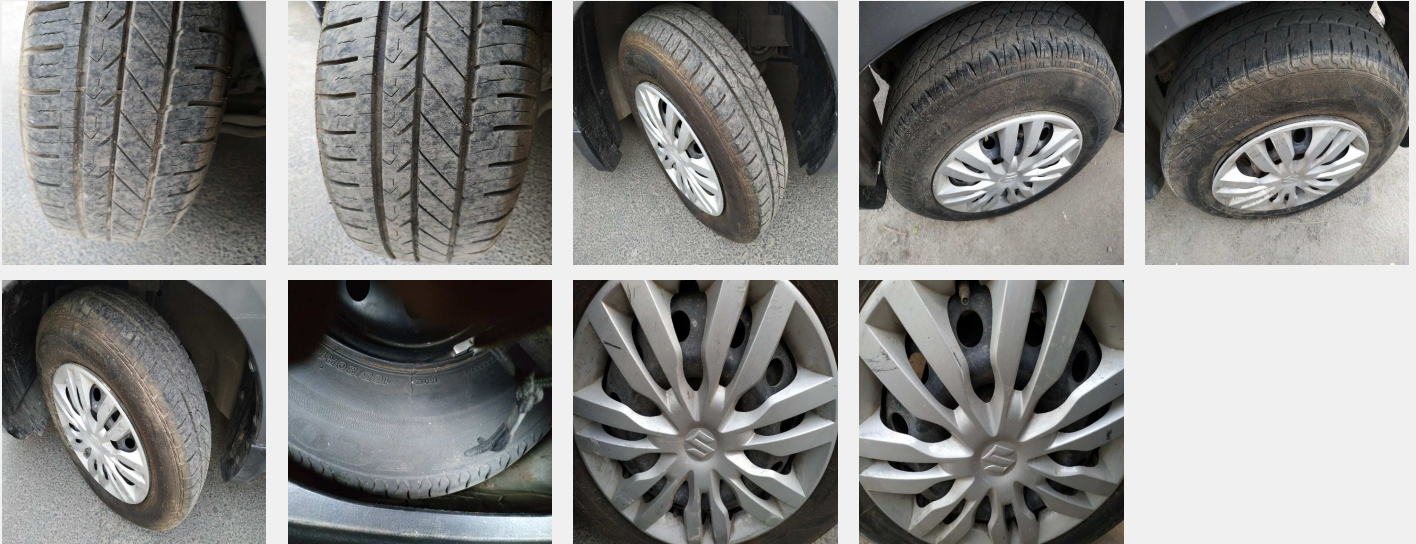
IMAGES

INSPECTION CHECKPOINTS	SCORE(X/10)	REMARKS/COMMENTS	OPTIONAL SPEND EST. (RS)
TYRES	7		0
SPARE TYRE (YES)	7		0
WHEEL ASSEMBLY (STEEL RIM)	7		0

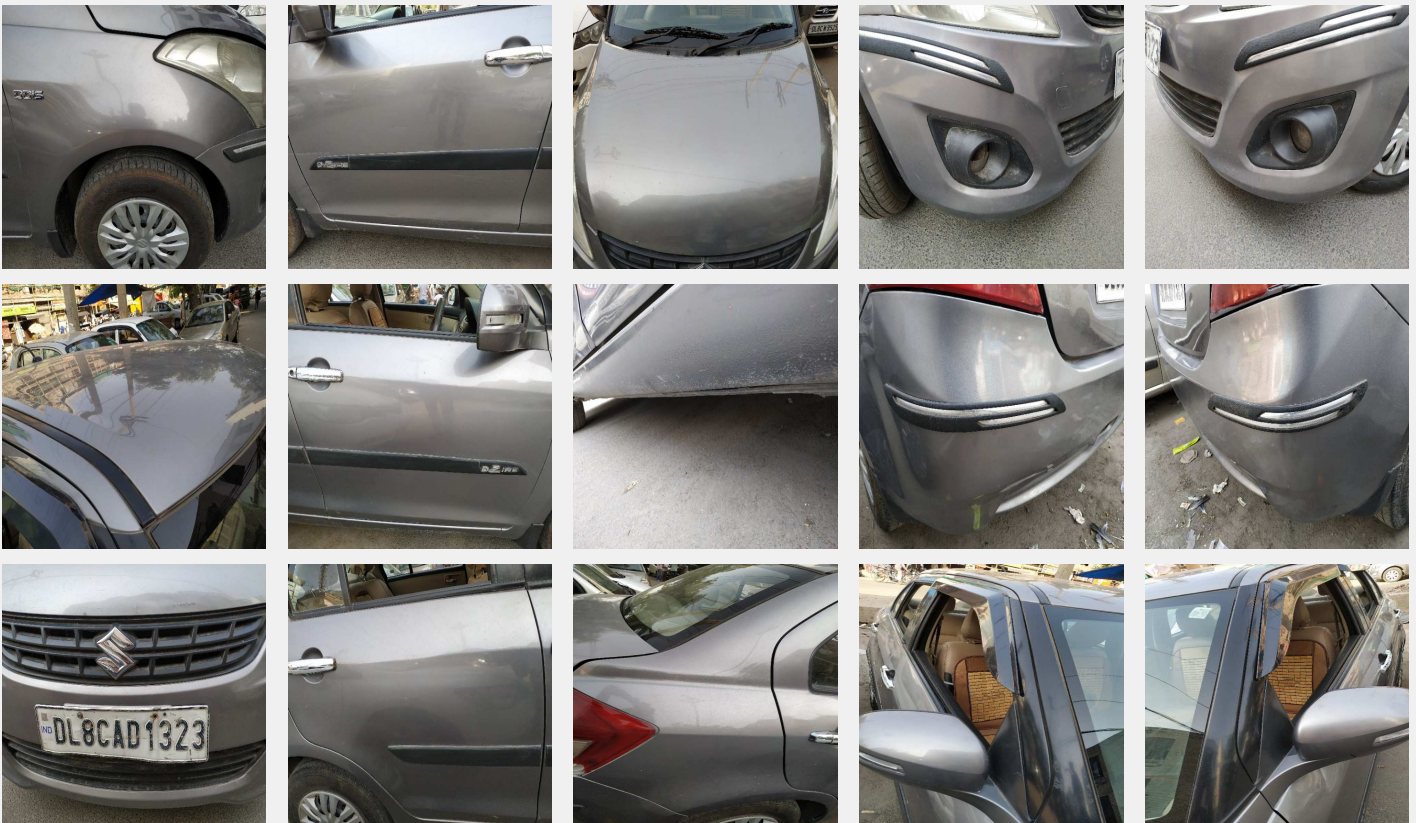
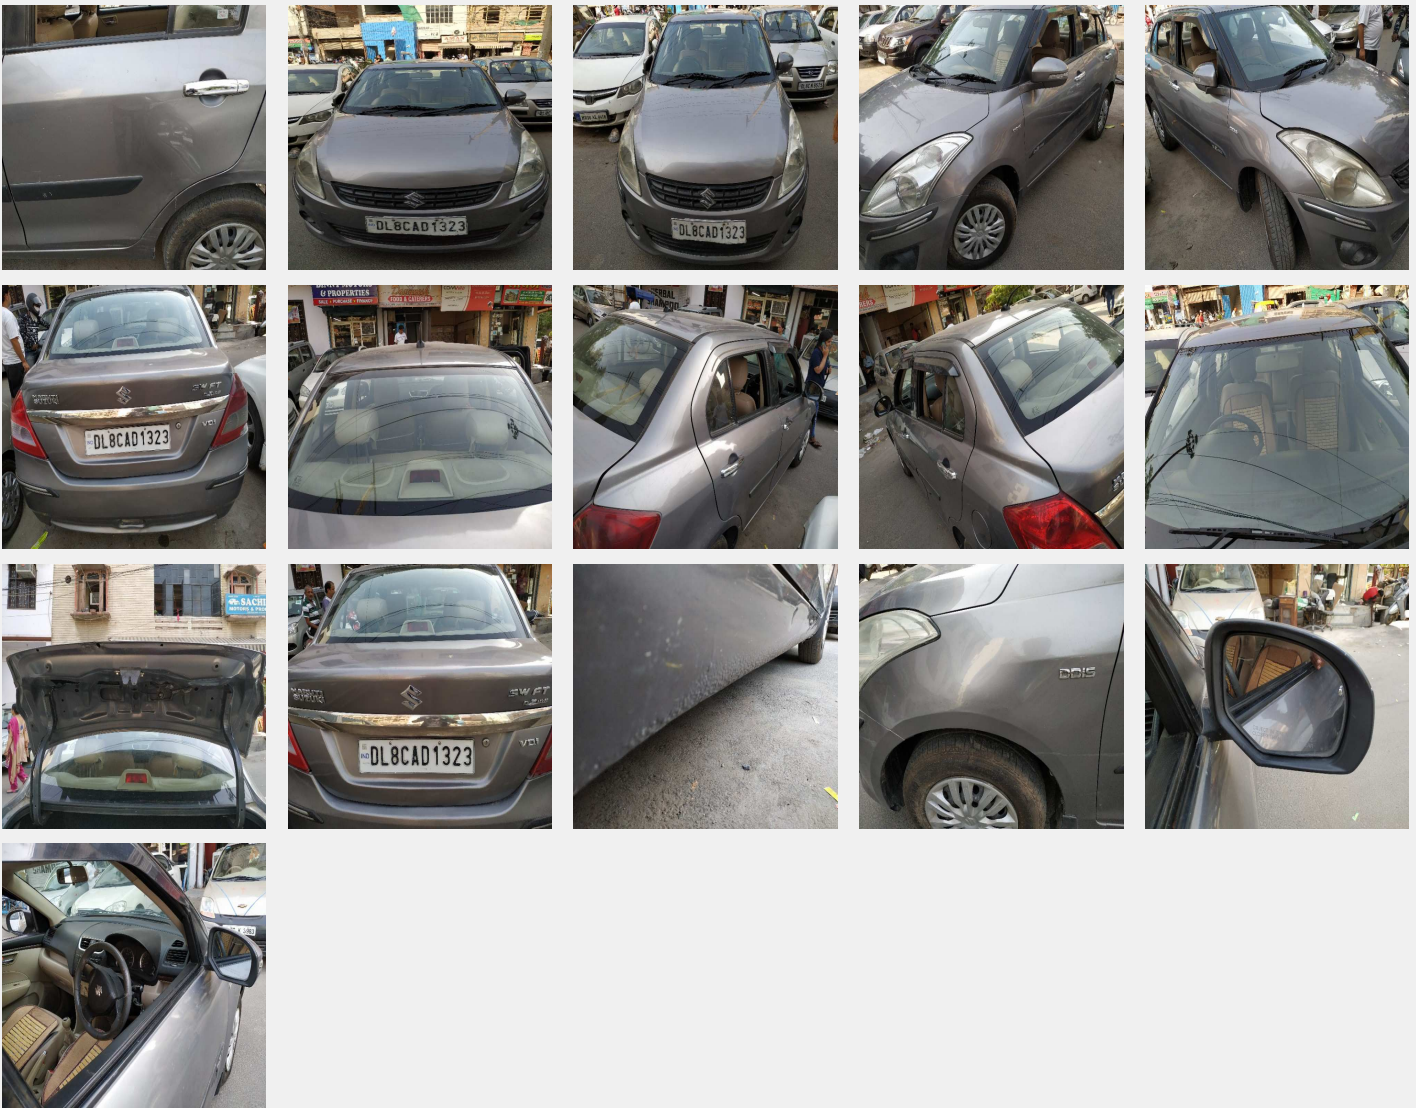
## IMAGES

INSPECTION CHECKPOINTS	SCORE(X/10)	REMARKS/COMMENTS	OPTIONAL SPEND EST. (RS)
FRONT BUMPER	7		0
GRILLE	7		0
HOOD	6	MINOR DENT	1000
PILLAR	7		0
FRONT WINDSHIELD	7		0
SIDE VIEW MIRRORS	7		0
LH FENDER	6	MINOR SCRATCHES	1000
LH FRONT DOOR	6	MINOR SCRATCHES	1000
LH REAR DOOR	6	MINOR SCRATCHES	1000
LH RUNNING BOARD	7		0
FUEL LID	7		0
REAR WINDSHIELD	7		0
REAR BUMPER	7		0
TRUNK LID/TAIL GATE	7		0
RH QUARTER PANEL	7		0
RH RUNNING BOARD	6	MINOR DENT AND SCRATCHES	1000
RH REAR DOOR	7		0
RH FRONT DOOR	7		0
RH FENDER	7		0
ROOF (REGULAR)	7		0
PAINT CONDITION	7		0
LICENSE PLATE	4	FRONT NEED REPLACE	300
HEAD LIGHTS	4	RHS NOT WORKING NEED REPAIR WIRING CONNECTION	500
TURN SIGNAL	2	RHS DAMAGE NEED REPLACE	300

INSPECTION CHECKPOINTS	SCORE(X/10)	REMARKS/COMMENTS	OPTIONAL SPEND EST. (RS)
FOG LAMPS	2	BOTH SIDE NOT WORKING AND DAMAGE NEED REPLACE	1500
LH QUARTER PANEL	4	NEED REPAIR DENT AND SCRATCHES	2500
TAIL LIGHT	4	RHS DAMAGE NEED REPLACE	700
LUGGAGE COMPARTMENT LIGHT	0	NA	0
BODY RUST	0	NA	0
