# ECO INSPECTION CERTIFICATE

Order ID : 83714

121 Points Vehicle Inspection Certificate

## Hyundai I20 ASTA (O) 1.2, 2010

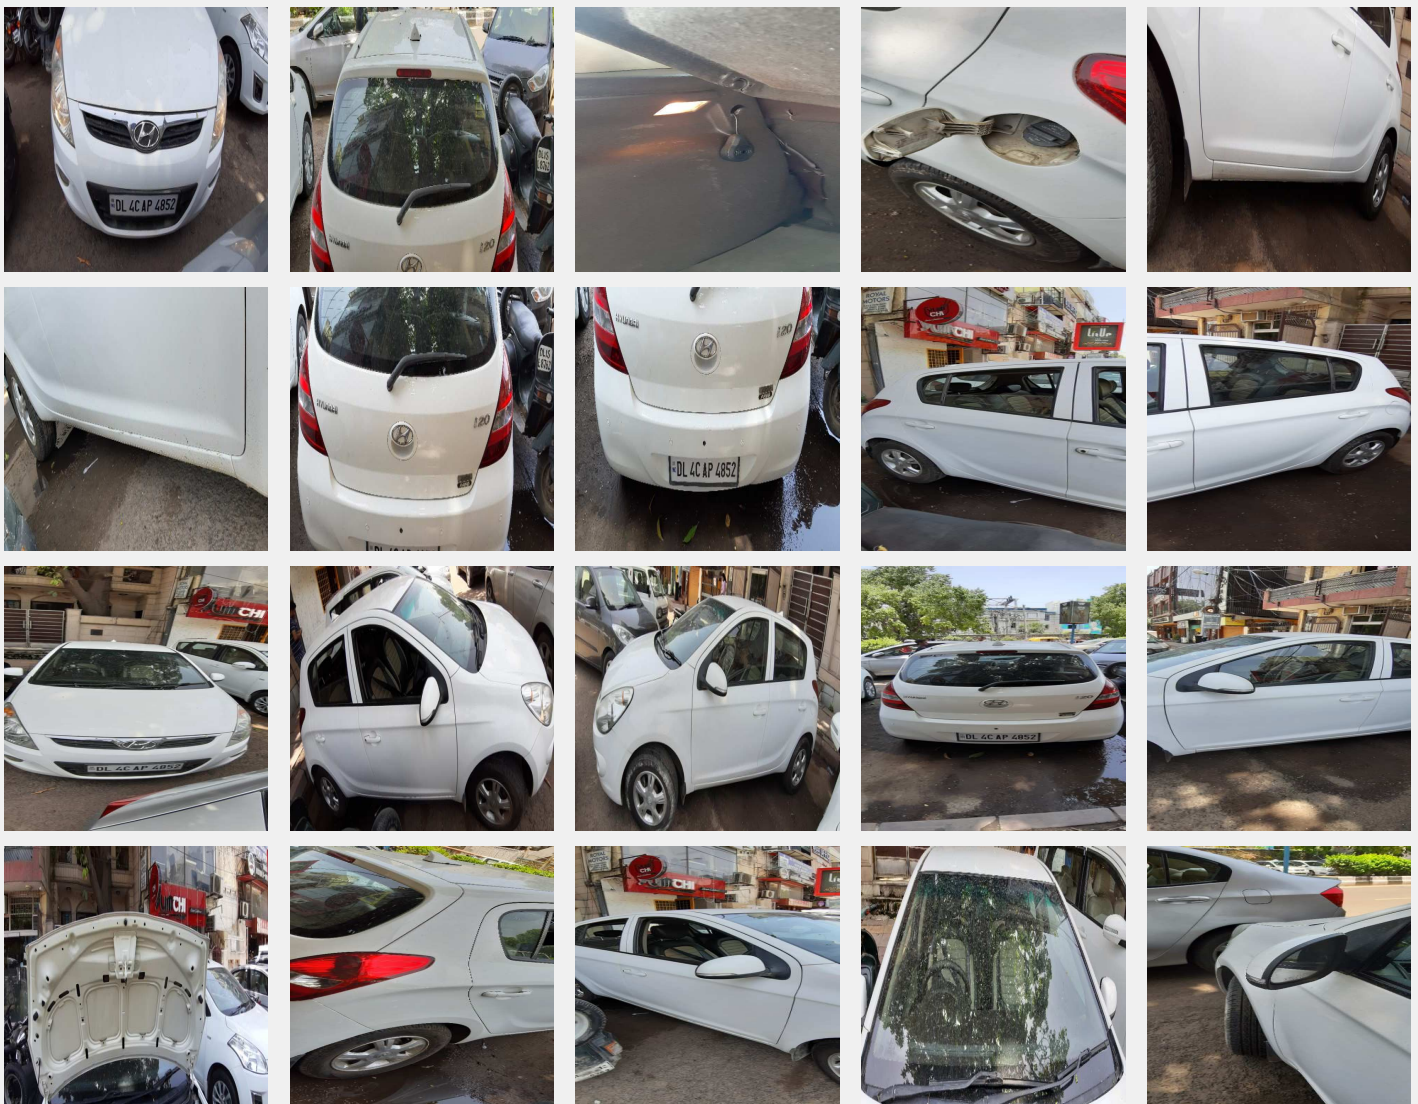
## IMAGES

all body condition is good all lights properly working
