# ECO INSPECTION CERTIFICATE

121 Points Vehicle Inspection Certificate

Inspection Date :  
2019-07-12

## Chevrolet Beat PS DIESEL, 2012

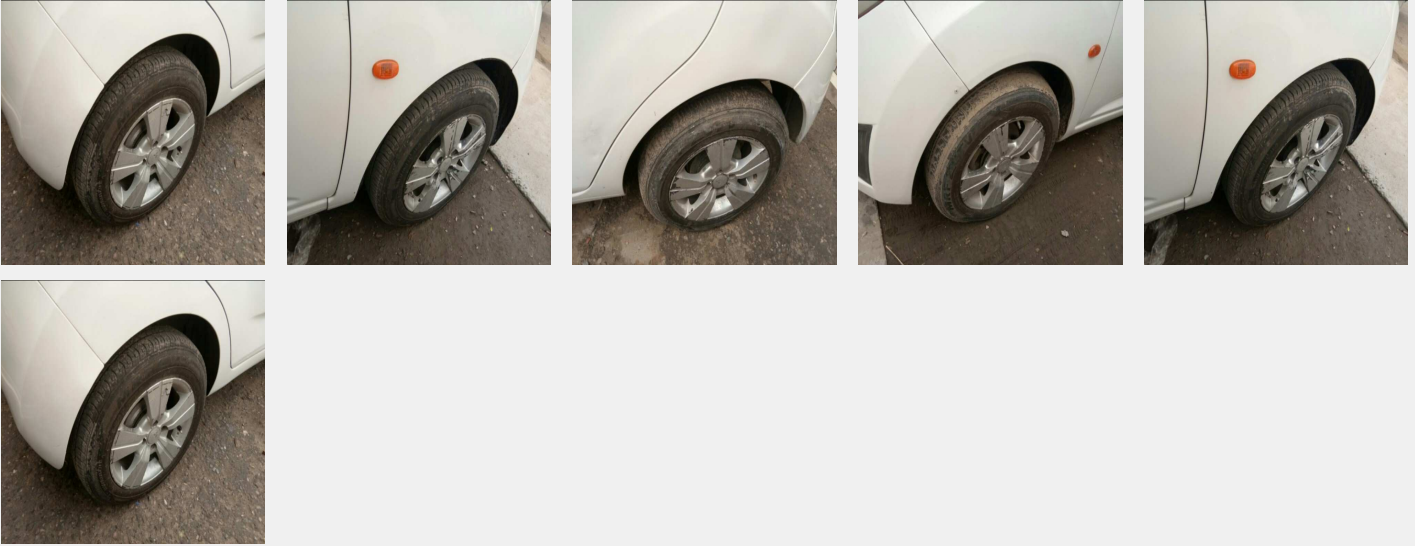
IMAGES

INSPECTION CHECKPOINTS	SCORE(X/10)	REMARKS/COMMENTS	OPTIONAL SPEND EST. (RS)
TYRES	6		0
SPARE TYRE (NO)	10		0
WHEEL ASSEMBLY (ALLOY RIM)	6		0

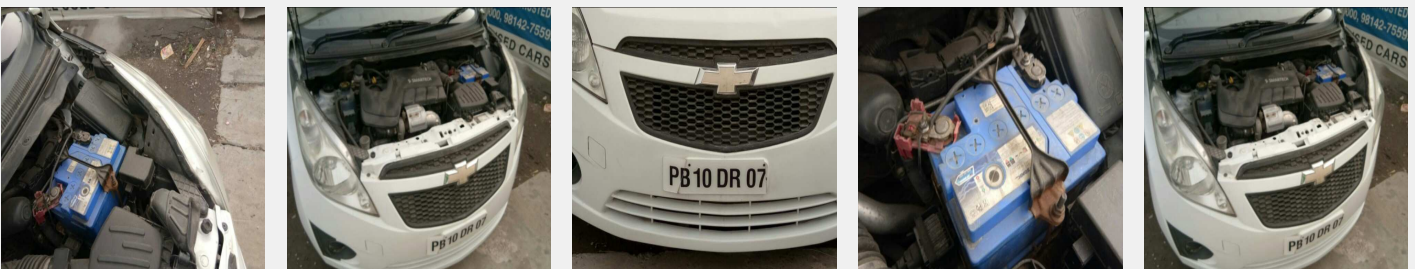
IMAGES

INSPECTION CHECKPOINTS	SCORE(X/10)	REMARKS/COMMENTS	OPTIONAL SPEND EST. (RS)
LH APRON	6		0
RH APRON	6		0
RADIATOR	6		0
WIRING	6		0
BATTERY	6		0
BRAKE FLUID LEVEL	6		0
ENGINE OIL	6		0
COOLANT LEVEL	6		0
BRAKE & COOLANT HOSE PIPES	6		0
UNDERCARRIAGE	6		0
EXHAUST SYSTEM	6		0

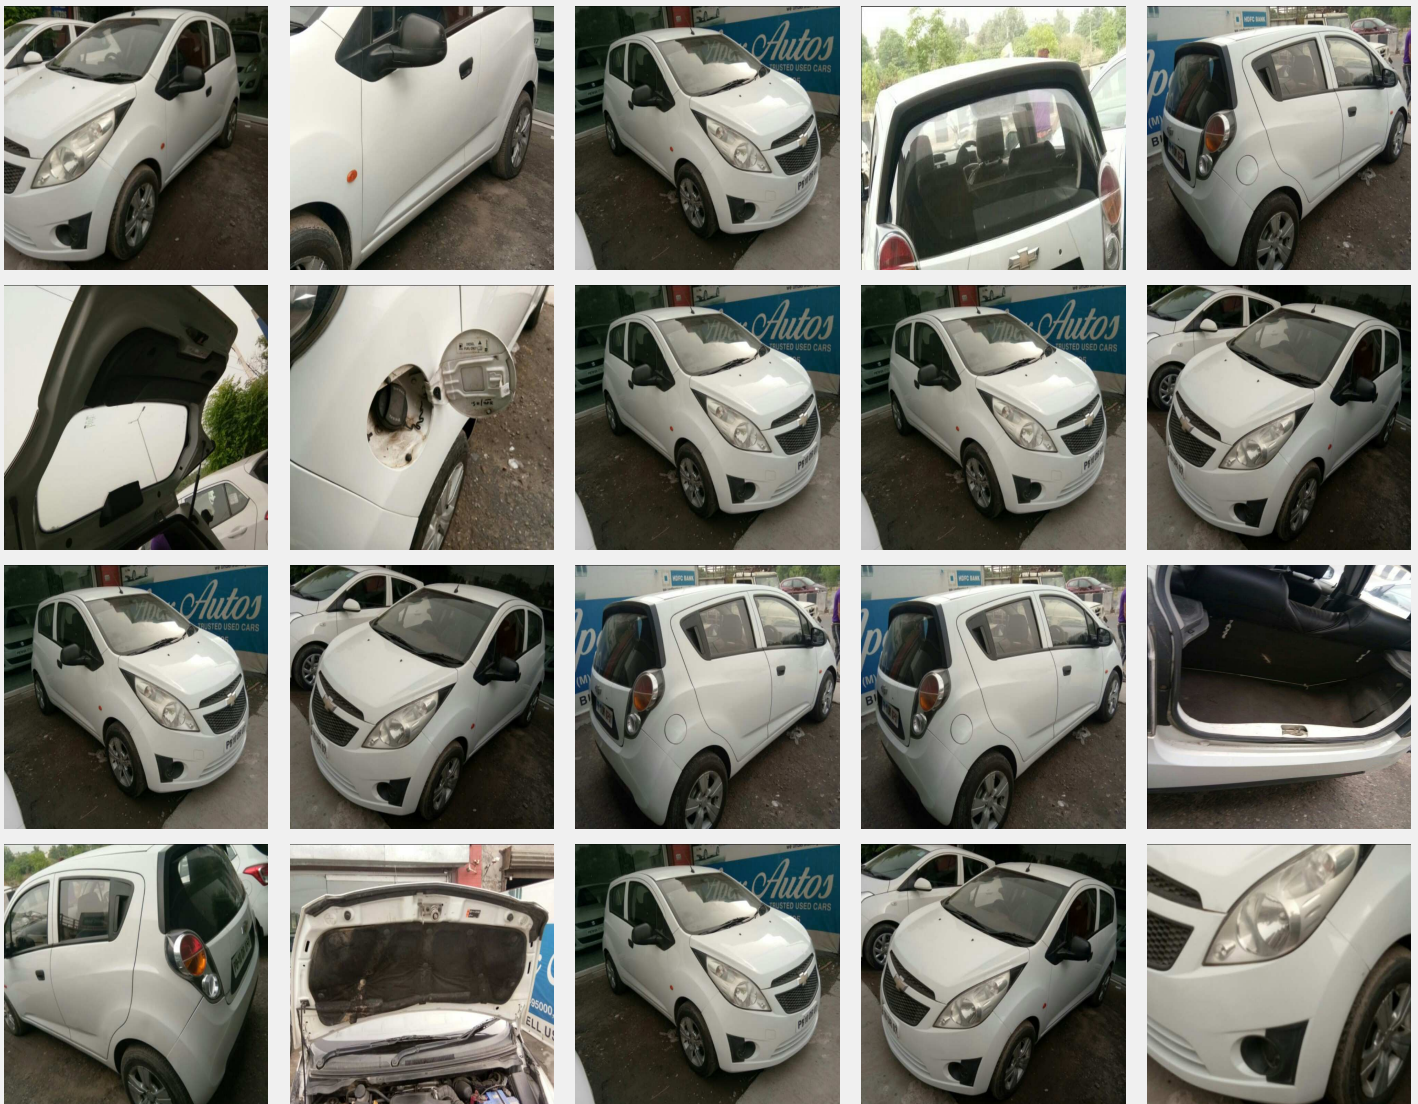
## IMAGES

INSPECTION CHECKPOINTS	SCORE(X/10)	REMARKS/COMMENTS	OPTIONAL SPEND EST. (RS)
ROOF (REGULAR)	7		0
PAINT CONDITION	7		0
LICENSE PLATE	5	BROKEN	500
LH QUARTER PANEL	5	PRESSED	5000
BODY RUST	0	NO	0
