ECO INSPECTION CERTIFICATE

Order ID : 83055

121 Points Vehicle Inspection Certificate

Maruti Suzuki Swift Dzire ZDI, 2013

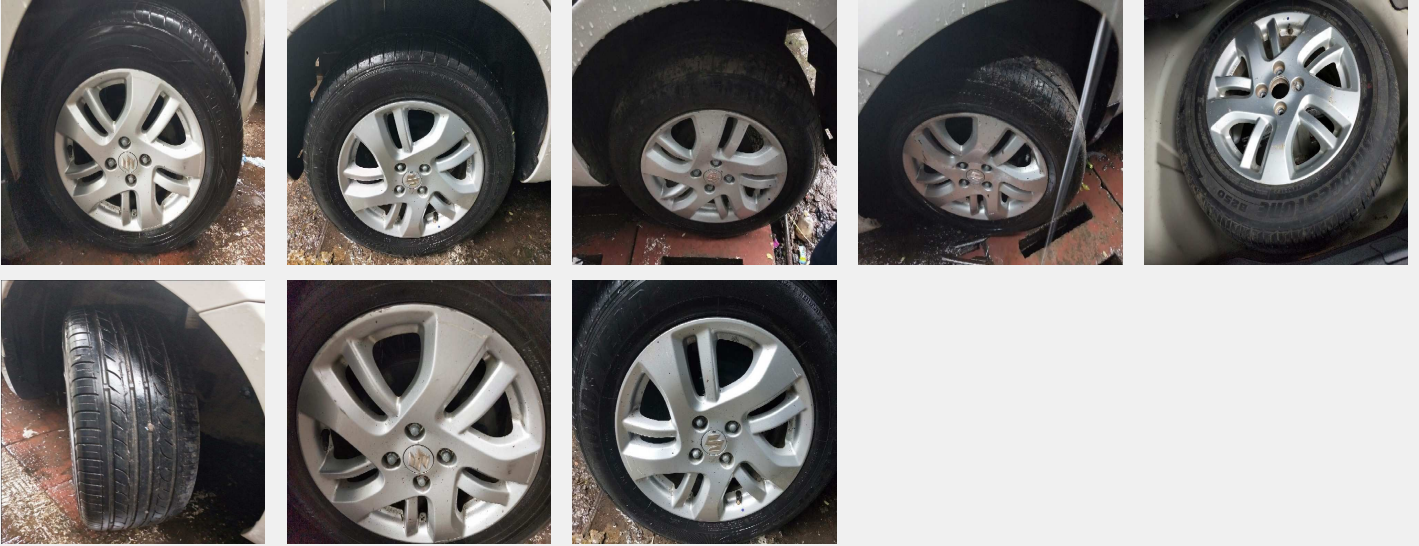
IMAGES

INSPECTION CHECKPOINTS	SCORE(X/10)	REMARKS/COMMENTS	OPTIONAL SPEND EST. (RS)
TYRES	6	NORMAL WEAR AND TEAR	0
SPARE TYRE (YES)	6	GOOD CONDITION	0

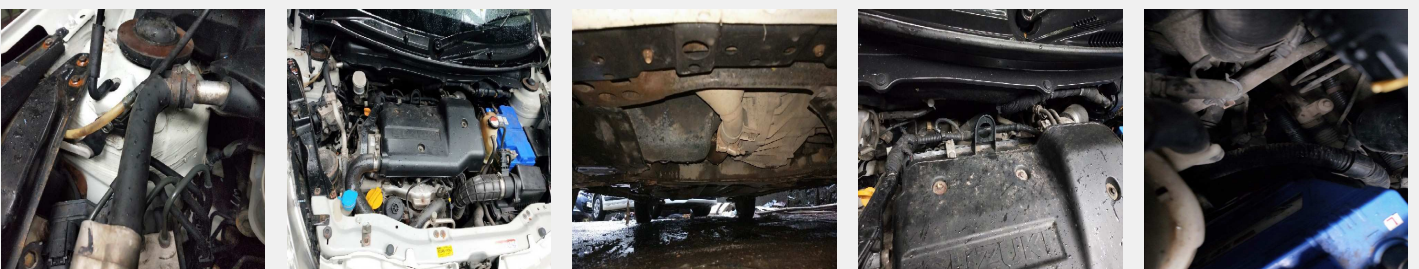
IMAGES

INSPECTION CHECKPOINTS	SCORE(X/10)	REMARKS/COMMENTS	OPTIONAL SPEND EST. (RS)
LH APRON	6	ACCEPTABLE CONDITION	0
RH APRON	6	ACCEPTABLE CONDITION	0
RADIATOR	6	GOOD WORKING	0
WIRING	6	ACCEPTABLE CONDITION	0
BATTERY	6	GOOD CONDITION	0
BRAKE FLUID LEVEL	6	MAXIMUM LEVEL	0
ENGINE OIL	6	GOOD VISCOSITY	0
COOLANT LEVEL	6	MAXIMUM LEVEL	0
BRAKE & COOLANT HOSE PIPES	6	ACCEPTABLE CONDITION	0
UNDERCARRIAGE	6	NO DAMAGE	0
EXHAUST SYSTEM	6	GOOD WORKING	0

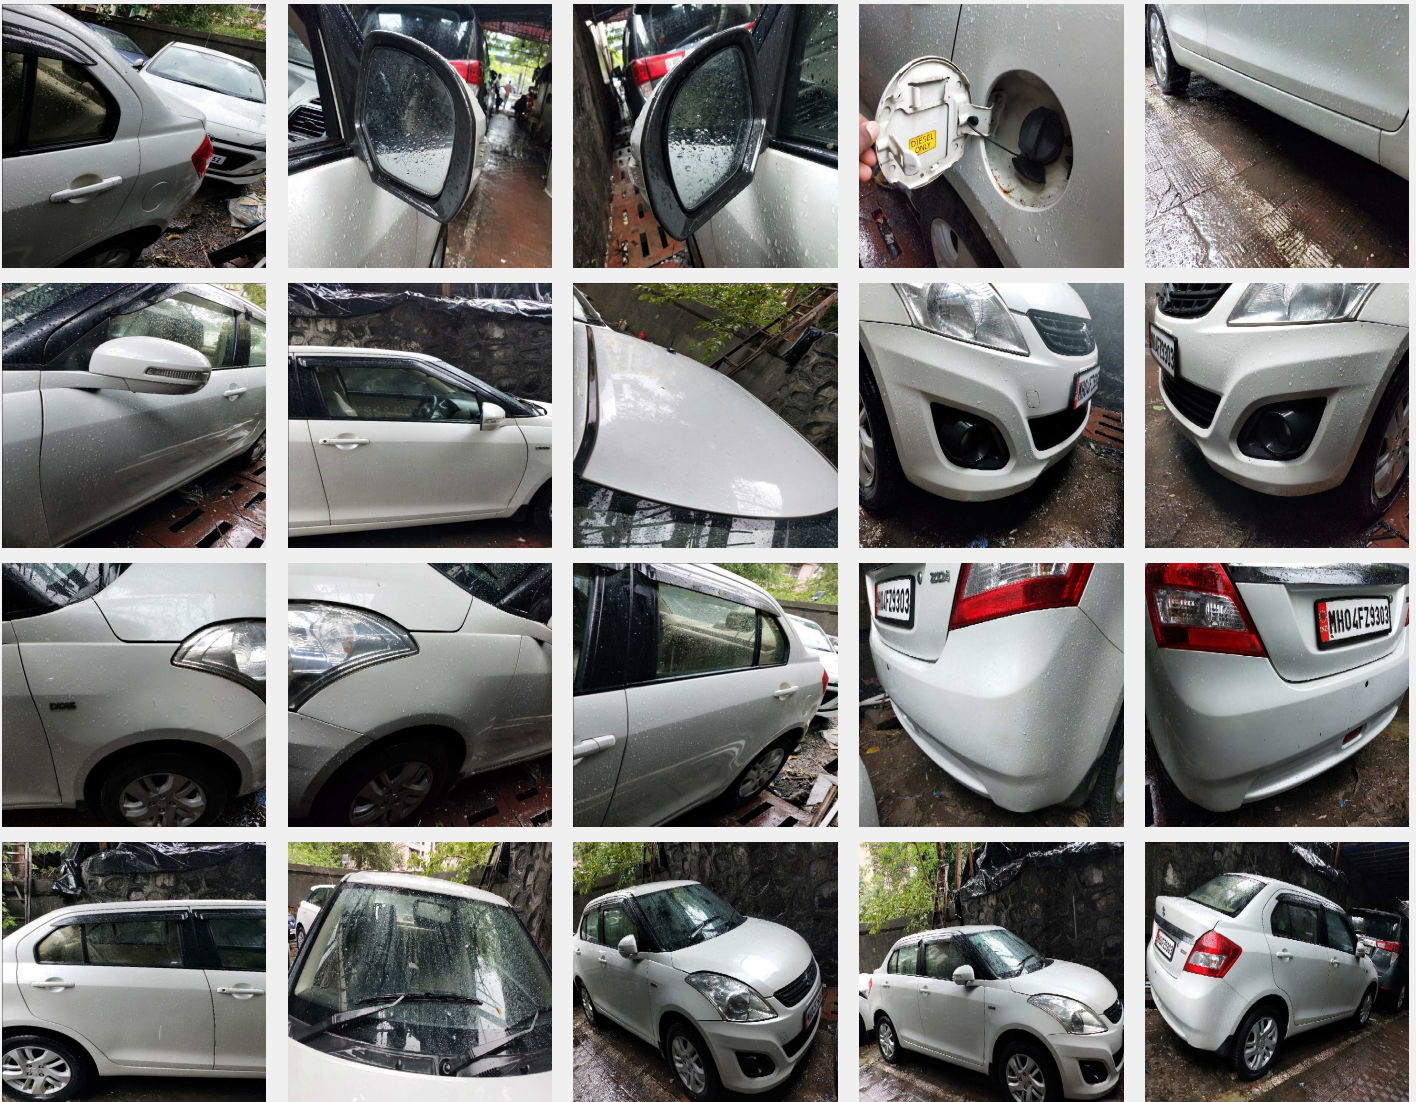
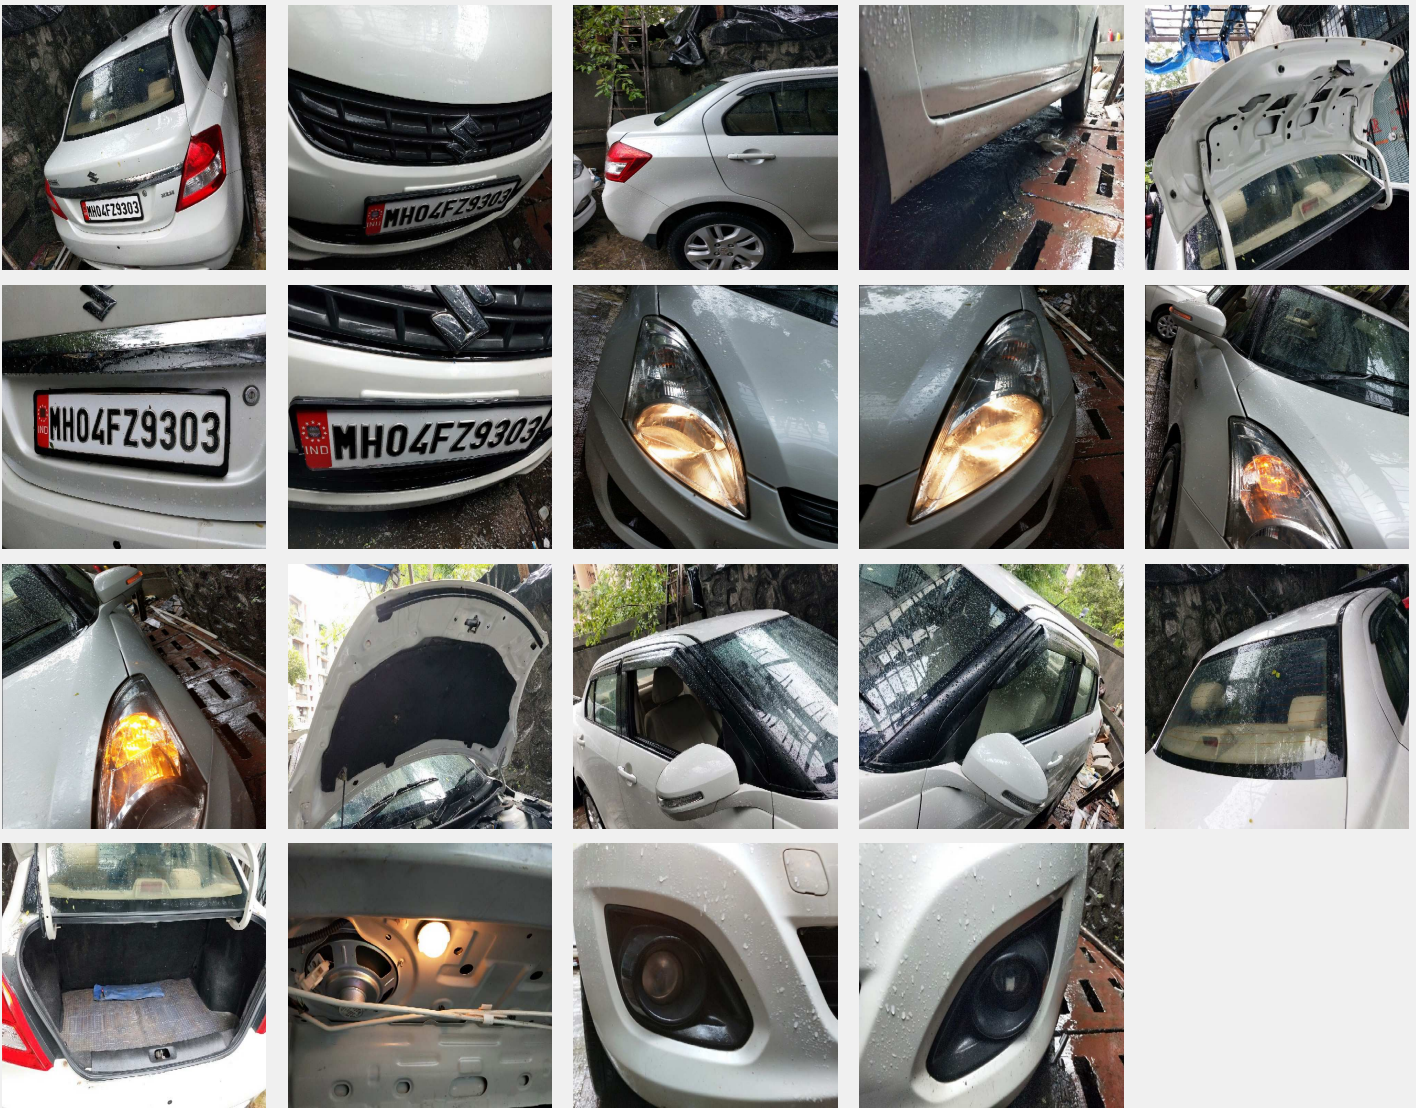
IMAGES

INSPECTION CHECKPOINTS	SCORE(X/10)	REMARKS/COMMENTS	OPTIONAL SPEND EST. (RS)
RH FENDER	6	GOOD CONDITION	0
BODY RUST	6	NO RUST FOUND	0
ROOF (REGULAR)	6	GOOD CONDITION	0
PAINT CONDITION	6	GOOD CONDITION	0
TAIL LIGHT	5	NEED TO CHECK WIRING	300
