ECO INSPECTION CERTIFICATE

121 Points Vehicle Inspection Certificate

Inspection Date :
2019-07-27

Volkswagen Cross Polo 1.2 MPI, 2015

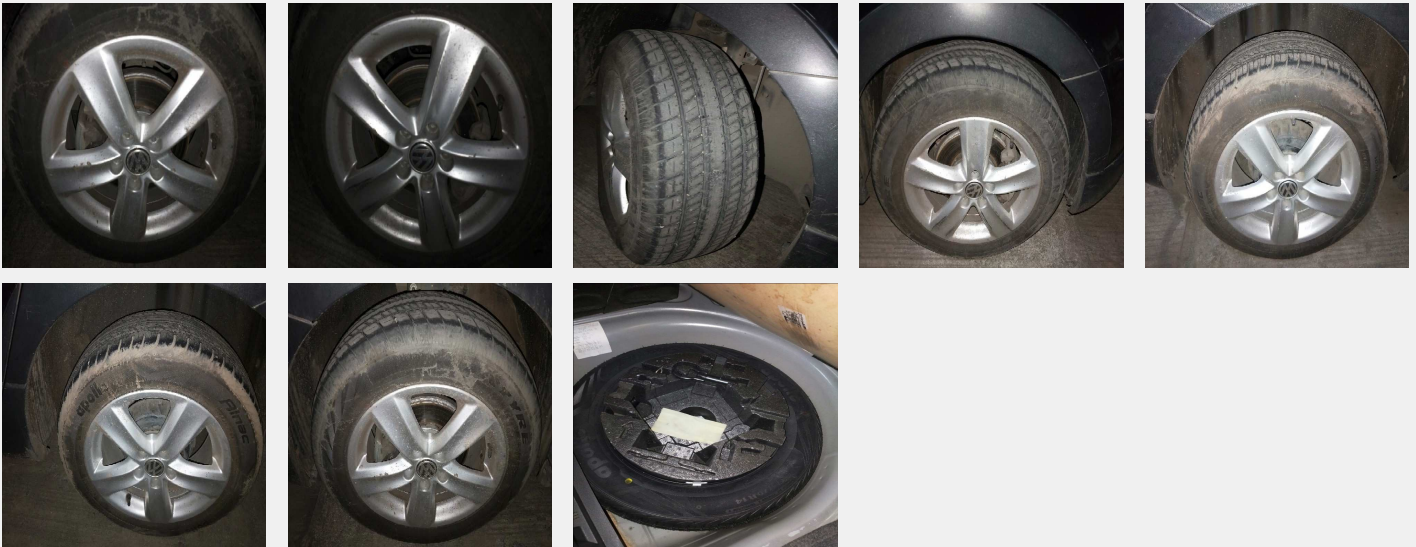
IMAGES

INSPECTION CHECKPOINTS	SCORE(X/10)	REMARKS/COMMENTS	OPTIONAL SPEND EST. (RS)
TYRES	6	NORMAL WEAR AND TEAR	0
SPARE TYRE (YES)	6	GOOD CONDITION	0

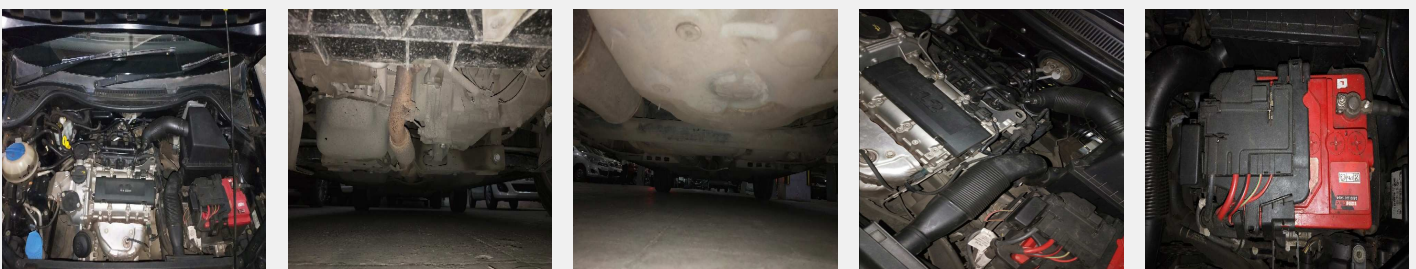
IMAGES

INSPECTION CHECKPOINTS	SCORE(X/10)	REMARKS/COMMENTS	OPTIONAL SPEND EST. (RS)
LH APRON	6	ACCEPTABLE CONDITION	0
RH APRON	6	ACCEPTABLE CONDITION	0
RADIATOR	6	GOOD WORKING	0
WIRING	6	ACCEPTABLE CONDITION	0
BATTERY	6	GOOD CONDITION	0
BRAKE FLUID LEVEL	6	MAXIMUM LEVEL	0
ENGINE OIL	6	GOOD VISCOSITY	0
COOLANT LEVEL	6	MAXIMUM LEVEL	0
BRAKE & COOLANT HOSE PIPES	6	ACCEPTABLE CONDITION	0
UNDERCARRIAGE	6	NO DAMAGE	0
EXHAUST SYSTEM	6	GOOD WORKING	0

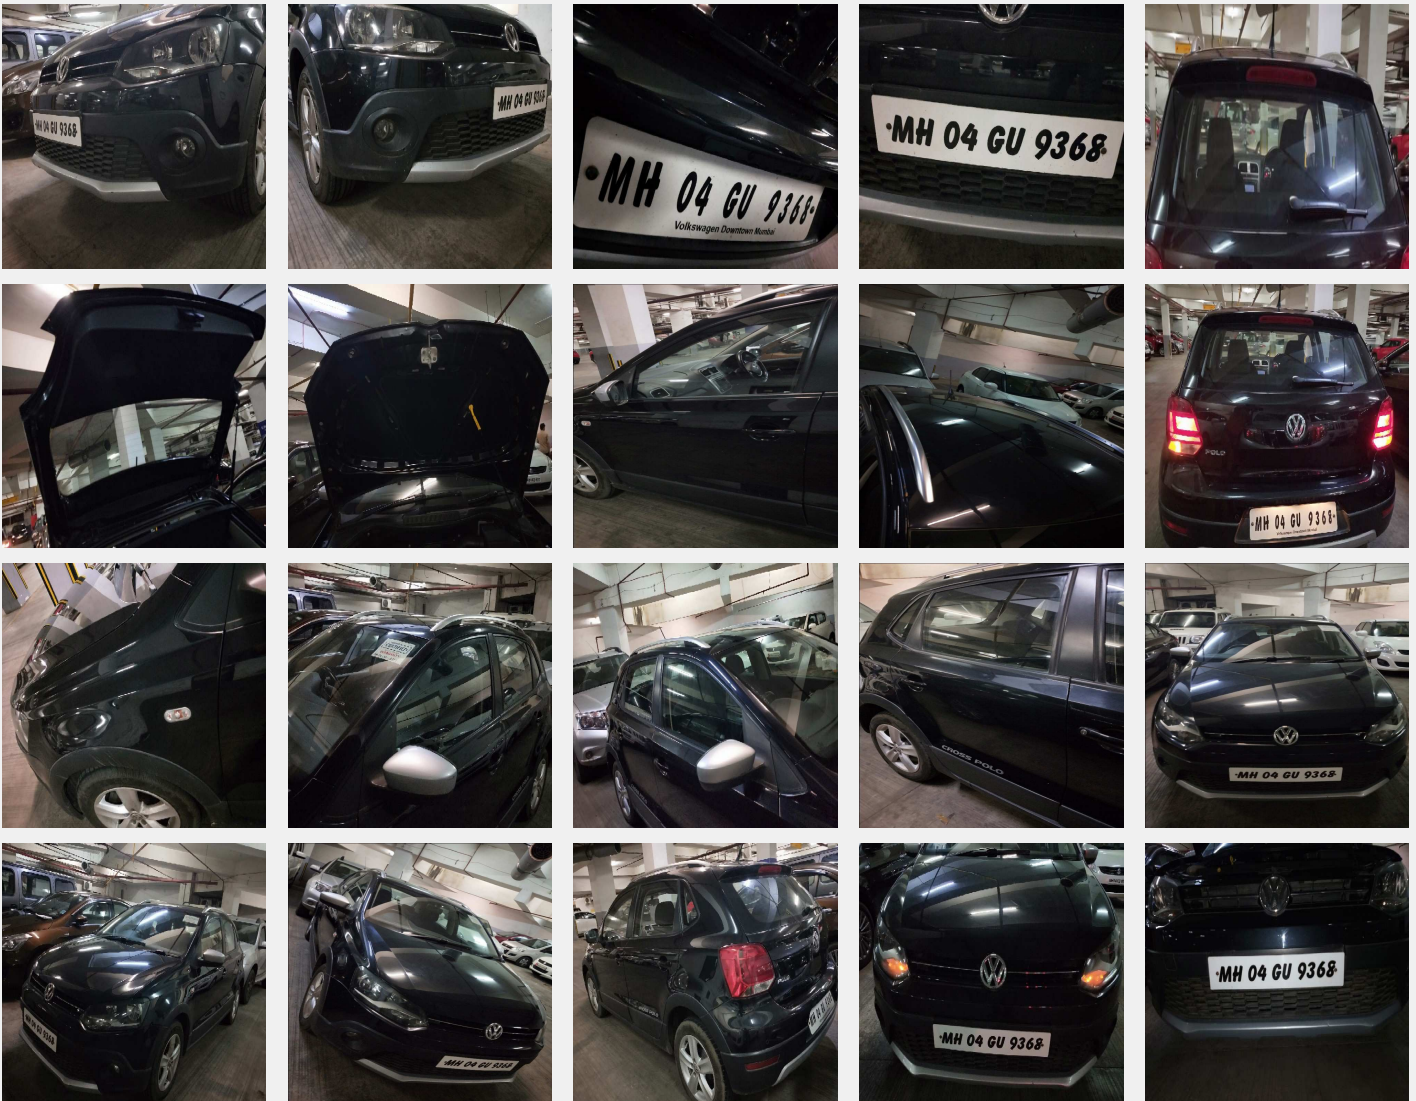
IMAGES

INSPECTION CHECKPOINTS	SCORE(X/10)	REMARKS/COMMENTS	OPTIONAL SPEND EST. (RS)
LICENSE PLATE	6	GOOD CONDITION	0
FRONT BUMPER	6	GOOD CONDITION	0
HEAD LIGHTS	6	GOOD WORKING	0
GRILLE	6	ACCEPTABLE CONDITION	0
TURN SIGNAL	6	GOOD WORKING	0
FOG LAMPS	6	GOOD WORKING	0
HOOD	6	GOOD CONDITION	0
PILLAR	6	GOOD CONDITION	0
FRONT WINDSHIELD	6	CLEAR VISIBILITY	0
SIDE VIEW MIRRORS	6	GOOD CONDITION	0
LH FENDER	6	GOOD CONDITION	0
LH FRONT DOOR	6	GOOD CONDITION	0
LH REAR DOOR	6	GOOD CONDITION	0
LH RUNNING BOARD	6	GOOD CONDITION	0
LH QUARTER PANEL	6	GOOD CONDITION	0
FUEL LID	6	GOOD CONDITION	0
REAR WINDSHIELD	6	CLEAR VISIBILITY	0
REAR BUMPER	6	GOOD CONDITION	0
TAIL LIGHT	6	GOOD WORKING	0
TRUNK LID/TAIL GATE	6	GOOD CONDITION	0
LUGGAGE COMPARTMENT LIGHT	6	GOOD SPACE	0
RH QUARTER PANEL	6	GOOD CONDITION	0
RH RUNNING BOARD	6	GOOD CONDITION	0
RH REAR DOOR	6	GOOD CONDITION	0

INSPECTION CHECKPOINTS	SCORE(X/10)	REMARKS/COMMENTS	OPTIONAL SPEND EST. (RS)
RH FRONT DOOR	6	GOOD CONDITION	0
RH FENDER	6	GOOD CONDITION	0
BODY RUST	6	NO RUST FOUND	0
ROOF (REGULAR)	6	GOOD CONDITION	0
PAINT CONDITION	6	GOOD CONDITION	0
