ECO INSPECTION CERTIFICATE

Order ID : 98896

121 Points Vehicle Inspection Certificate

Maruti Suzuki Ciaz ZXI+ RS, 2018

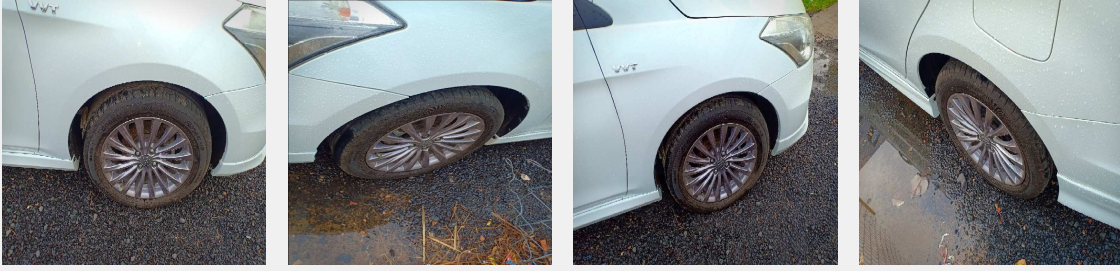
IMAGES

INSPECTION CHECKPOINTS	SCORE(X/10)	REMARKS/COMMENTS	OPTIONAL SPEND EST. (RS)
TYRES	7		0
SPARE TYRE (YES)	8		0
WHEEL ASSEMBLY (ALLOY RIM)	8		0

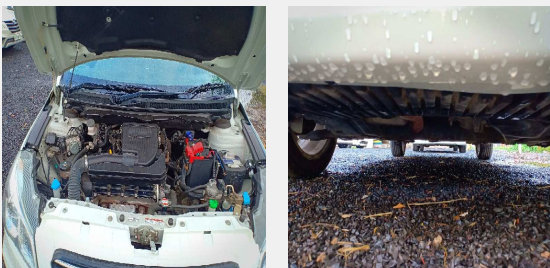
IMAGES

INSPECTION CHECKPOINTS	SCORE(X/10)	REMARKS/COMMENTS	OPTIONAL SPEND EST. (RS)
LH APRON	7		0
RH APRON	7		0
RADIATOR	7		0
WIRING	7		0
BATTERY	8		0
BRAKE FLUID LEVEL	7		0
ENGINE OIL	8		0
COOLANT LEVEL	7		0
BRAKE & COOLANT HOSE PIPES	7		0
UNDERCARRIAGE	7		0
EXHAUST SYSTEM	8		0

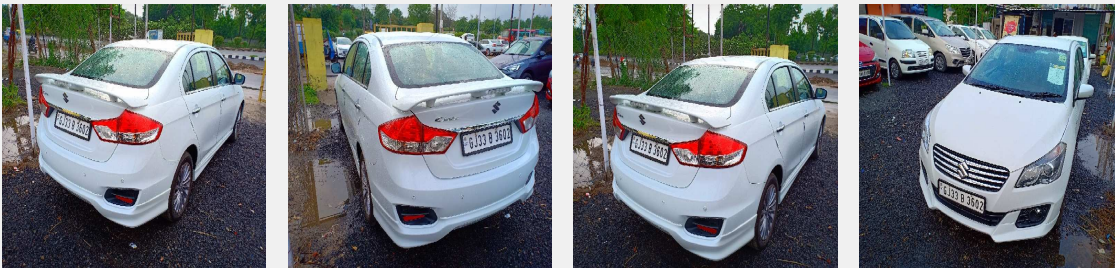
IMAGES

INSPECTION CHECKPOINTS	SCORE(X/10)	REMARKS/COMMENTS	OPTIONAL SPEND EST. (RS)
RH FRONT DOOR	8		0
RH FENDER	8		0
BODY RUST	8		0
ROOF (REGULAR)	8		0
PAINT CONDITION	8		0
