ECO INSPECTION CERTIFICATE

Order ID : 107745

121 Points Vehicle Inspection Certificate

Maruti Suzuki Alto 800 LXI, 2013

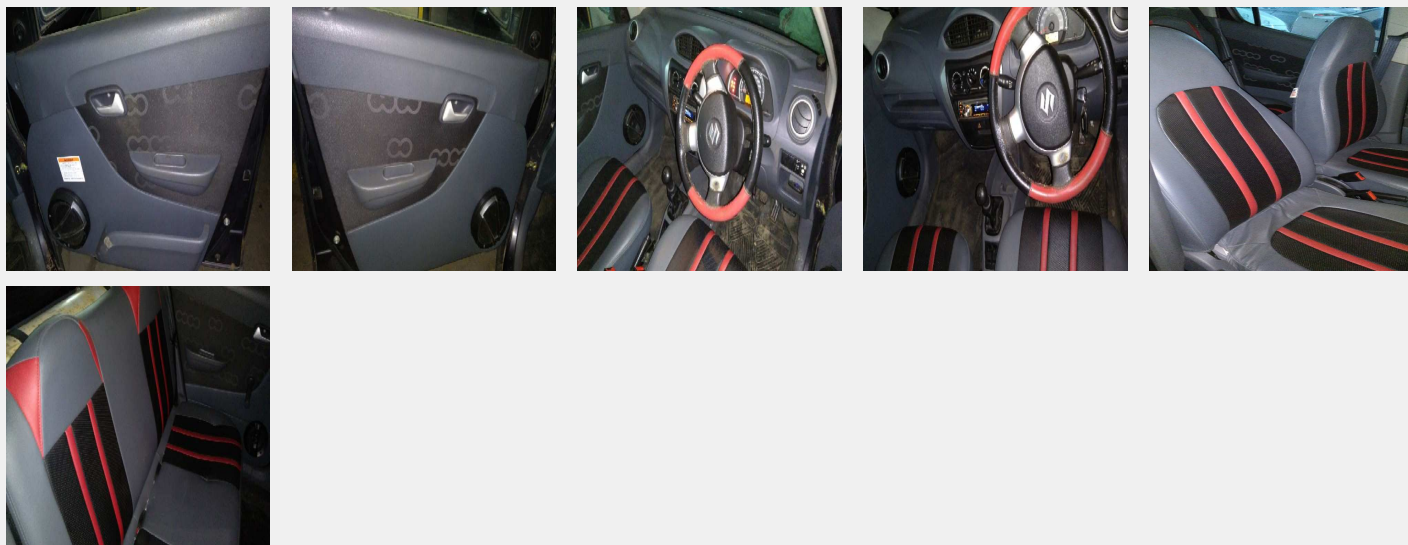
INSPECTION CHECKPOINTS	SCORE(X/10)	REMARKS/COMMENTS	OPTIONAL SPEND EST. (RS)
DOOR PANEL	6	BOTH DOOR'S PANELS ARE IN AVERAGE CONDITION	0
DOOR HINGES	6	BOTH DOOR'S HINGES & LATCH ARE WORKING IN AVERAGE CONDITION	0
CARPET & FLOOR MAT	6	CARPET IS IN AVERAGE CONDITION	0
SEAT & SEAT BELT	6	SEATS/SEAT COVERS ARE IN AVERAGE CONDITION	0
DASHBOARD & INSTRUMENT PANEL	6	DASHBOARD/INSTRUMENT PANEL IS IN AVERAGE CONDITION	0
HORN	6	HORN SOUND IS IN AVERAGE CONDITION	0
SPEAKERS & MUSIC SYSTEM	8	SPEAKER'S SOUND IS IN GOOD CONDITION	0
HANDBRAKE	6	HAND BRAKE IS IN AVERAGE CONDITION	0
PEDALS	6	ALL PEDAL'S BOOT IS IN AVERAGE CONDITION	0
CENTRAL LOCK	8	ALL DOOR'S LOCKS ARE WORKING IN GOOD CONDITION	0
A/C VENTS & HEATER	10	AC/HEATER IS WORKING AND COOLING/HEATING	0
ODOMETER	6	ODOMETER IS WORKING IN AVERAGE CONDITION	0
POWER WINDOWS (YES - FRONT ONLY)	6	ALL POWER WINDOWS ARE WORKING IN AVERAGE CONDITION.	0
HAZARD LIGHT	6	HAZARD LIGHT IS WORKING IN AVERAGE CONDITION	0

STEERING-MOUNTED CONTROLS	0	STEERING MOUNTED CONTROLS NOT WORKING	0
CUP HOLDERS	0	CUP HOLDERS DAMAGED	0

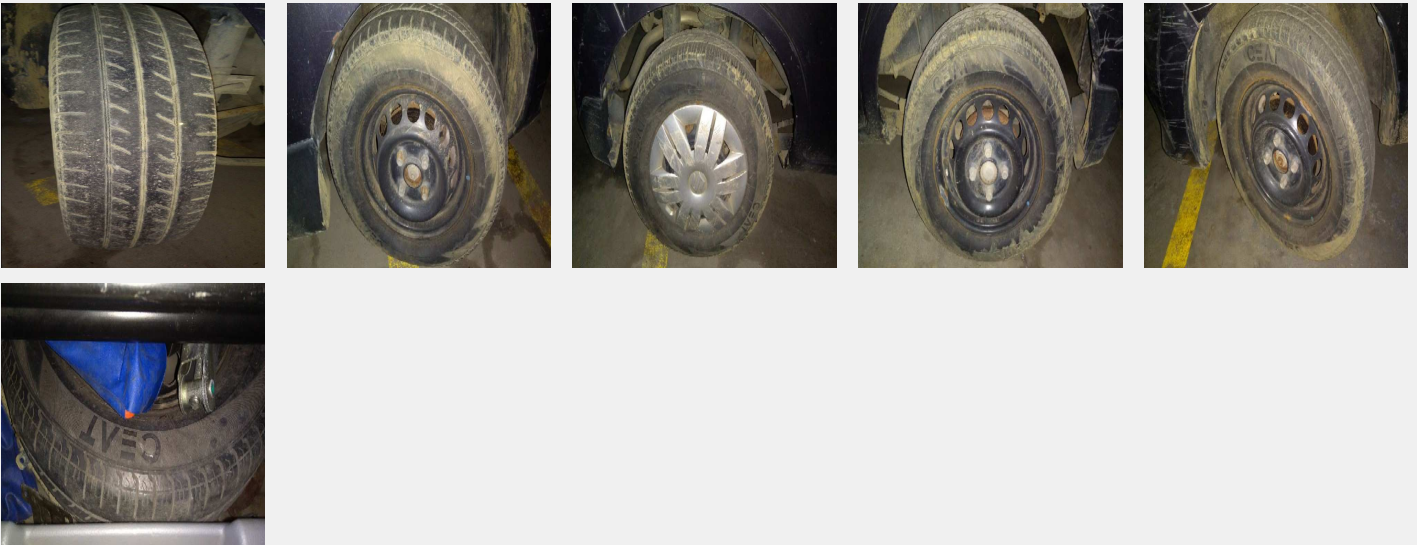
INSPECTION CHECKPOINTS	SCORE(X/10)	REMARKS/COMMENTS	OPTIONAL SPEND EST. (RS)
TYRES	6	TIRES ARE IN AVERAGE CONDITION	0
SPARE TYRE (YES)	6	SPARE TYRE IS IN AVERAGE CONDITION	0
WHEEL ASSEMBLY (STEEL RIM)	6	WHEEL ALIGNMENT IS IN AVERAGE CONDITION.	0

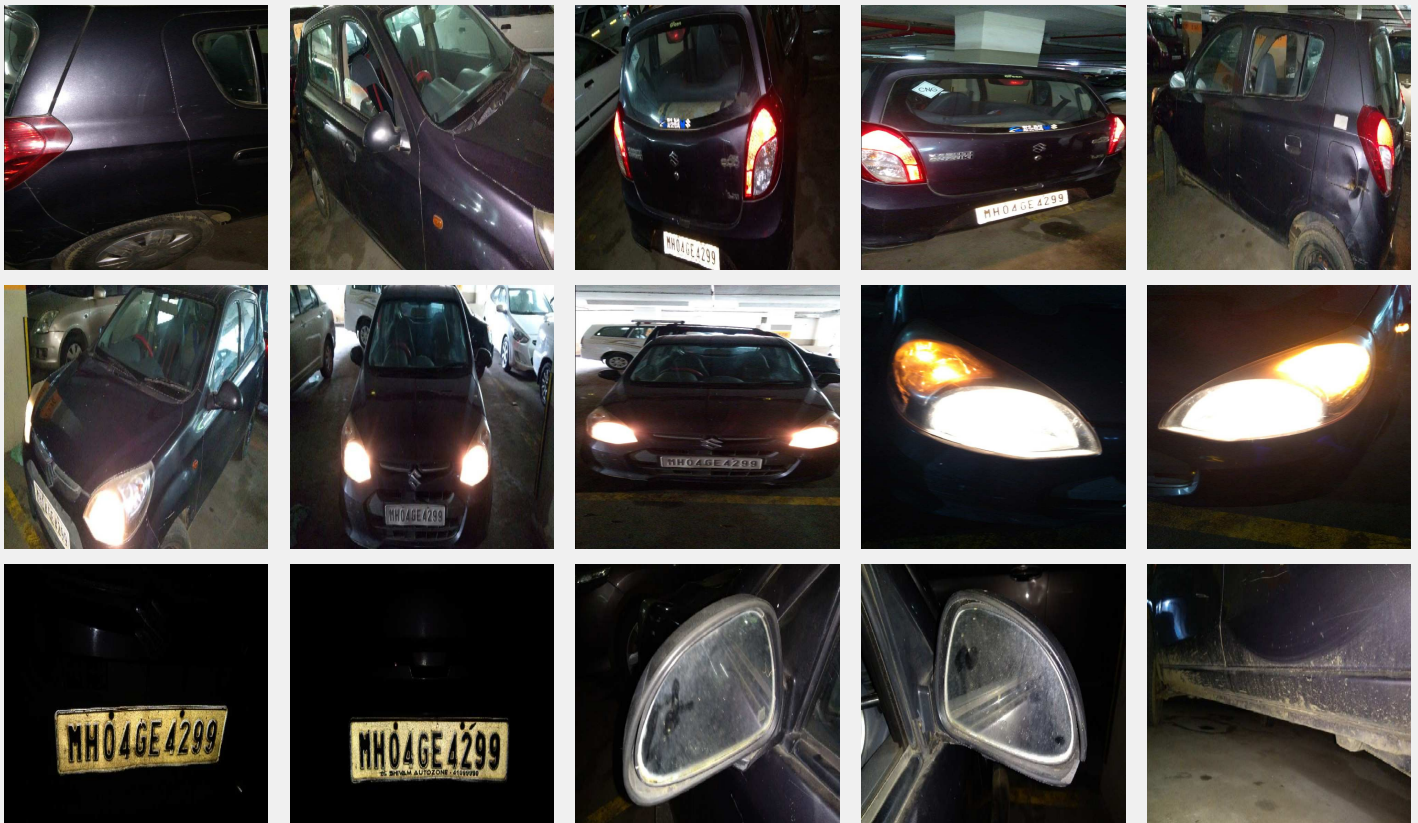
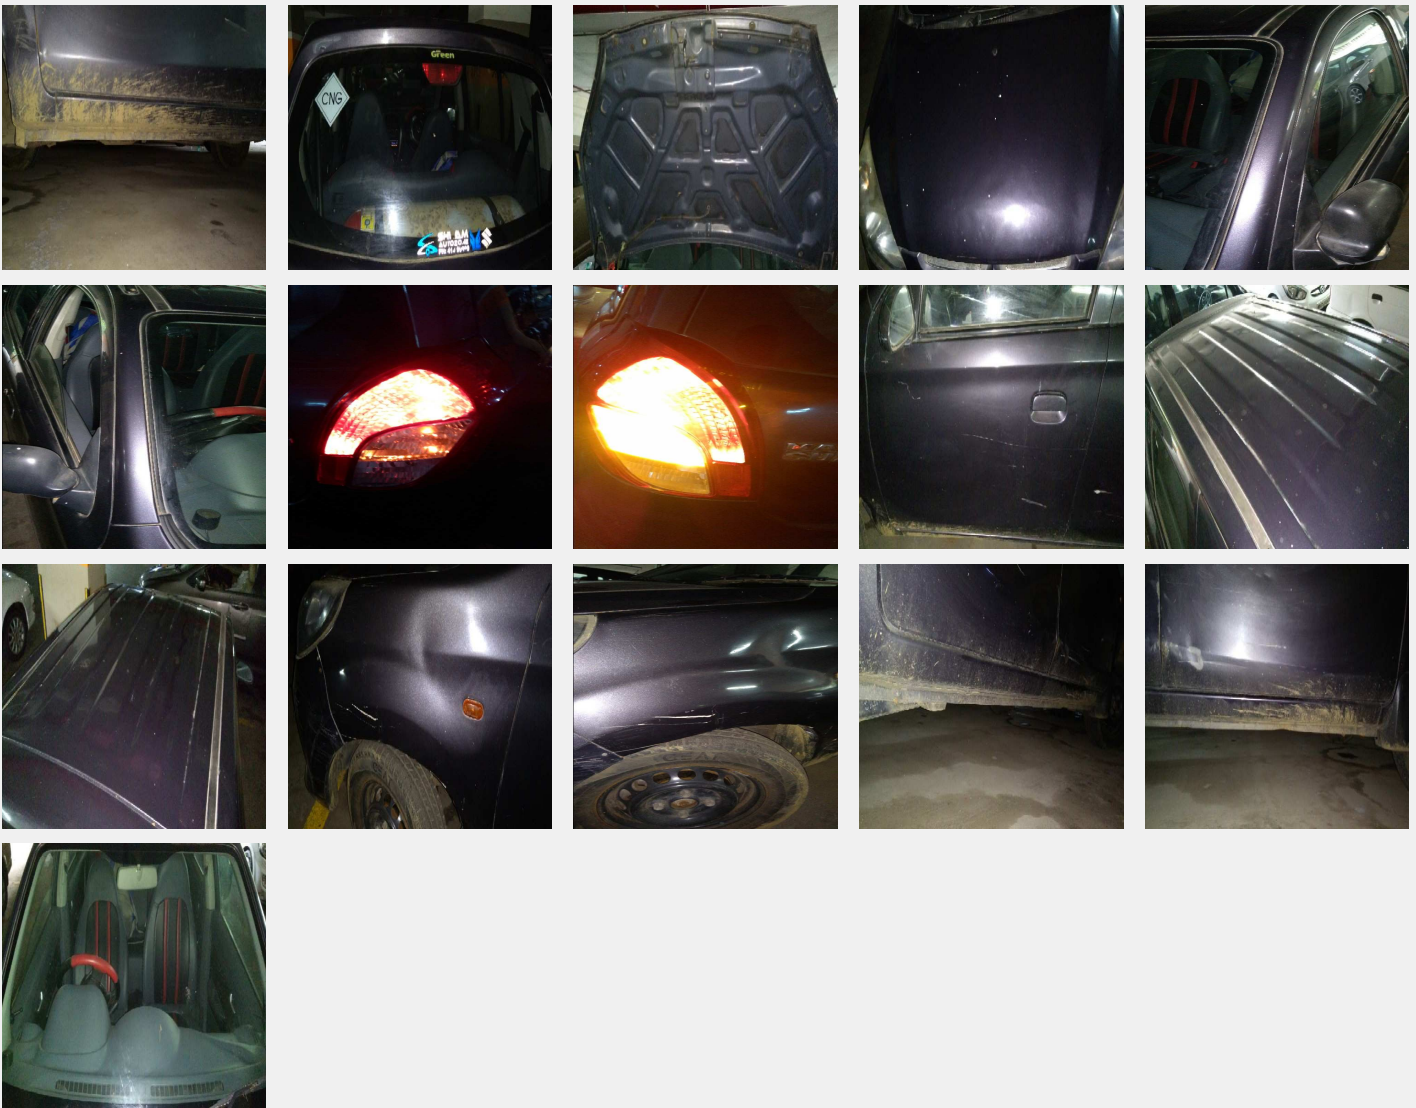
INSPECTION CHECKPOINTS	SCORE(X/10)	REMARKS/COMMENTS	OPTIONAL SPEND EST. (RS)
LICENSE PLATE	6	LICENSE PLATE IS IN AVERAGE CONDITION.	0
HEAD LIGHTS	6	HEAD LIGHTS ARE WORKING IN AVERAGE CONDITION	0
GRILLE	6	GRILLE IS IN AVERAGE CONDITION	0
TURN SIGNAL	6	INDICATOR IS WORKING IN AVERAGE CONDITION	0
HOOD	6	HOOD IS IN AVERAGE CONDITION	0
PILLAR	6	LH PILLARS ARE IN AVERAGE CONDITION	0
FRONT WINDSHIELD	6	FRONT WINDSHIELD IS IN AVERAGE CONDITION	0
SIDE VIEW MIRRORS	6	LH SIDE VIEW MIRROR/ASSY IS IN AVERAGE CONDITION	0
LH FENDER	6	LH FENDER IS IN AVERAGE CONDITION	1800
LH FRONT DOOR	6	LH FRONT DOOR IS IN AVERAGE CONDITION	0
LH RUNNING BOARD	6	LH RUNNING BOARD IS IN AVERAGE CONDITION	0
REAR WINDSHIELD	6	REAR WINDSHIELD IS IN AVERAGE CONDITION	0
TAIL LIGHT	6	TAIL LIGHT IS WORKING IN AVERAGE CONDITION	0
RH QUARTER PANEL	6	RH QUARTER PANEL IS IN AVERAGE CONDITION	0
RH RUNNING BOARD	6	RH RUNNING BOARD IS IN AVERAGE CONDITION	0

BODY RUST	6	BODY RUST 25%-MINOR	0
ROOF (REGULAR)	6	ROOF IS IN AVERAGE CONDITION	0
		PAINT IS IN AVERAGE

PAINT CONDITION	6	PAINT IS IN AVERAGE CONDITION	0
FRONT BUMPER	4	FRONT BUMPER SCRATCHED/DENTED/LOOSED- MINOR	1500
FOG LAMPS	0	FOG LAMPS DAMAGED	0
LH REAR DOOR	4	LH REAR DOOR DENTED/SCRATCHEDD-MINOR	1500
LH QUARTER PANEL	2	LH QUARTER PANEL DENTED/SCRATCHED-MAJOR	2000
FUEL LID	4	FUEL LID DENTED/SCRATCHEDD-MINOR	500
REAR BUMPER	4	REAR BUMPER SCRATCHED/DENTED/LOOSED- MINOR	1500

INSPECTION CHECKPOINTS	SCORE(X/10)	REMARKS/COMMENTS	OPTIONAL SPEND EST. (RS)
TRUNK LID/TAIL GATE	4	TRUNK LID DENTED/SCRATCHED-MINOR	1500
LUGGAGE COMPARTMENT LIGHT	0	LUGGAGE COMPARTMENT LIGHT NOT AVAILABLE	0
RH REAR DOOR	4	RH REAR DOOR DENTED/SCRATCHED-MINOR	1500
RH FRONT DOOR	4	RH FRONT DOOR DENTED/SCRATCHED-MINOR	1500
RH FENDER	4	RH FENDER DENTED/SCRATCHED-MINOR	1500

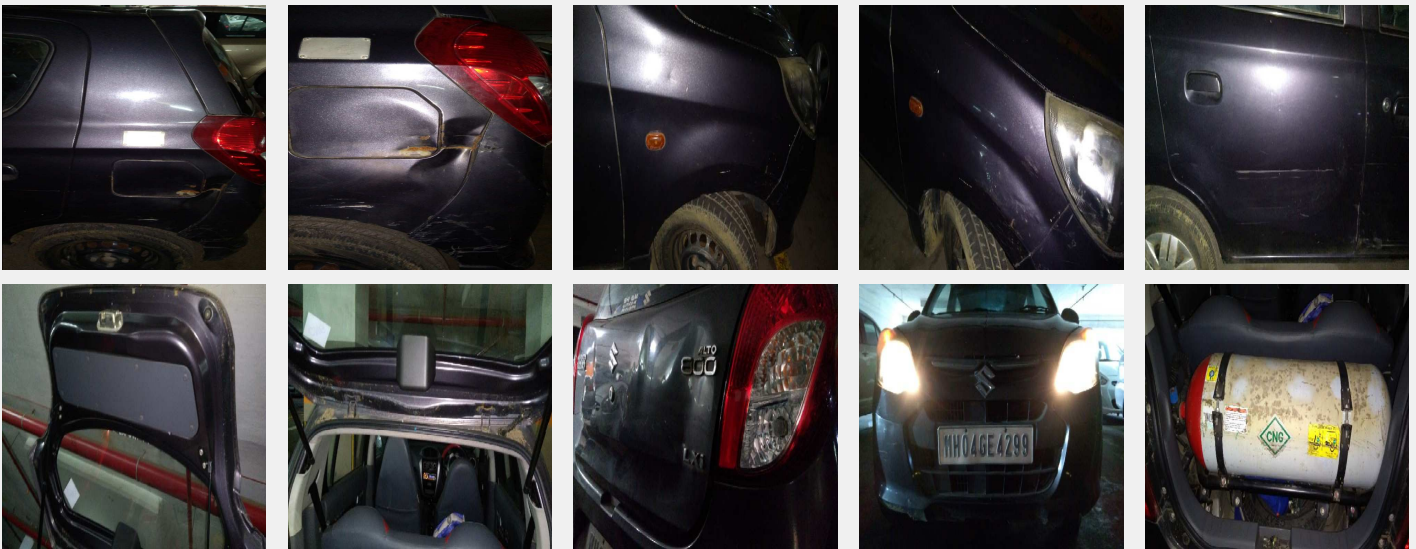
**NEED ATTENTION**

Petro-CNG car, Major dent & scratches, overall Average condition
