ECO INSPECTION CERTIFICATE

Order ID : 112107

121 Points Vehicle Inspection Certificate

Ford Figo DURATORQ ZXI 1.4, 2013

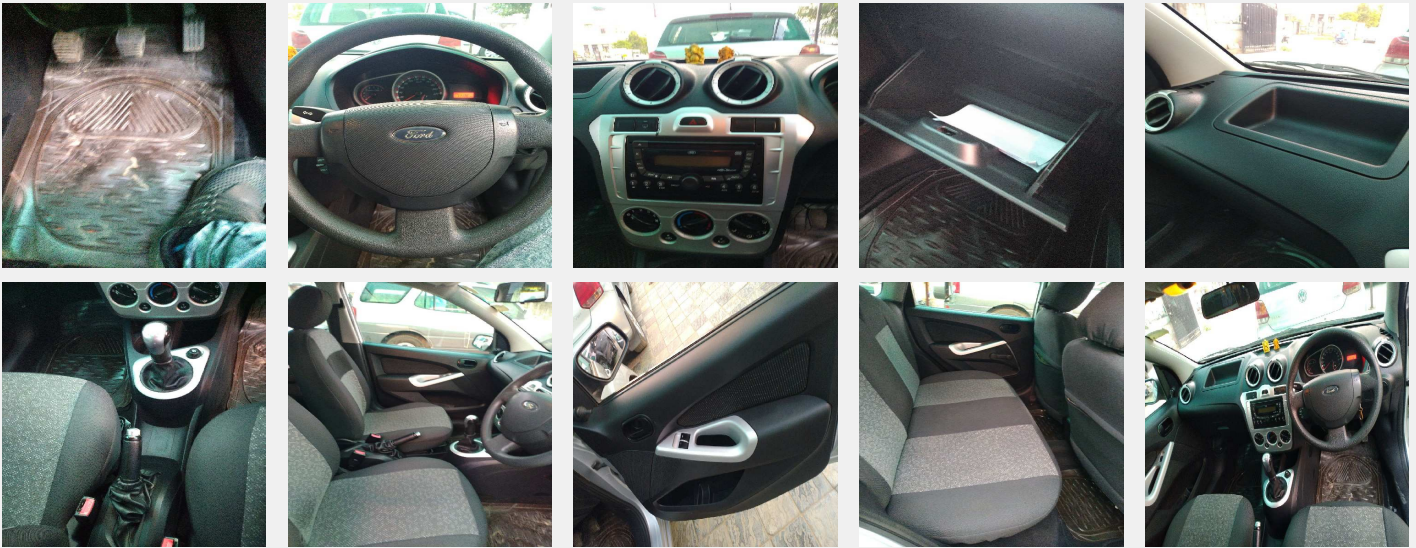
IMAGES

INSPECTION CHECKPOINTS	SCORE(X/10)	REMARKS/COMMENTS	OPTIONAL SPEND EST. (RS)
DOOR PANEL	8	BOTH DOOR'S PANELS ARE IN GOOD CONDITION	0
DOOR HINGES	8	BOTH DOOR'S HINGES & LATCH ARE WORKING IN GOOD CONDITION	0
CARPET & FLOOR MAT	8	CARPET IS IN GOOD CONDITION	0
SEAT & SEAT BELT	8	SEATS/SEAT COVERS ARE IN GOOD CONDITION	0
DASHBOARD & INSTRUMENT PANEL	8	DASHBOARD/INSTRUMENT PANEL IS IN GOOD CONDITION	0
HORN	8	HORN SOUND IS IN GOOD CONDITION	0
SPEAKERS & MUSIC SYSTEM	8	SPEAKER'S SOUND IS IN GOOD CONDITION	0
HANDBRAKE	8	HAND BRAKE IS IN GOOD CONDITION	0
STEERING-MOUNTED CONTROLS	8	STEERING MOUNTED CONTROLS ARE WORKING IN GOOD CONDITION	0
PEDALS	8	ALL PEDAL'S BOOT IS IN GOOD CONDITION	0
CENTRAL LOCK	8	ALL DOOR'S LOCKS ARE WORKING IN GOOD CONDITION	0
A/C VENTS & HEATER	10	AC/HEATER IS WORKING AND COOLING/HEATING	0
CUP HOLDERS	8	CUP HOLDERS ARE IN GOOD CONDITION	0
ODOMETER	8	ODOMETER IS WORKING IN GOOD CONDITION	0

POWER WINDOWS (YES - FRONT ONLY)	8	ALL POWER WINDOWS ARE WORKING IN GOOD CONDITION	0
HAZARD LIGHT	8	HAZARD LIGHT IS WORKING IN GOOD CONDITION	0

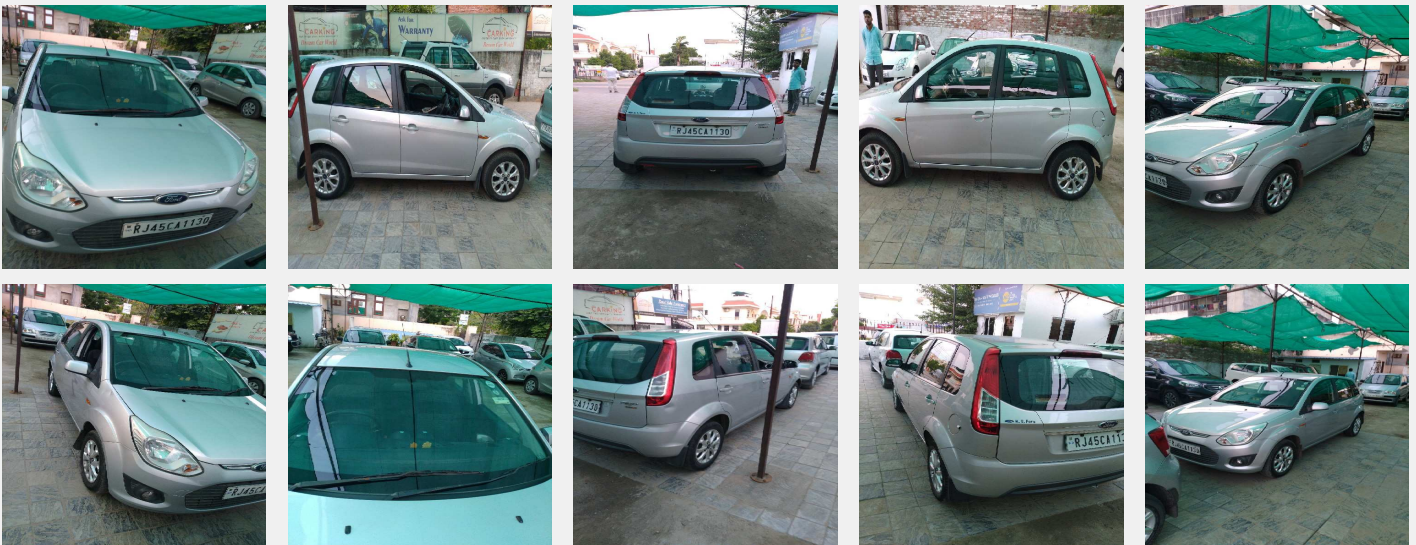
IMAGES

INSPECTION CHECKPOINTS	SCORE(X/10)	REMARKS/COMMENTS	OPTIONAL SPEND EST. (RS)
RH FRONT DOOR	8	RH FRONT DOOR IS IN GOOD CONDITION	0
RH FENDER	8	RH FENDER IS IN GOOD CONDITION	0
BODY RUST	8	NO ANY BODY RUST	0
ROOF (REGULAR)	8	ROOF IS IN GOOD CONDITION	0
PAINT CONDITION	8	PAINT IS IN GOOD CONDITION	0
