ECO INSPECTION CERTIFICATE

Order ID : 120898

121 Points Vehicle Inspection Certificate

Volkswagen Polo HIGHLINE 1.2L (P), 2014

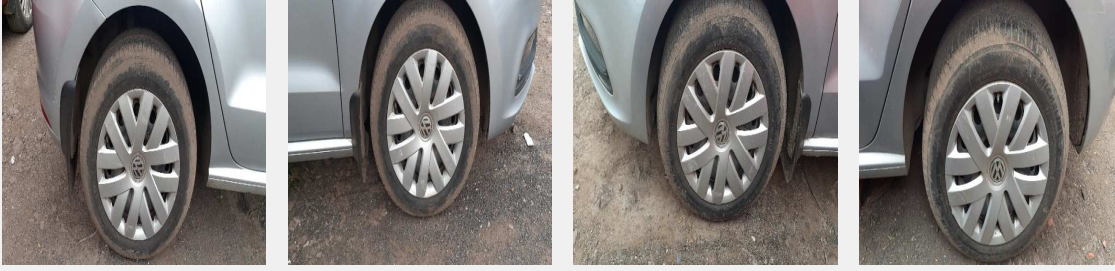
IMAGES

INSPECTION CHECKPOINTS	SCORE(X/10)	REMARKS/COMMENTS	OPTIONAL SPEND EST. (RS)
TYRES	8	TIRES ARE IN GOOD CONDITION	0
SPARE TYRE (YES)	8	SPARE TYRE IS IN GOOD CONDITION	0
WHEEL ASSEMBLY (STEEL RIM)	8	WHEEL ALIGNMENT IS IN GOOD CONDITION	0

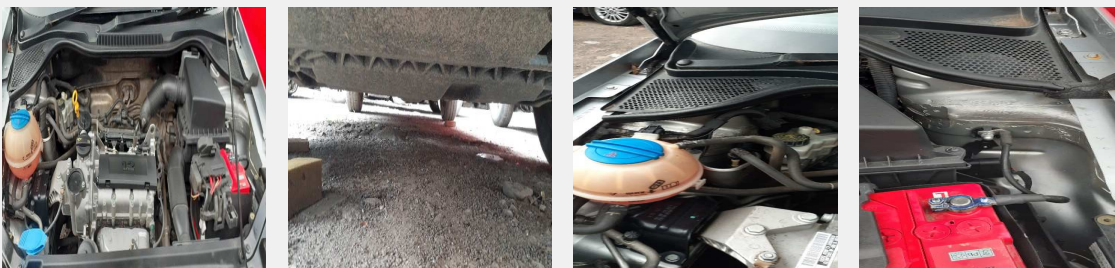
IMAGES

INSPECTION CHECKPOINTS	SCORE(X/10)	REMARKS/COMMENTS	OPTIONAL SPEND EST. (RS)
LH APRON	8	LH APRON IS IN GOOD CONDITION	0
RH APRON	8	RH APRON IS IN GOOD CONDITION	0
RADIATOR	8	RADIATOR IS IN GOOD CONDITION	0
WIRING	8	WIRING HARNESS IS IN GOOD CONDITION	0
BATTERY	8	BATTERY IS IN GOOD CONDITION	0
BRAKE FLUID LEVEL	8	BRAKE FLUID & LEVEL IS IN GOOD CONDITION	0
ENGINE OIL	8	ENGINE OIL IS IN GOOD CONDITION	0
COOLANT LEVEL	8	COOLANT LEVEL IS IN GOOD CONDITION	0
BRAKE & COOLANT HOSE PIPES	8	ALL HOSES/PIPES IS IN GOOD CONDITION	0
UNDERCARRIAGE	8	UNDERCARRIAGE IS IN GOOD CONDITION	0
EXHAUST SYSTEM	8	NORMAL SMOKE	0

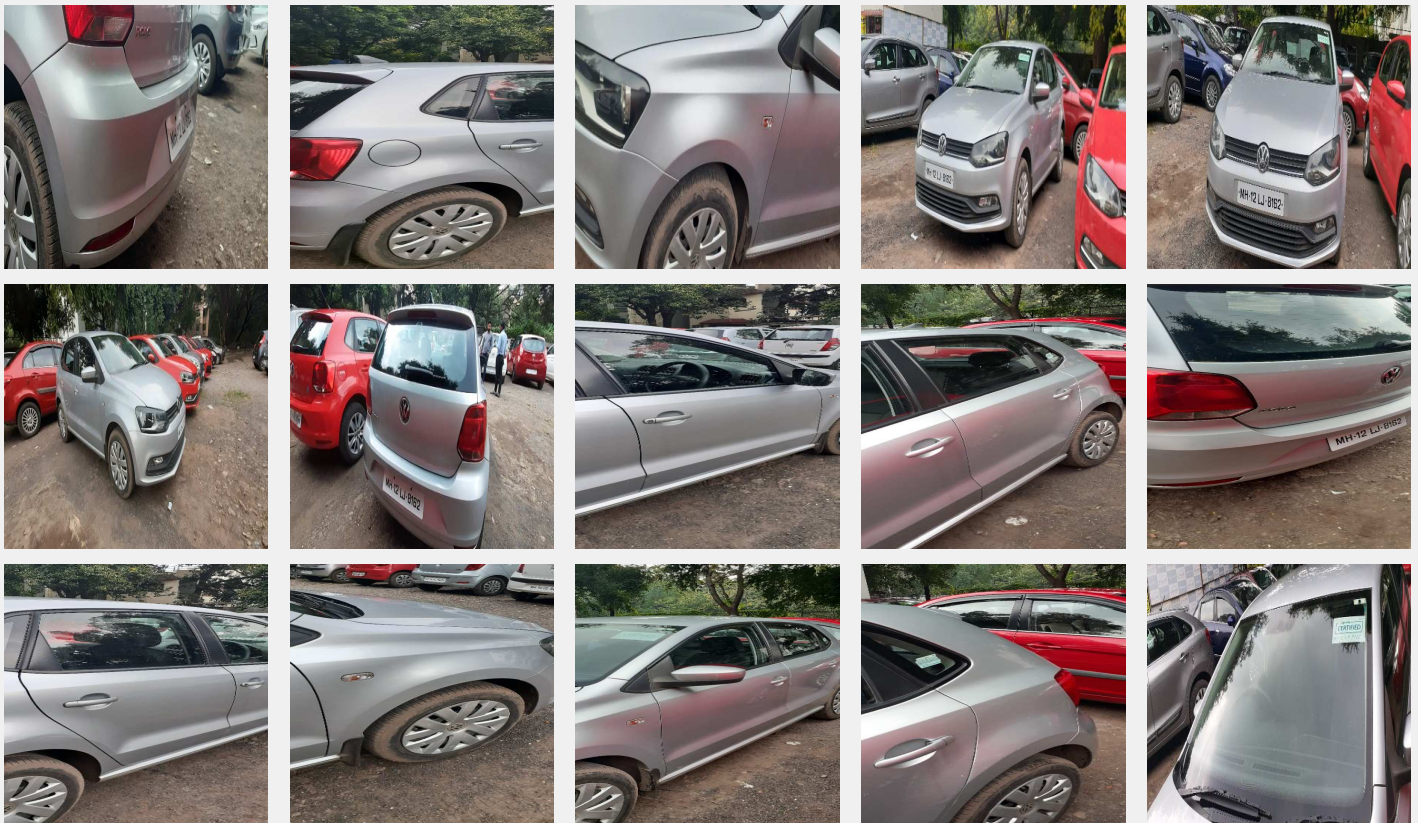
IMAGES

INSPECTION CHECKPOINTS	SCORE(X/10)	REMARKS/COMMENTS	OPTIONAL SPEND EST. (RS)
RH FRONT DOOR	8	RH FRONT DOOR IS IN GOOD CONDITION	0
RH FENDER	8	RH FENDER IS IN GOOD CONDITION	0
BODY RUST	8	NO ANY BODY RUST	0
ROOF (REGULAR)	8	ROOF IS IN GOOD CONDITION	0
PAINT CONDITION	8	PAINT IS IN GOOD CONDITION	0
