ECO INSPECTION CERTIFICATE

Order ID : 122618

121 Points Vehicle Inspection Certificate

Maruti Suzuki Swift VDI AMT, 2019

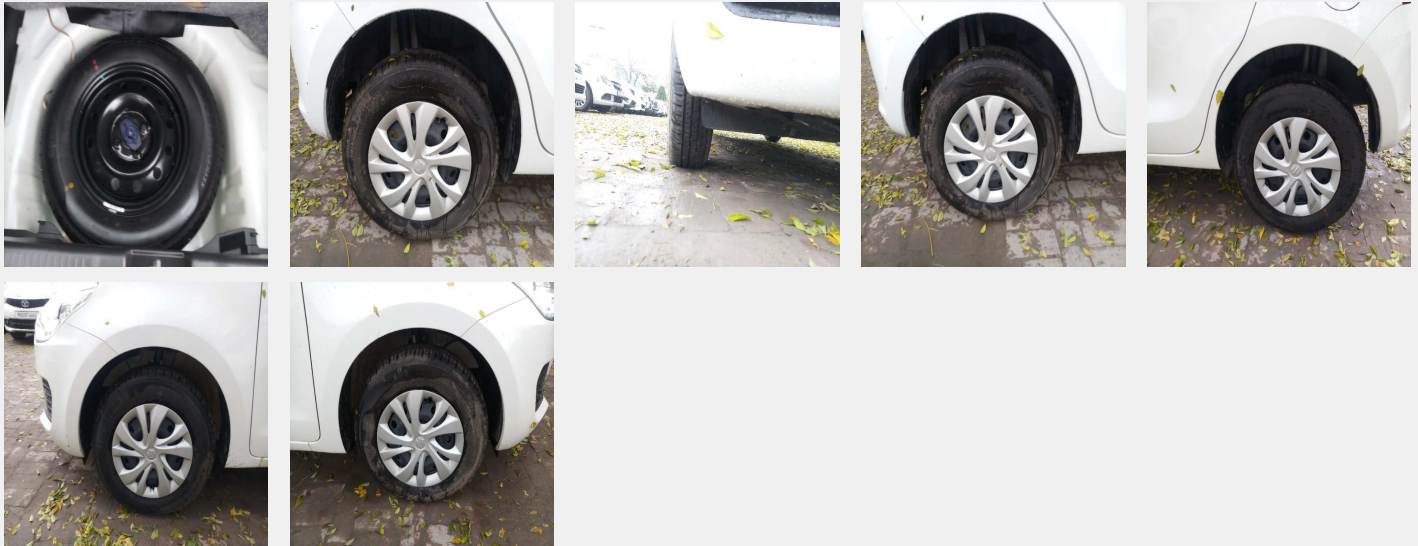
IMAGES

INSPECTION CHECKPOINTS	SCORE(X/10)	REMARKS/COMMENTS	OPTIONAL SPEND EST. (RS)
TYRES	8	TIRES ARE IN GOOD CONDITION	0
SPARE TYRE (YES)	8	SPARE TYRE IS IN GOOD CONDITION	0
WHEEL ASSEMBLY (STEEL RIM)	8	WHEEL ALIGNMENT IS IN GOOD CONDITION	0

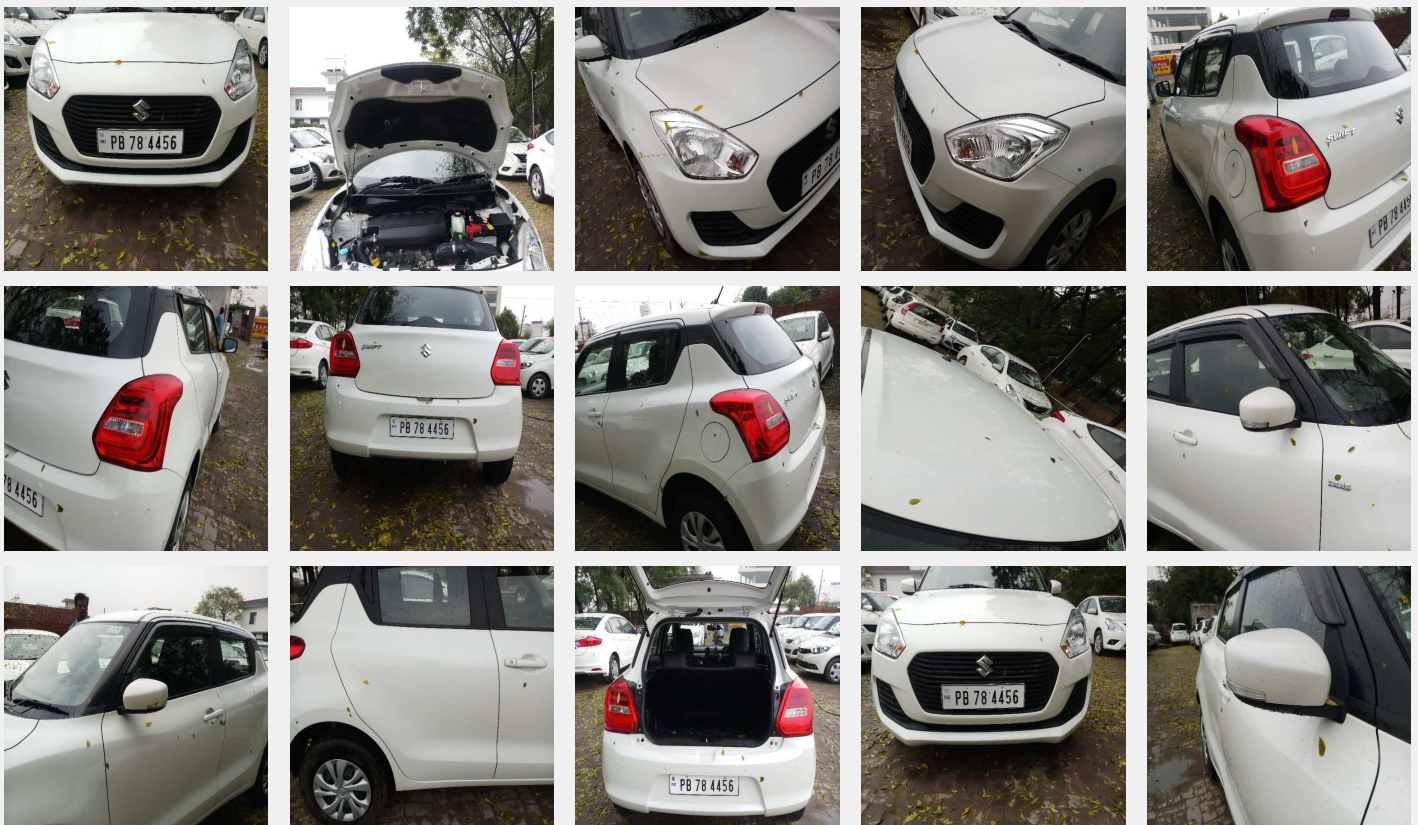
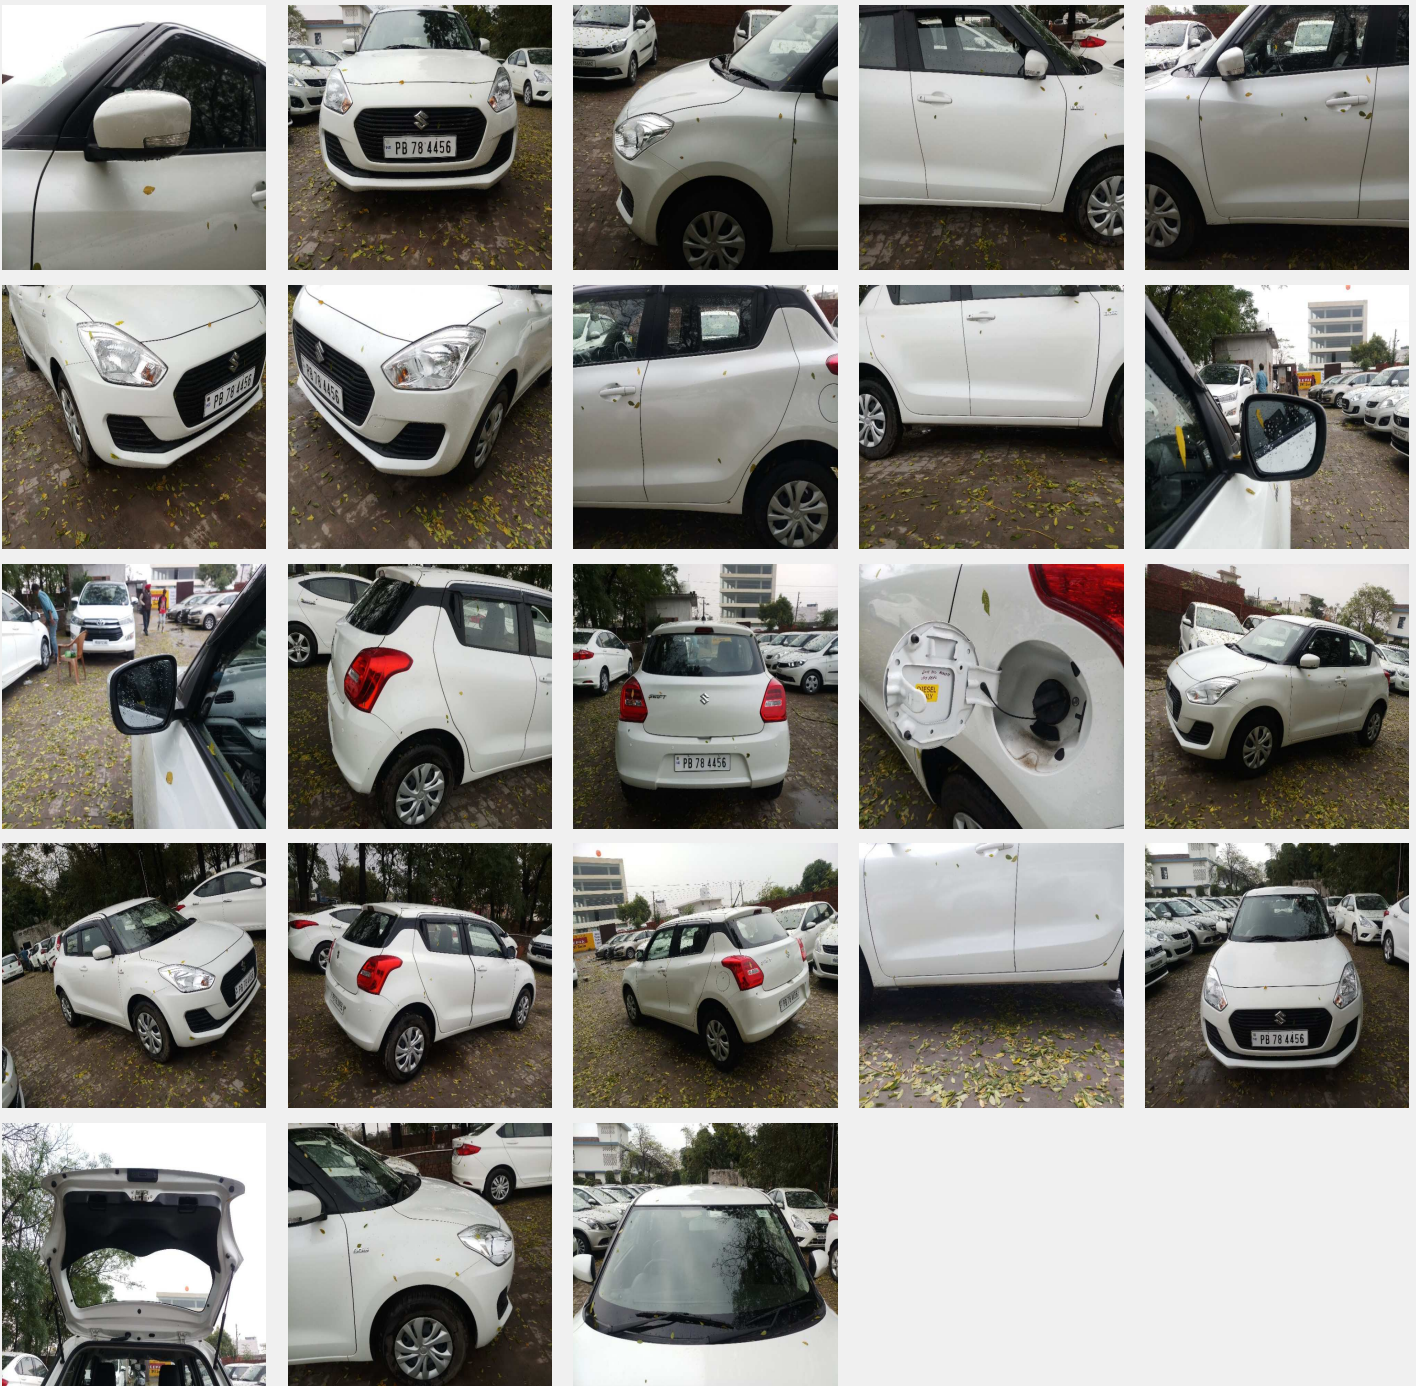
IMAGES

INSPECTION CHECKPOINTS	SCORE(X/10)	REMARKS/COMMENTS	OPTIONAL SPEND EST. (RS)
RH FRONT DOOR	8	RH FRONT DOOR IS IN GOOD CONDITION	0
RH FENDER	8	RH FENDER IS IN GOOD CONDITION	0
BODY RUST	8	NO ANY BODY RUST	0
ROOF (REGULAR)	8	ROOF IS IN GOOD CONDITION	0
PAINT CONDITION	8	PAINT IS IN GOOD CONDITION	0
