ECO INSPECTION CERTIFICATE

121 Points Vehicle Inspection Certificate

Chevrolet Beat Ls Diesel, 2012

MAKE	CHEVROLET	ENGINE NUMBER	630187
MODEL	BEAT	REGISTRATION NO.	MH14DF3217
MFG. DATE	02/2011	VIN/CHASSIS NUMBER	MA6BFBMNBBT086607
TRIM	LS DIESEL	ODOMETER READING	75728
COLOR	WHITE	INSURANCE EXPIRY	2019-12-16
BODY TYPE	HATCHBACK	VEHICLE PASSING	PRIVATE
FUEL TYPE	DIESEL	ENGINE SOUND LINK	NIL

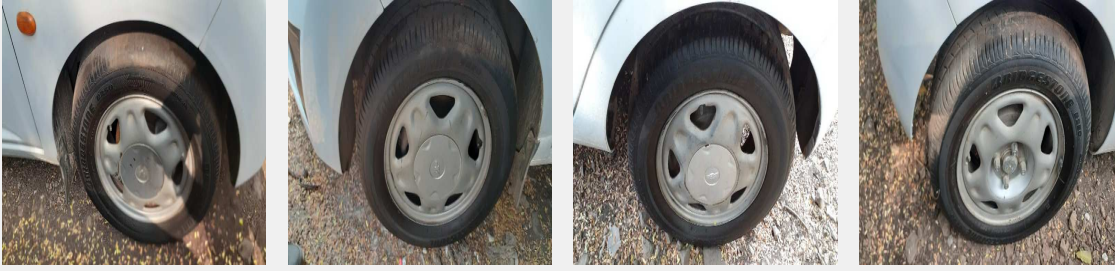
IMAGES

INSPECTION CHECKPOINTS	SCORE(X/10)	REMARKS/COMMENTS	OPTIONAL SPEND EST. (RS)
TYRES	8	TIRES ARE IN GOOD CONDITION	0
SPARE TYRE (YES)	8	SPARE TYRE IS IN GOOD CONDITION	0
WHEEL ASSEMBLY (STEEL RIM)	8	WHEEL ALIGNMENT IS IN GOOD CONDITION	0

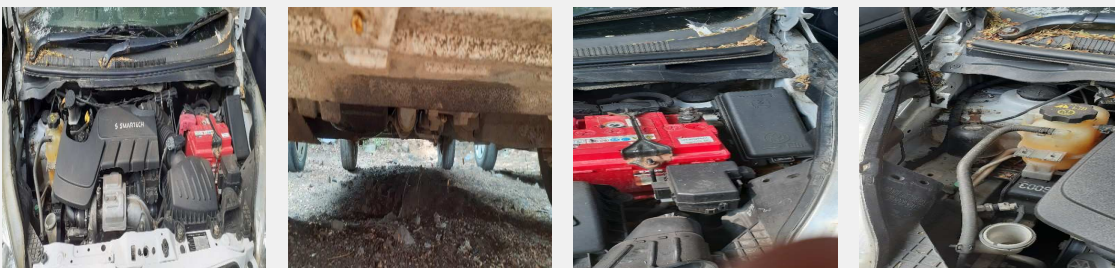
IMAGES

INSPECTION CHECKPOINTS	SCORE(X/10)	REMARKS/COMMENTS	OPTIONAL SPEND EST. (RS)
LH APRON	8	LH APRON IS IN GOOD CONDITION	0
RH APRON	8	RH APRON IS IN GOOD CONDITION	0
RADIATOR	8	RADIATOR IS IN GOOD CONDITION	0
WIRING	8	WIRING HARNESS IS IN GOOD CONDITION	0
BATTERY	8	BATTERY IS IN GOOD CONDITION	0
BRAKE FLUID LEVEL	8	BRAKE FLUID & LEVEL IS IN GOOD CONDITION	0
ENGINE OIL	8	ENGINE OIL IS IN GOOD CONDITION	0
COOLANT LEVEL	8	COOLANT LEVEL IS IN GOOD CONDITION	0
BRAKE & COOLANT HOSE PIPES	8	ALL HOSES/PIPES IS IN GOOD CONDITION	0
UNDERCARRIAGE	8	UNDERCARRIAGE IS IN GOOD CONDITION	0
EXHAUST SYSTEM	8	NORMAL SMOKE	0

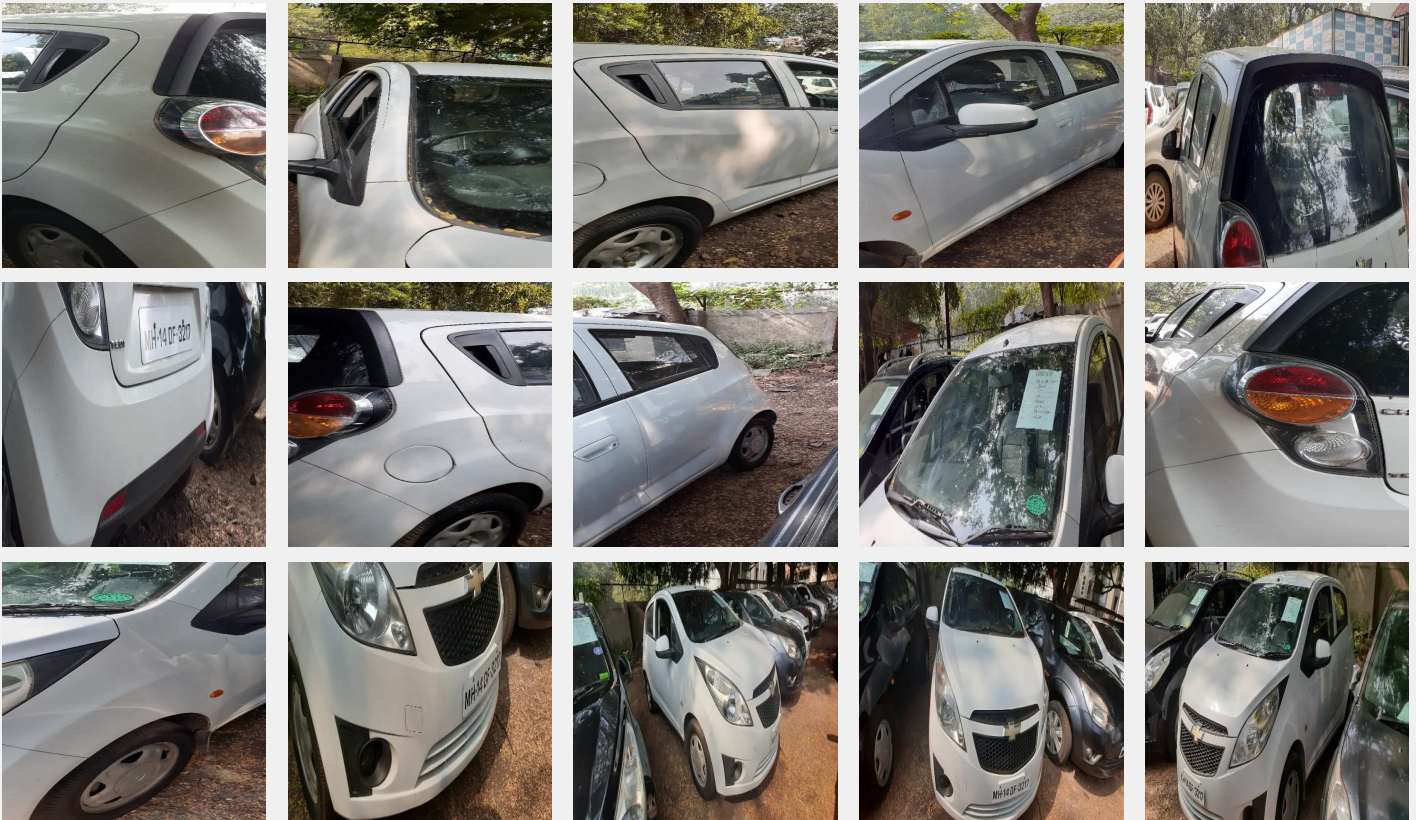
IMAGES

INSPECTION CHECKPOINTS	SCORE(X/10)	REMARKS/COMMENTS	OPTIONAL SPEND EST. (RS)
RH FENDER	8	RH FENDER IS IN GOOD CONDITION	0
BODY RUST	8	NO ANY BODY RUST	0
ROOF (REGULAR)	8	ROOF IS IN GOOD CONDITION	0
PAINT CONDITION	8	PAINT IS IN GOOD CONDITION	0
FOG LAMPS	4	FOG LAMPS CRACKED-MINOR	0
