ENGINE DIAGNOSTICS REPORT

1000+ Checkpoints Engine Health Inspection

Hyundai Grand i10 Era 1.2 Kappa 2015

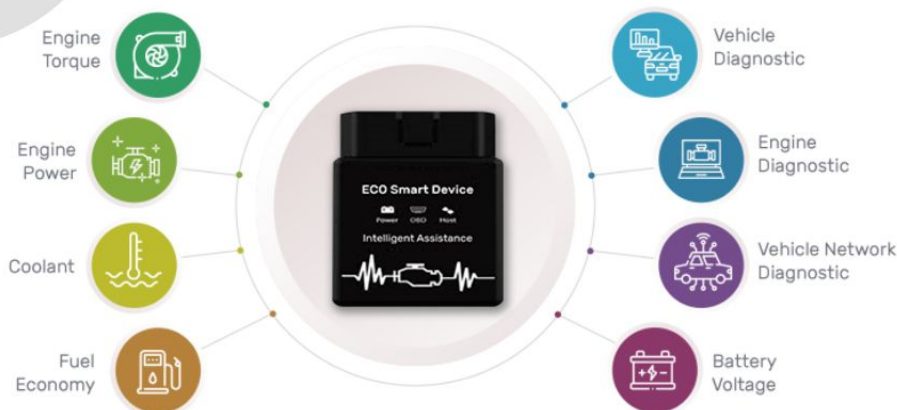
Vehicle Diagnostics Checkpoints

Test Drive Results

Test Drive Distance
2.57 Kilometres

Test Drive Duration
12 Minutes

Atmospheric Pressure
93.00 kPa

Ambient Temperature
25.00 degC

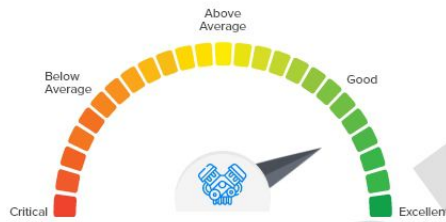
Expected Torque Value for 2015 Hyundai Grand i10

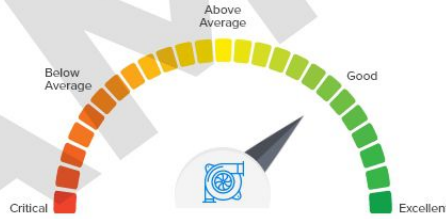
Expected Power Value 2015 Hyundai Grand i10

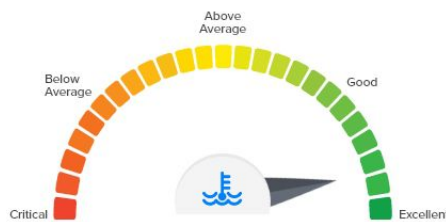
Coolant System

Max. Coolant Temp. - **88° C**
Nominal Coolant Temp. - **86° C**
Min. Coolant Temp. - **85° C**

Expected Coolant Value 2015 Hyundai Grand i10

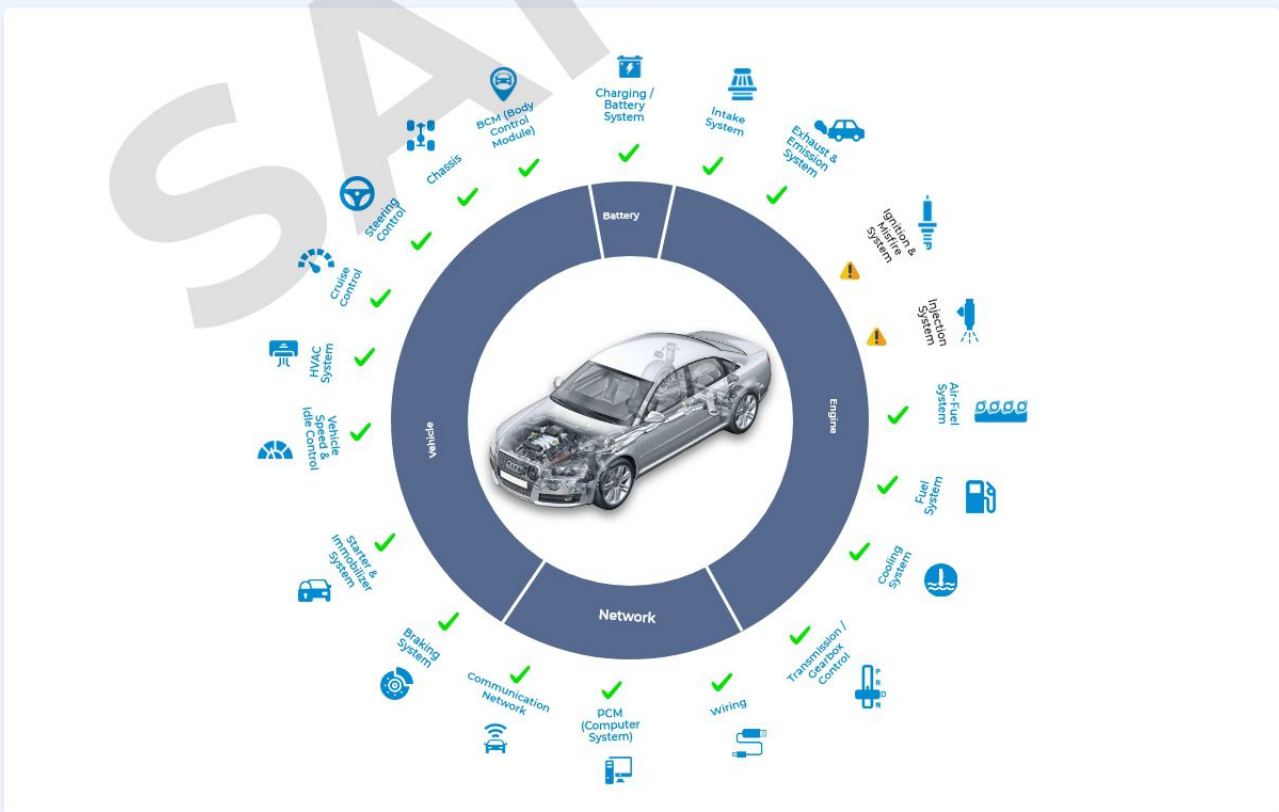
Vehicle System Overview

DTC CODE : P0300

Random/Multiple Cylinder Misfire Detected

DTC CODE : P0301

Cylinder 1 Misfire Detected

DTC CODE : P0410

Secondary Air Injection System Malfunction

DTC CODE : P0411

Secondary Air Injection System Incorrect Flow Detected
