203682
Order ID

06 Sep 2022
Generated on

Vehicle Health Report

BMW X3 2018, XDRIVE 30I LUXURY LINE

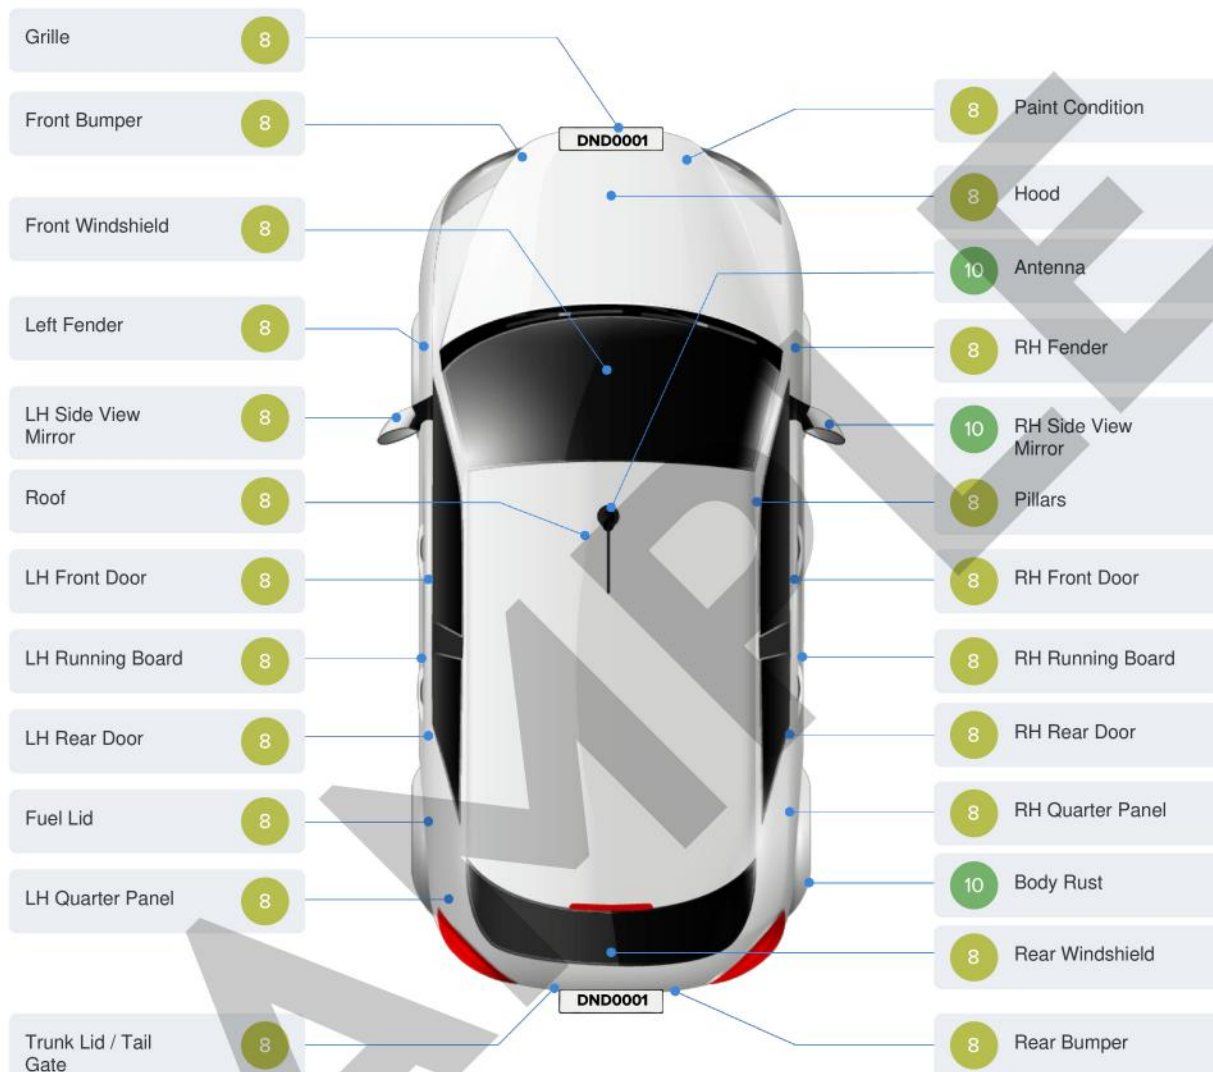
Vehicle Exterior View and Condition

Front License Plate is in Good Condition?	✓
License Plates are HSRP compliant?	✓
Head Lights are working in Good Condition?	✓
Turn Signal lamps are working in Good Condition?	✓
Hazard Lamps are working?	✓
License Plate Light is working in Good Condition?	✓
Rear Windshield Wiper is working in good condition?	✗

Rear License Plate is in Good Condition?	✓
HSRP colour sticker is available?	✗
Tail Lights are working in Good Condition?	✓
Fog Lamps are working in Good Condition?	✓
Brake Lights are working in Good Condition?	✓
Front Windshield Wiper is working in good condition?	✓
Reverse Parking lights are working in Good Condition?	✓

Remarks HSRP colour sticker is not available
Repair Estimate ₹ 600

Remarks Rear windshield wiper is not working or is damaged
Repair Estimate ₹ 100
