ECO INSPECTION REPORT

10 / 01 / 2021

Audi A4 Premium Plus, 2019

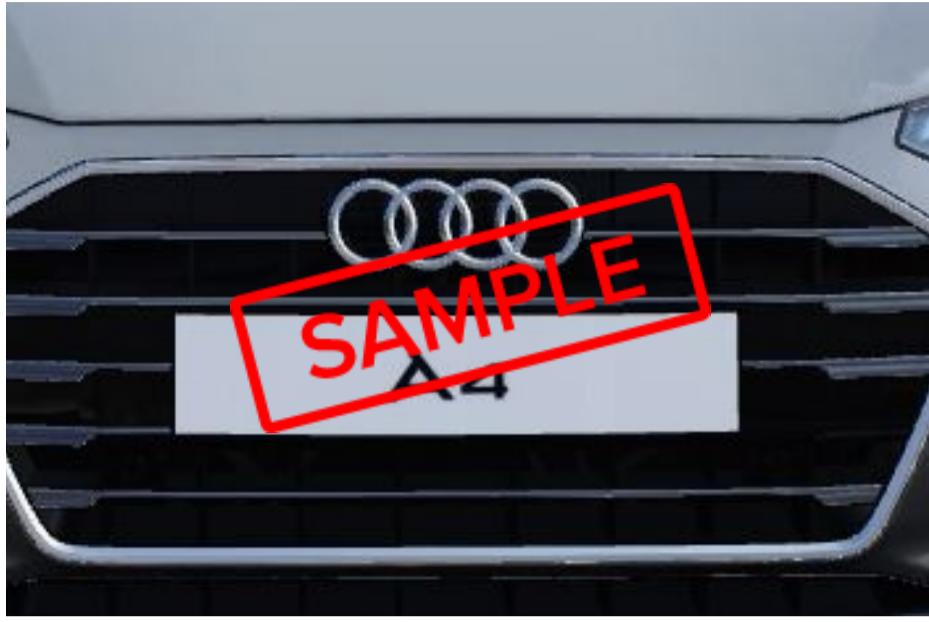
GRILLE

Grille 6		Paint Condition 10
Front Bumper 8		Hood 4
Front Windshield 8		Antenna 10
Left Fender 4		RH Fender 10
LH Side View Mirror 10		RH Side View Mirror 6
Roof 10		Pillars 10
LH Front Door 10		RH Front Door 8
LH Running Board 6		RH Running Board 6
LH Rear Door 10		RH Rear Door 4
Fuel Lid 2		RH Quarter Panel 8
LH Quarter Panel 6		Body Rust 8
Trunk Lid / Tail Gate 10		Rear Winshield 8
		Rear Bumper 10

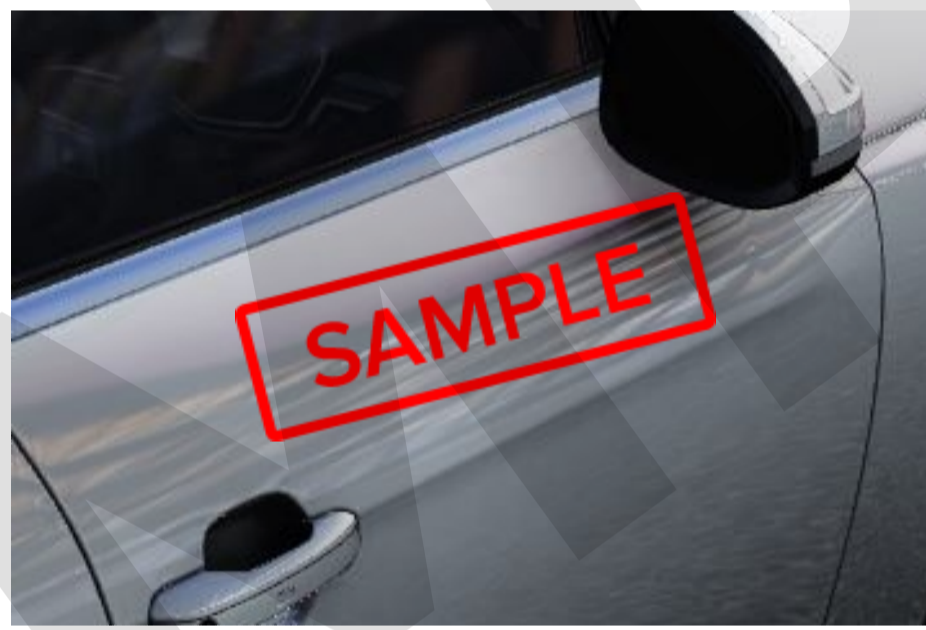
LH FRONT DOOR

Remarks: Scratches/Dents in Front Door
Repair Estimate: ₹ 900

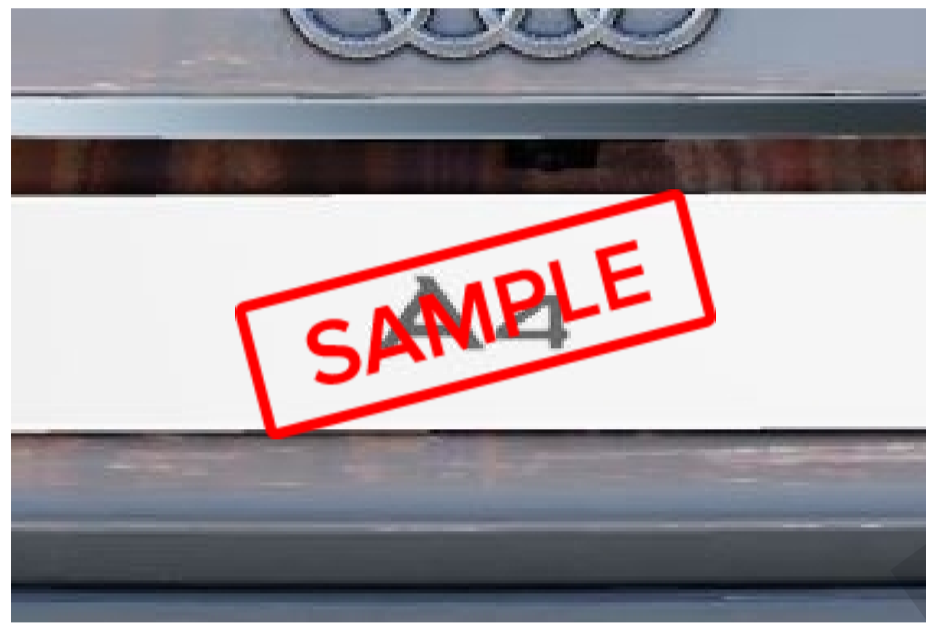
HSRP COLOUR STICKER

Front License Plate is available?	✓
License Plates are HSRP complaint?	✗
Head Lights are working?	✓
Turn Signal lamps are working?	✗
Hazard Lamps are working?	✓
License plate light is working?	✓
Rear windshield wiper is working in good condition?	✓
