ECO INSPECTION CERTIFICATE

Order ID : 75112

121 Points Vehicle Inspection Certificate

Volkswagen Vento HIGHLINE PETROL AT, 2018

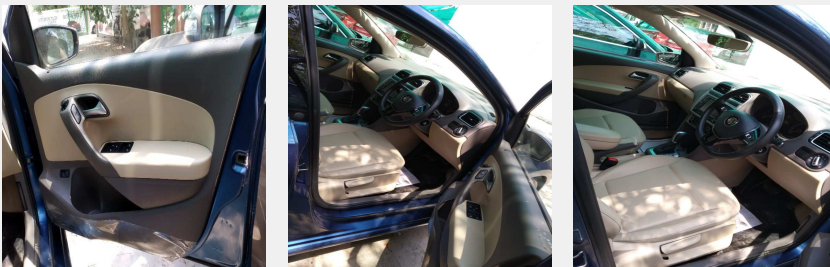
IMAGES

INSPECTION CHECKPOINTS	SCORE(X/10)	REMARKS/COMMENTS	OPTIONAL SPEND EST. (RS)
DOOR PANEL	8		0
DOOR HINGES	8		0
CARPET & FLOOR MAT	8		0
SEAT & SEAT BELT	8		0
DASHBOARD & INSTRUMENT PANEL	8		0
HORN	9		0
SPEAKERS & MUSIC SYSTEM	8		0
HANDBRAKE	9		0
STEERING-MOUNTED CONTROLS	8		0
PEDALS	8		0
CENTRAL LOCK	8		0
A/C VENTS & HEATER	8		0
CUP HOLDERS	8		0
NAVIGATION (NO)	10		0
ODOMETER	9		0
POWER WINDOWS (YES)	8		0
HAZARD LIGHT	8		0

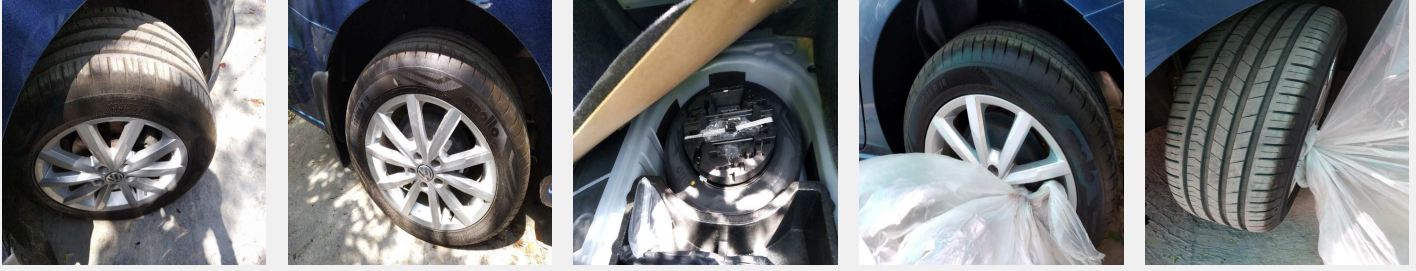
IMAGES

INSPECTION CHECKPOINTS	SCORE(X/10)	REMARKS/COMMENTS	OPTIONAL SPEND EST. (RS)
TYRES	8		0
SPARE TYRE (YES)	8		0
WHEEL ASSEMBLY (ALLOY RIM)	8		0

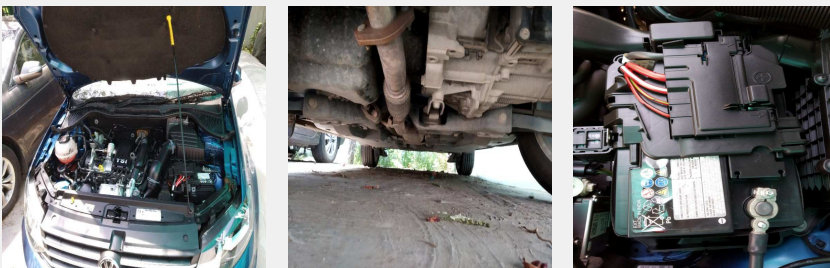
IMAGES

INSPECTION CHECKPOINTS	SCORE(X/10)	REMARKS/COMMENTS	OPTIONAL SPEND EST. (RS)
LH APRON	8		0
RH APRON	8		0
RADIATOR	8		0
WIRING	8		0
BATTERY	9		0
BRAKE FLUID LEVEL	8		0
ENGINE OIL	8		0
COOLANT LEVEL	8		0
BRAKE & COOLANT HOSE PIPES	8		0
UNDERCARRIAGE	8		0
EXHAUST SYSTEM	8		0
