# ECO INSPECTION CERTIFICATE

Order ID : 75041

121 Points Vehicle Inspection Certificate

## Toyota Etios Liva GD, 2013

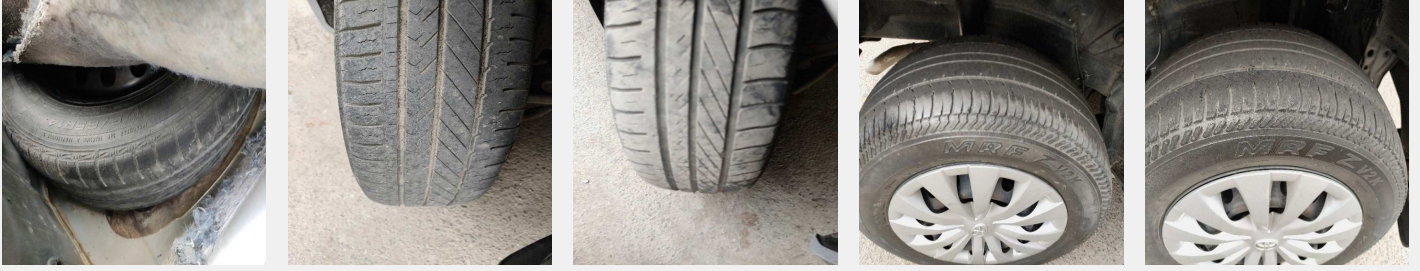
IMAGES

INSPECTION CHECKPOINTS	SCORE(X/10)	REMARKS/COMMENTS	OPTIONAL SPEND EST. (RS)
TYRES	7		0
SPARE TYRE (YES)	6	AVERAGE CONDITION	0
WHEEL ASSEMBLY (STEEL RIM)	7		0

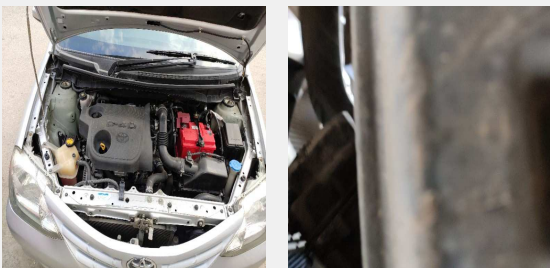
IMAGES

INSPECTION CHECKPOINTS	SCORE(X/10)	REMARKS/COMMENTS	OPTIONAL SPEND EST. (RS)
LH APRON	7		0
RH APRON	7		0
RADIATOR	7		0
WIRING	7		0
BATTERY	7		0
BRAKE FLUID LEVEL	7		0
ENGINE OIL	7		0
COOLANT LEVEL	7		0
BRAKE & COOLANT HOSE PIPES	7		0
UNDERCARRIAGE	7		0
EXHAUST SYSTEM	7		0

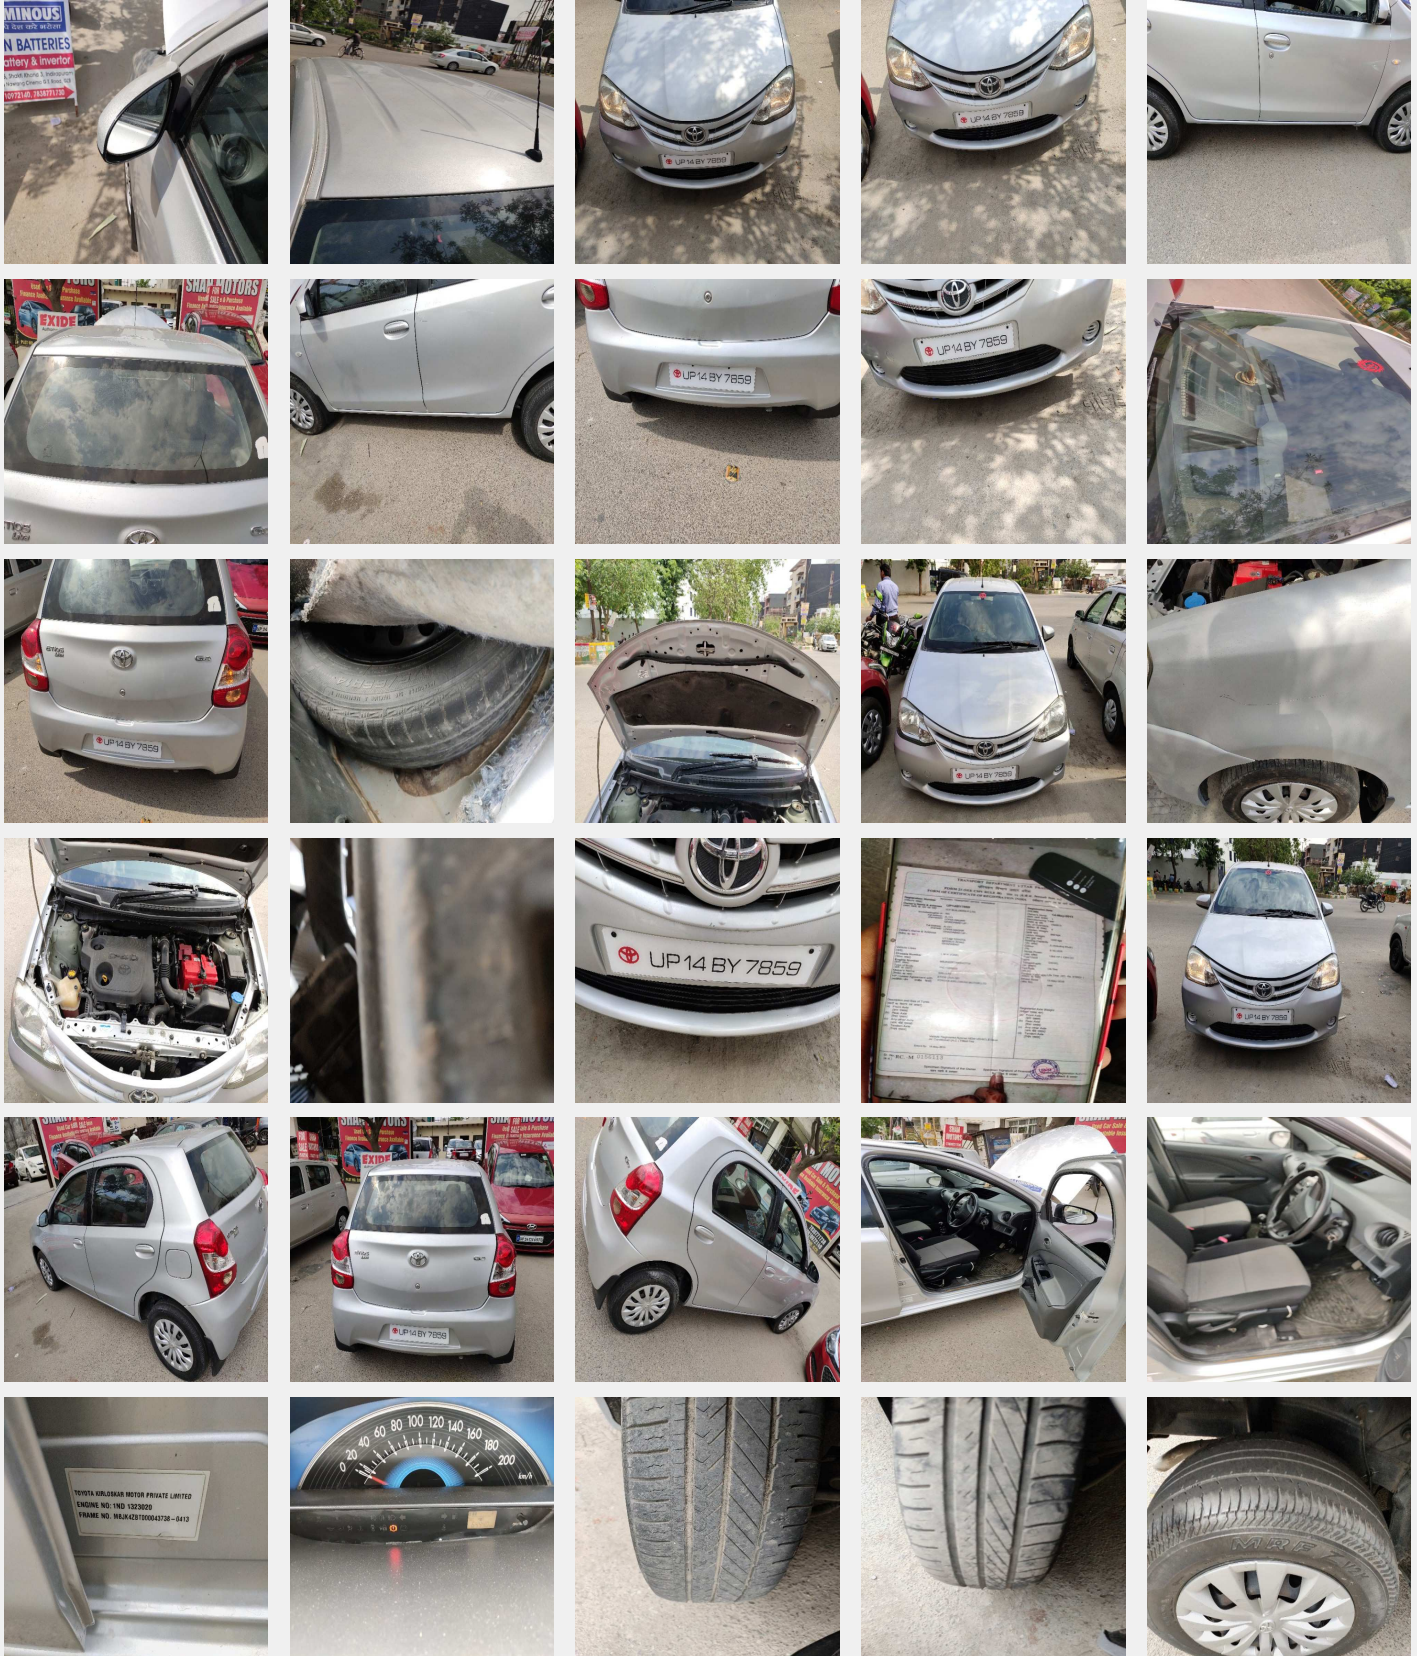
IMAGES

all body painted and scratches
