# ECO INSPECTION CERTIFICATE

121 Points Vehicle Inspection Certificate

Inspection Date :  
2019-07-12

## Chevrolet Beat PS DIESEL, 2012

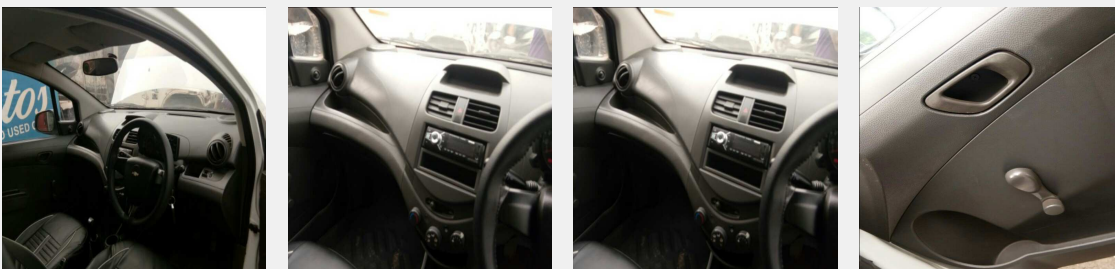
## IMAGES

INSPECTION CHECKPOINTS	SCORE(X/10)	REMARKS/COMMENTS	OPTIONAL SPEND EST. (RS)
DOOR PANEL	6		0
DOOR HINGES	7		0
CARPET & FLOOR MAT	7		0
SEAT & SEAT BELT	7		0
DASHBOARD & INSTRUMENT PANEL	7		0
HORN	7		0
SPEAKERS & MUSIC SYSTEM	7		0
HANDBRAKE	7		0
STEERING-MOUNTED CONTROLS	7		0
PEDALS	7		0
CENTRAL LOCK	7		0
A/C VENTS & HEATER	7		0
CUP HOLDERS	7		0
NAVIGATION (NO)	10		0
ODOMETER	7		0
POWER WINDOWS (NO)	10		0
HAZARD LIGHT	7		0
