Certification Package

MAHINDRA, XUV500, Delhi

ECO Inspection Certificate (3 of 3)

Mahindra Xuv500 W8, 2012

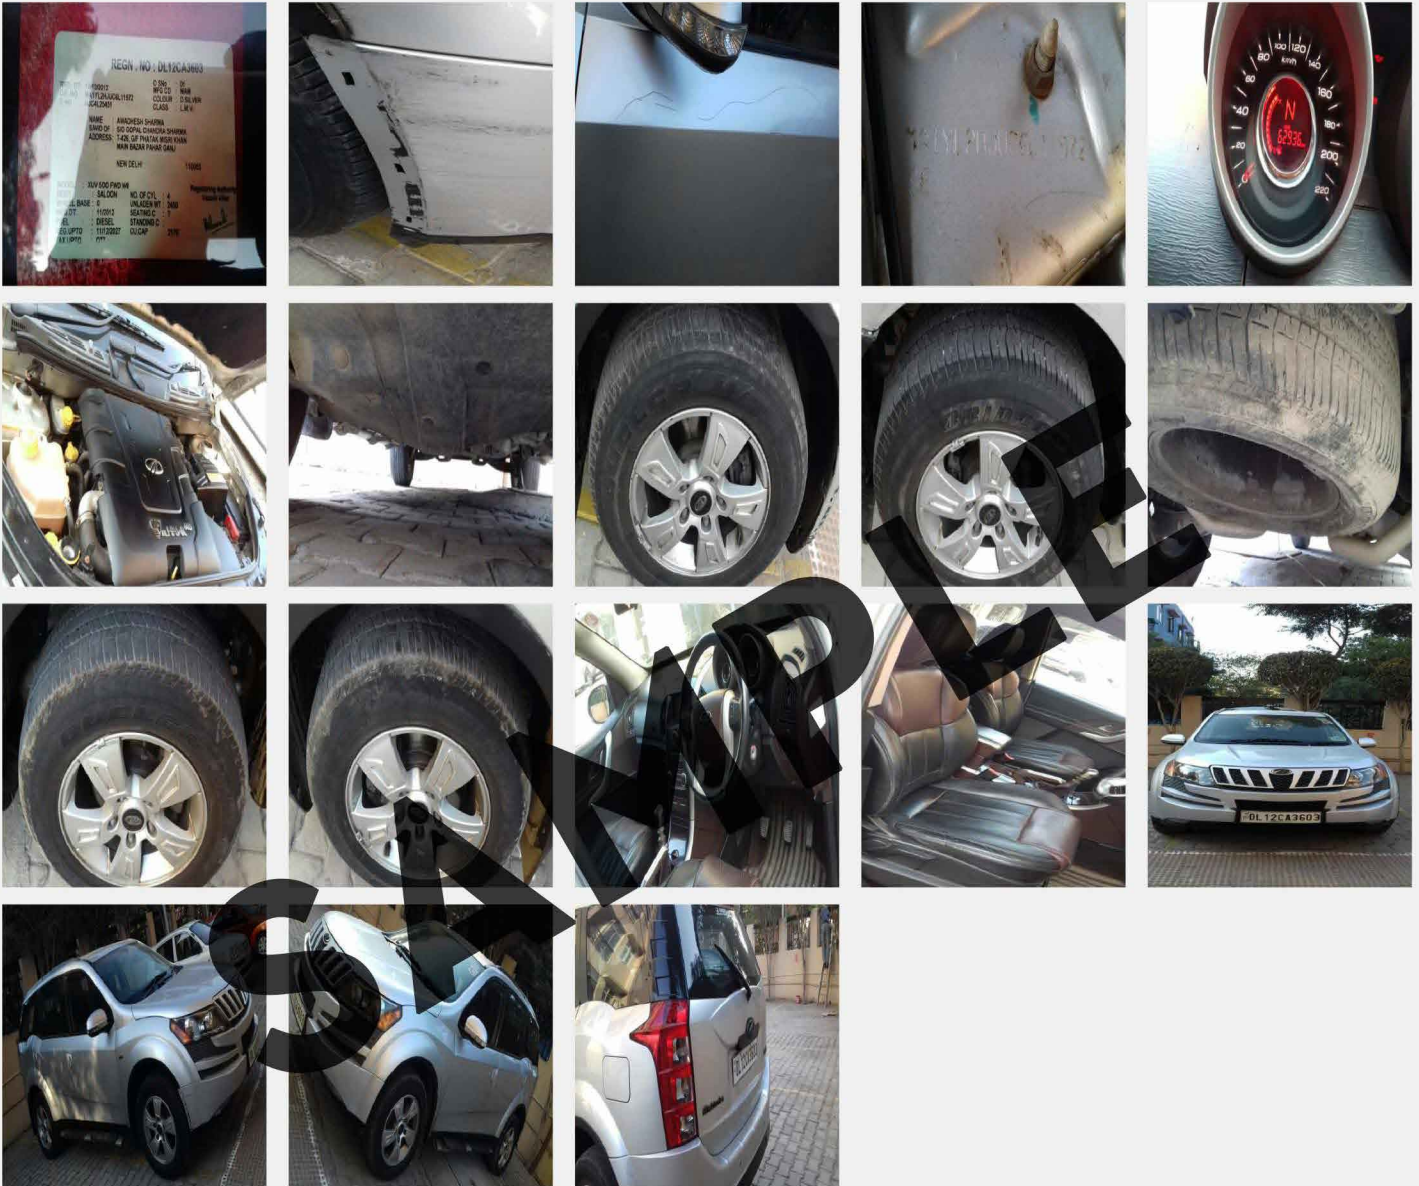
IMAGES

INSPECTION CHECKPOINTS	SCORE(X/10)	REMARKS/COMMENTS	OPTIONAL SPEND EST(RS)
LICENSE PLATE	7	GOOD	0
FRONT BUMPER	6	MINOR PAINTED	0
HEAD LIGHTS	7	GOOD	0
GRILLE	6	GOOD	0
TURN SIGNAL	7	GOOD	0
HOOD	6	MINOR SCREATCH	0
FRONT WINDSHIELD	7	GOOD	0
LH REAR DOOR	6	MINOR SCREATCH	0
LH RUNNING BOARD	7	GOOD	0
LH QUARTER PANEL	7	GOOD	0
FUEL LID	7	GOOD	0
REAR WINDSHIELD	6	MINOR SCREATCH	0
REAR BUMPER	7	GOOD	0
TAIL LIGHT	7	GOOD	0
