ECO INSPECTION REPORT

10 / 02 / 2022

Triumph Bonneville T100 2020

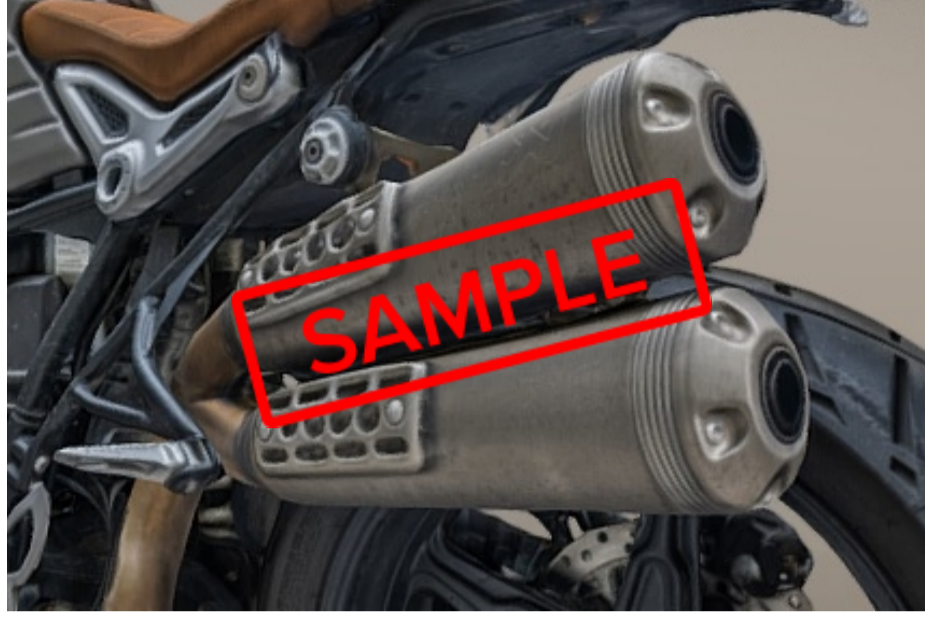
SILENCER/MUFFLER

Remarks: Silencer Not Working Properly
Repair Estimate: ₹ 350

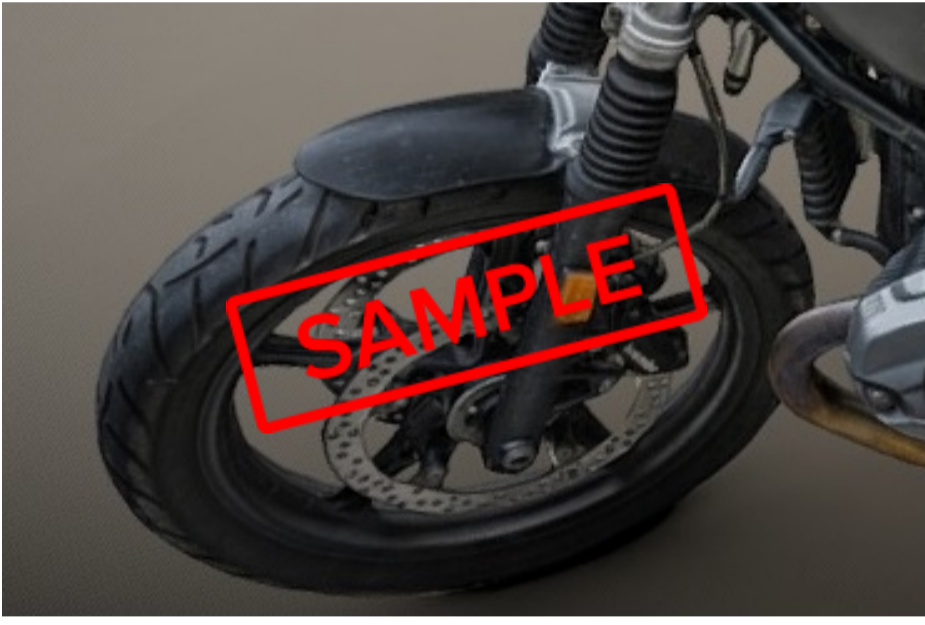
FRONT FENDER/MUDGUARD

Remarks: Front Fender Damage
Repair Estimate: ₹ 400

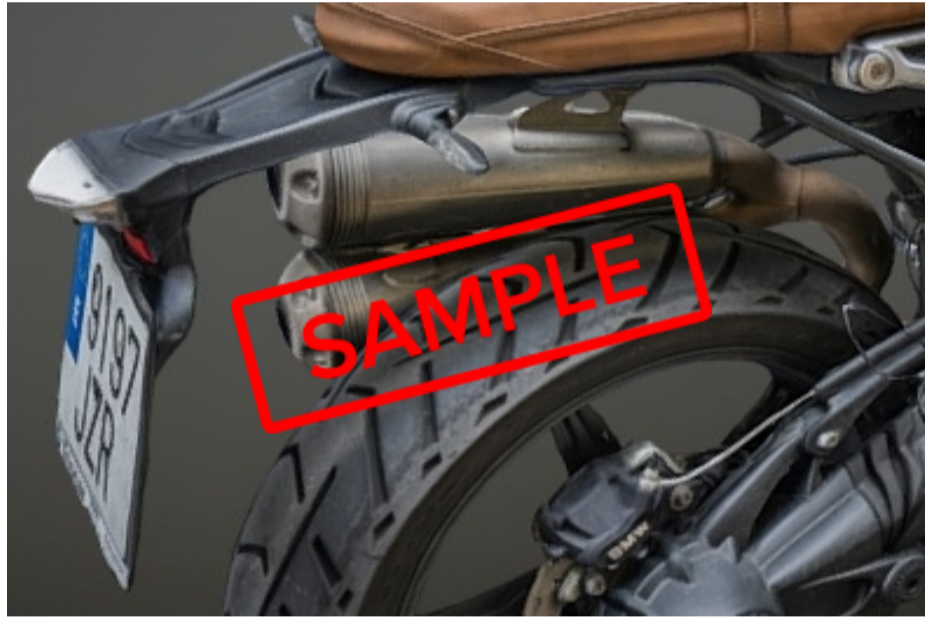
REAR FENDER/MUDGUARD

Remarks: Rear Fender Cracked
Repair Estimate: ₹ 300

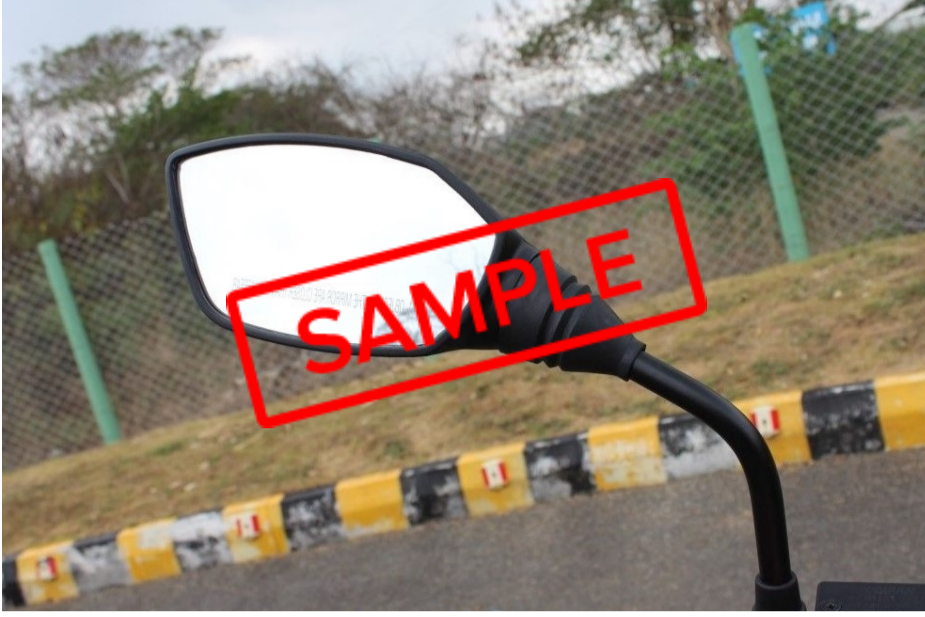
LH REAR VIEW MIRROR

Remarks: Glass Broken
Repair Estimate: ₹ 150

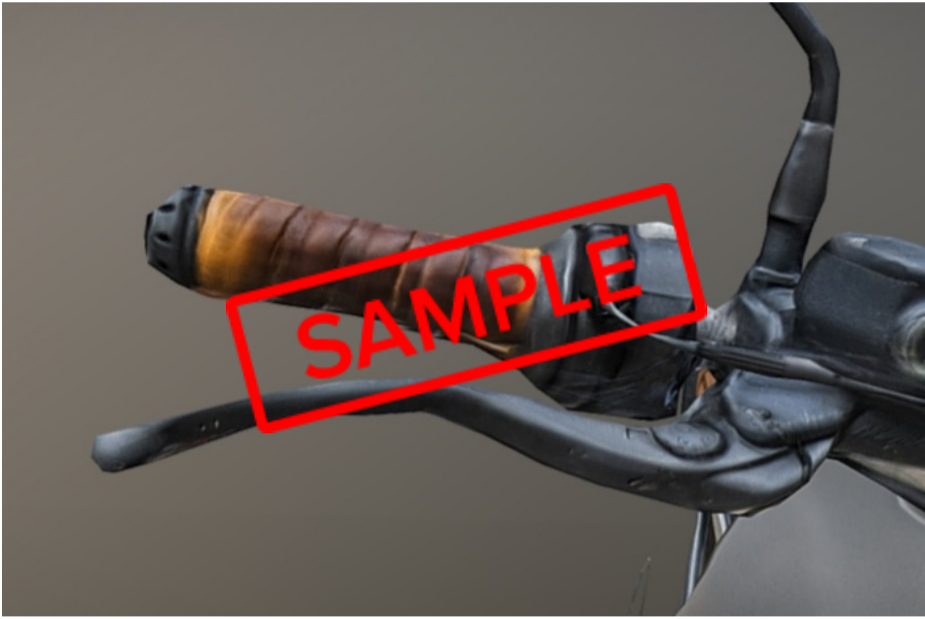
FRONT BRAKE LEVER

Remarks: Lever Bearing Needs To Be Replaced
Repair Estimate: ₹ 350

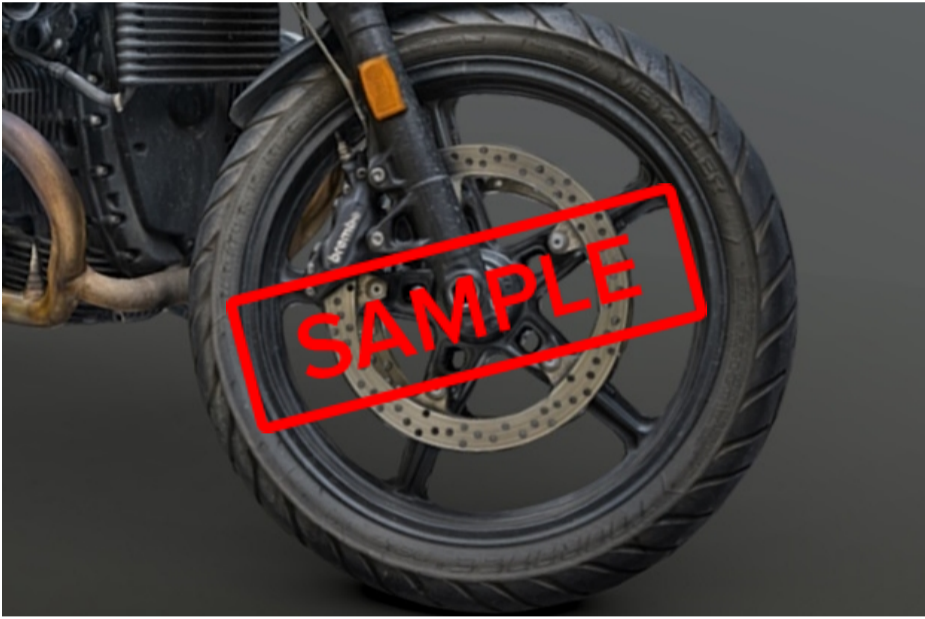
FRONT BRAKE

Remarks: Front Brake Needs Grease
Repair Estimate: ₹ 50

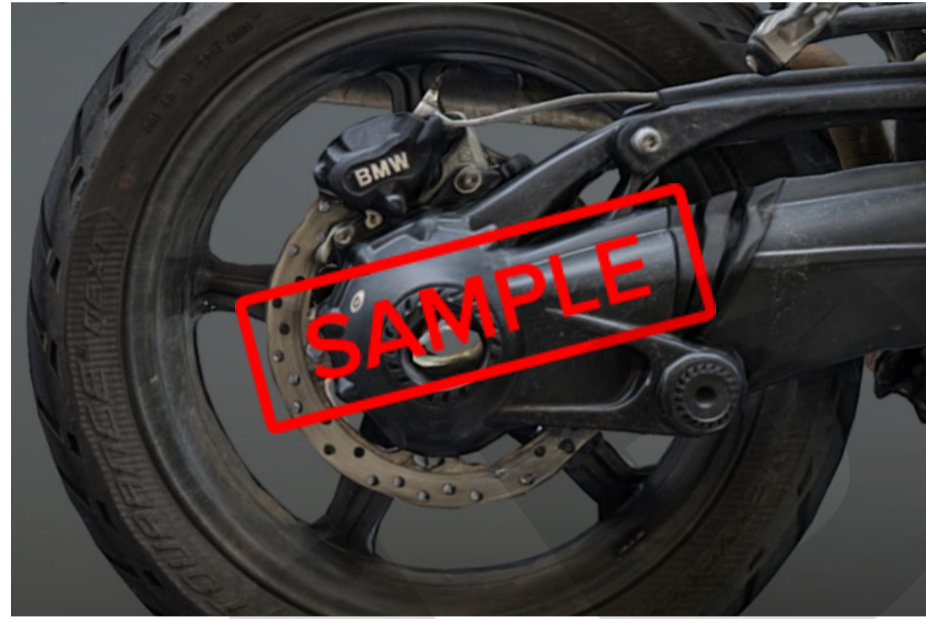
REAR BRAKE

Remarks: Rear Brake Need Overhaul
Repair Estimate: ₹ 800

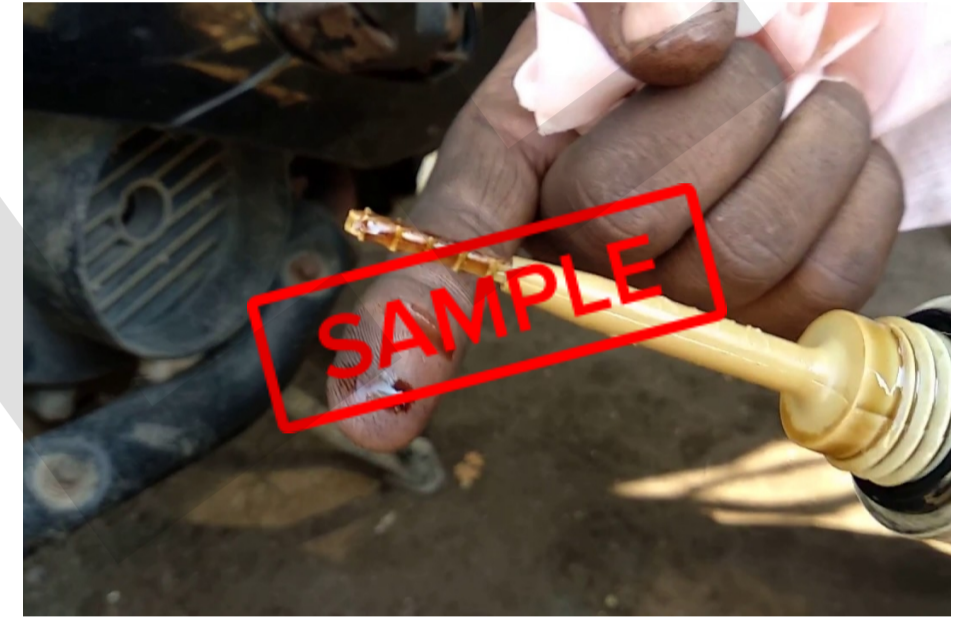
ENGINE OIL LEVEL

Remarks: Engine Oil Needs Replacement
Repair Estimate: ₹ 400

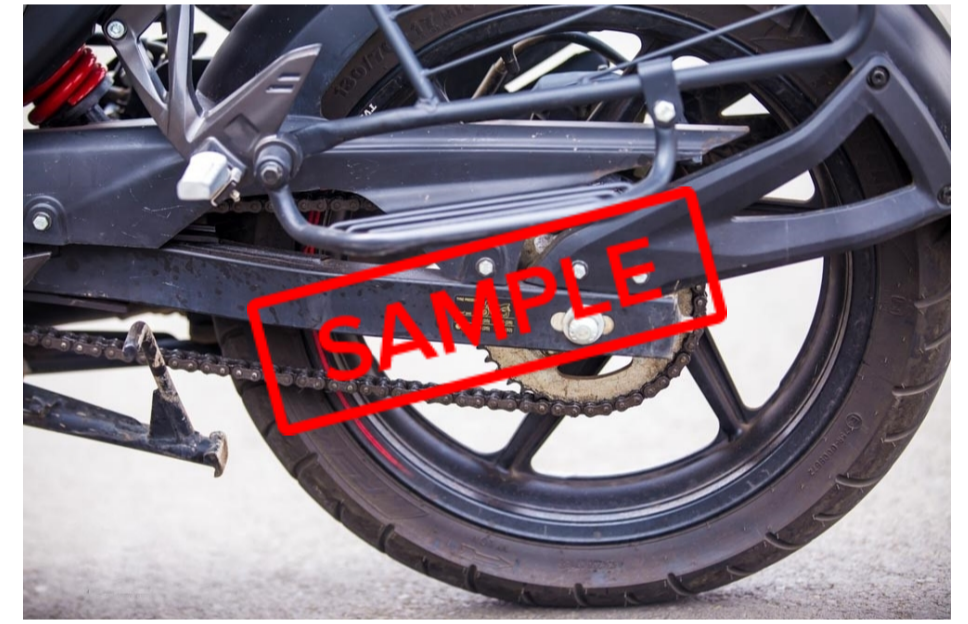
CHAIN TENSION

Remarks: Chain Performance Has Major Fault
Repair Estimate: ₹ 600
