ECO INSPECTION REPORT

10 / 02 / 2022

Triumph Bonneville T100 2020

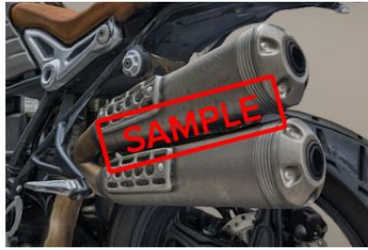
SILENCER/MUFFLER

Remarks Silencer Not Working Properly
Repair Estimate ₹ 350

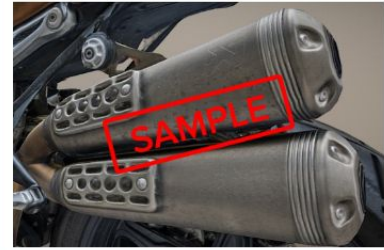
SILENCER COVER

Silencer Cover

4

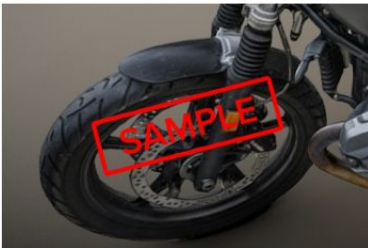
FRONT FENDER/MUDGUARD

Remarks Front Fender Damage
Repair Estimate ₹ 400

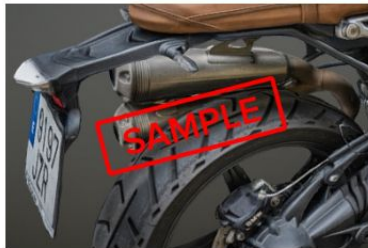
REAR FENDER/MUDGUARD

Remarks Rear Fender Cracked
Repair Estimate ₹ 300

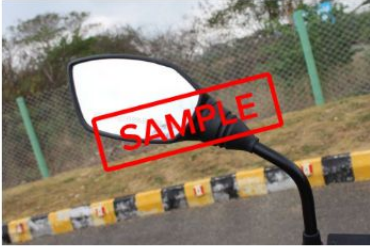
LH REAR VIEW MIRROR

Remarks Glass Broken
Repair Estimate ₹ 150

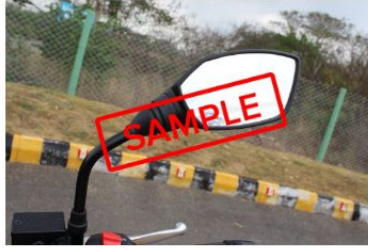
RH REAR VIEW MIRROR

Remarks Casing Torn
Repair Estimate ₹ 100

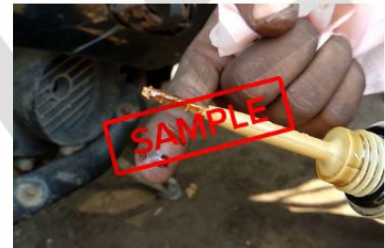
ENGINE OIL LEVEL

Engine Oil Needs Replacement
