ECO INSPECTION REPORT

Audi A4 Premium Plus, 2019

Make	Audi	Transmission Type	Automatic
Model	A4	Registration Type	Private
Year	2019	Registration No.	DL10CG3657
Trim	Premium Plus	VIN/Chassis Number	16191
Exterior Color	Terra Gray	Kms Run	25105
Interior Color	Beige	Manufacturing Date	2022-05-20
Body Type	Sedan	Registration Date	2022-07-15
Fuel Type	Petrol	Insurance Expiry	2020-7-14
Engine CC	200	CNG Validity	2025-6-20
Engine No.	452390	Location	Janak Puri
Number of Owners	2	Engine Sound Link	Listen Engine Sound

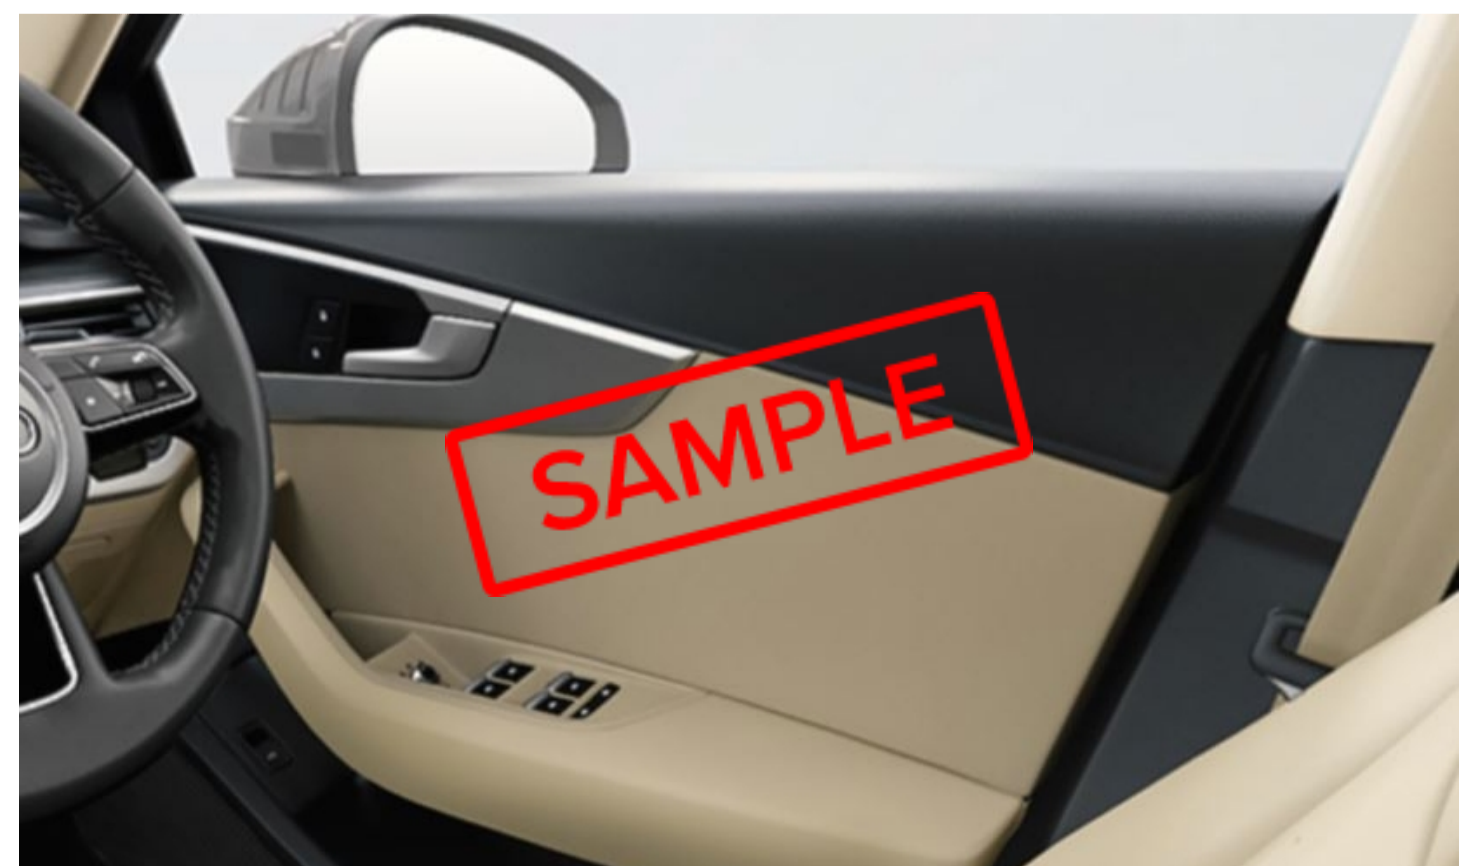
INTERIOR DOOR PANEL

Remarks: Power Window Not Working
Repair Estimate: ₹ 600

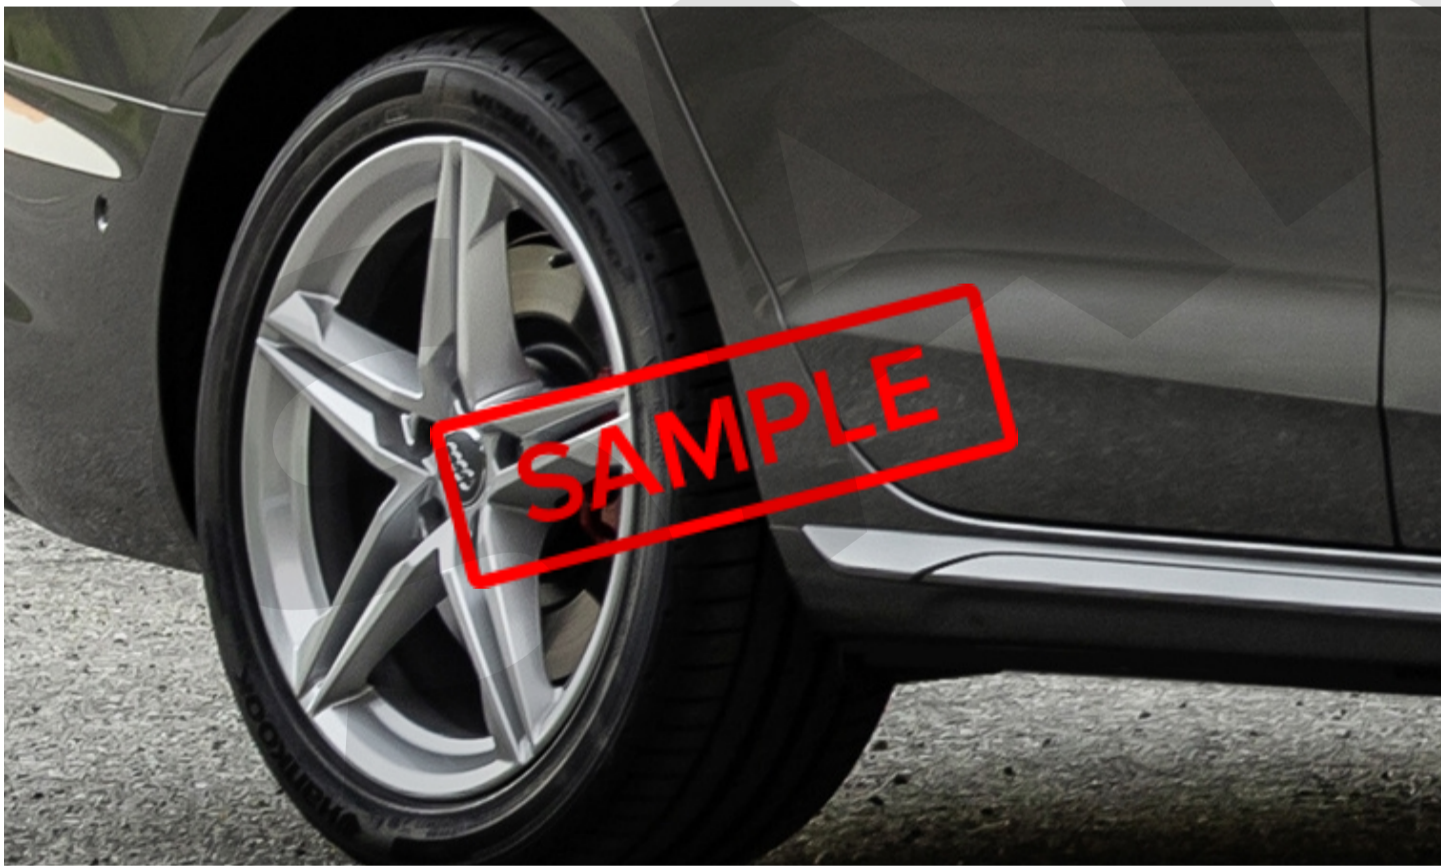
RIGHT FRONT TYRE

Remarks: Front tyres are not in a good condition
Repair Estimate: ₹ 600

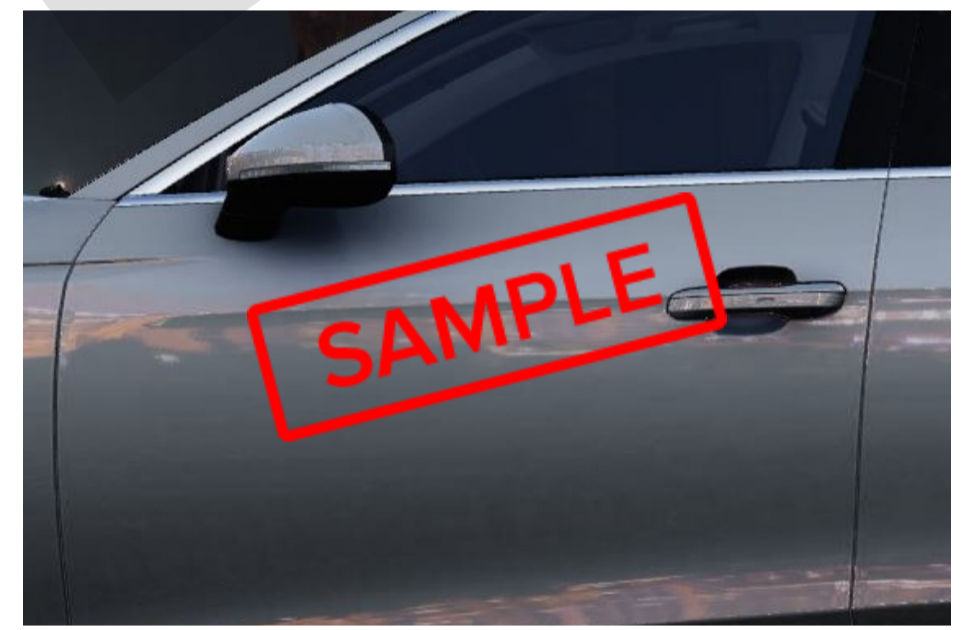
LH FRONT DOOR

Remarks: Scratches/Dents in Front Door
Repair Estimate: ₹ 900
